## Churches in Australia and New Zealand

**Cintec Australasia** has been responsible for the repair and strengthening of a number of significant church buildings in Australia and New Zealand. Starting with the earthquake restoration of Christ Church Cathedral, Newcastle which used some 4000 m of Cintec anchors (see separate **Cintec** publications), **Cintec** has gone on to provide sympathetic and cost-effective masonry strengthening solutions when alternatives involved demolition and rebuilding.

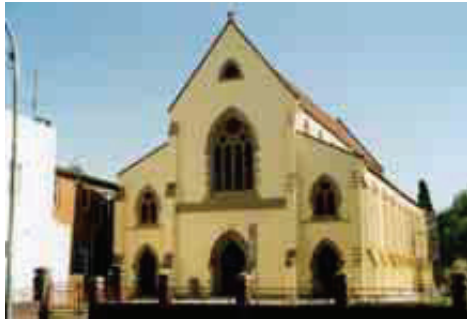
◀ Methodist Church, Maitland, NSW (1858). This building suffered damage in the 1989 Newcastle earthquake. 6 m Cintec anchors were used in the wall buttresses to provide the additional strength required to resist future seismic damage.

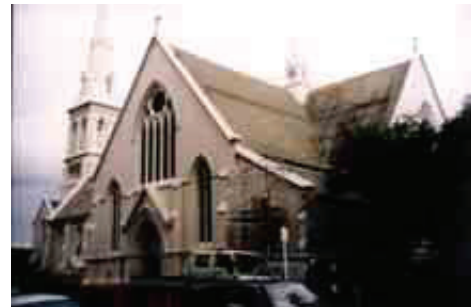
St Patrick's Cathedral, Auckland New Zealand (1885/1907). Cintec anchors up to 3 m long have been used to repair cracking from foundation movement. ▶

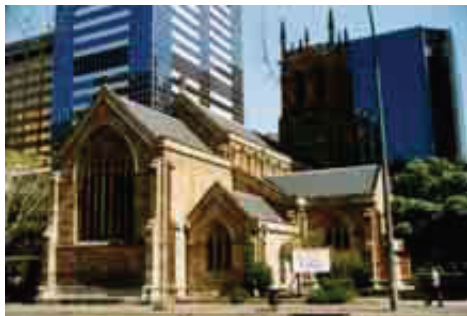
◀ St Philip's Church, Sydney, NSW (1856). Roof spread had led to wall cracking at eave level. Cintec anchors provided the economical repair solution with a guaranteed long life with no visible affect on the building.

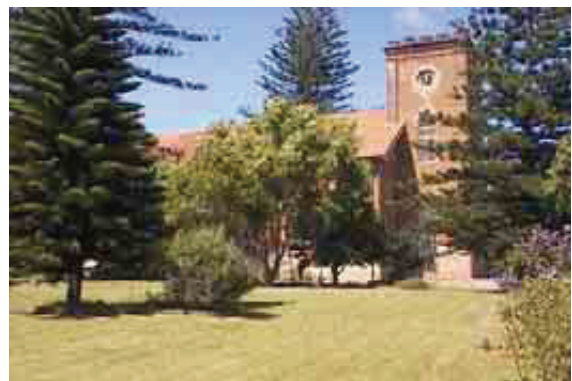
◀ St Paul's Church, Spring Hill, Brisbane, Queensland (1889). In order to protect the deteriorating stone spire of this church with a copper-clad cover, the tower had to be strengthened. 6 m long Cintec anchors in each corner of the tower provided the necessary extra strength. The tops of the anchors were threaded to fasten the frame of the cover.
