World Heritage Site Blaenavon Iron Works South Wales (UK)

Conservation of Blaenavon Ironworks in South Wales continues to rely on Cintec anchors to solve the problem of stabilising walls of unknown and inconsistent structure.

The 2003/4 phase of conservation of this historical industrial site involves both the stabilising of retaining walls and the strengthening of an adjacent Gas Tunnel built into the hillside behind the site's five furnaces.

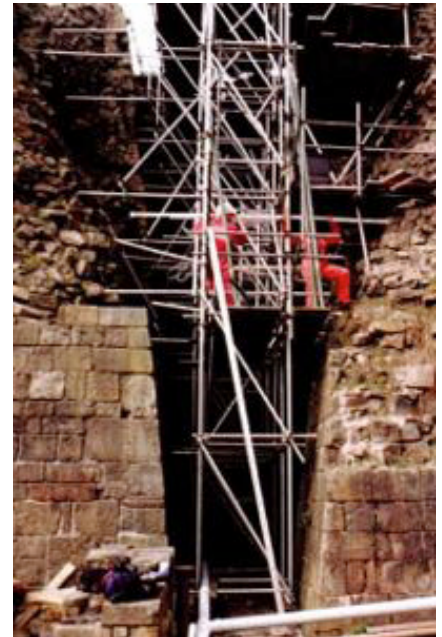
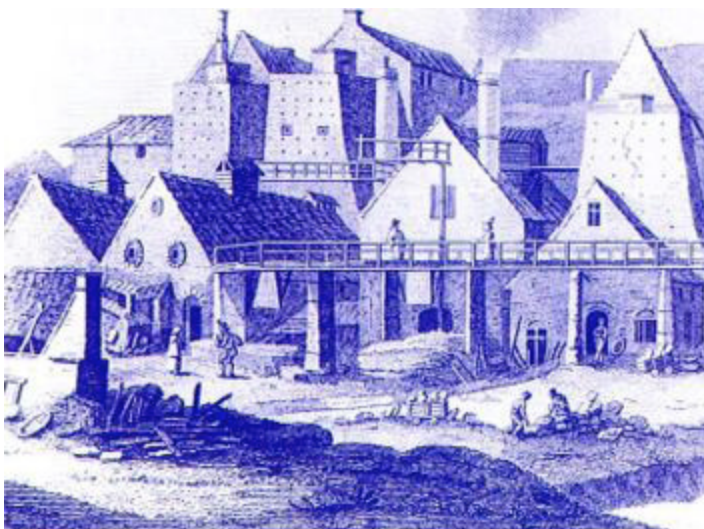
The remaining furnaces required consolidation. In the first phase of this long term and ongoing project, a series of Cintec anchors were installed to support the delicate structures and so enable more extensive repairs and refurbishment to proceed. (middle right).

Working in very difficult conditions, data was acquired so that 3D models could then be generated to facilitate the accurate positioning of the strengthening anchors. (below right).

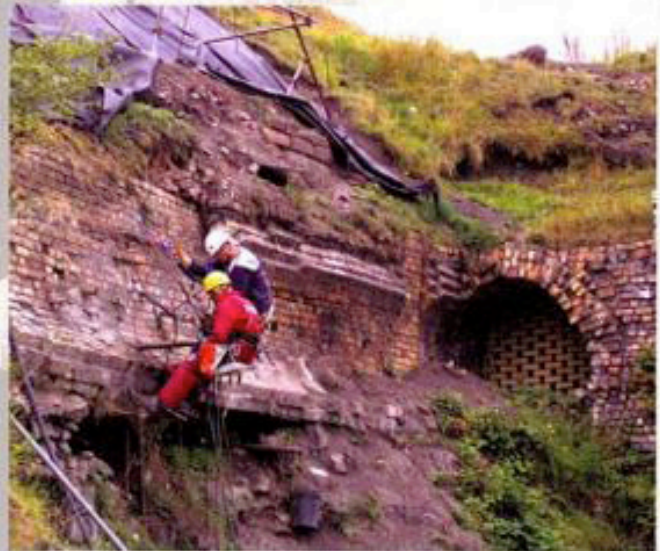
A double mining barrel, with an inner and outer sleeve, was used in areas where drilled cores could collapse before reinforcing members could be introduced due to the instability of the wall materials. The outer sleeve then creates a rigid conduit for the inner sleeve to work through, allowing core to be extracted to the required depth. With the outer sleeve still in place, the inner sleeve is removed and the Cintec anchor system inserted. The outer sleeve is then withdrawn before the anchor is permanently bonded into position with injection of grout into the Cintec sock.
