*HEMSLEY BUILDING 230 PARK AVENUE, NY, NY U.S.A.: TERRACOTTA REPAIR*

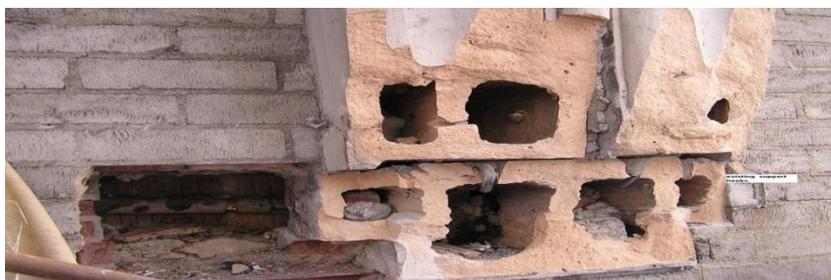
By 2009, the building had begun to show its age. At the top of the building some of the twenty-six east and south facing Terra-Cotta columns [ with the base starting at the 26<sup>th</sup> floor and extending past the 34<sup>th</sup> floor] had begun to show cracking and in some areas had begun to shed large pieces of stone. The building owners/management had inquired as to replacement cost of these Terra-cotta Brackets and had been quoted prices exceeding 16 Million dollars. By employing the Cintec method of repair, the owner was able to save more than 15 million Dollars effecting by repairs for just over 1million dollars.
