## Castle Ward House

Castle Ward House is situated near Strangford, Northern Ireland. The property was constructed in 1756.

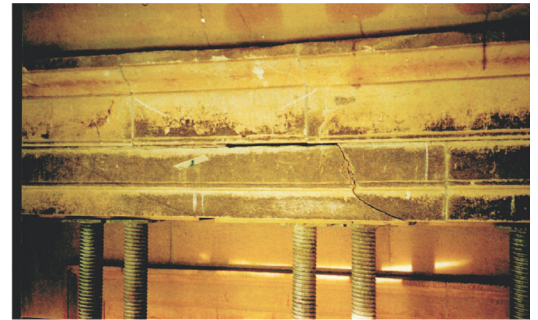
An inspection during the course of repairs revealed that one of the original timber beams in the area of the Tympanum had seriously decayed. This beam acted as a support for the upper stonework and a hanger for the lower stones. With this decay the lower stones had cracked and showed signs of falling out.

First sign of distressed beam

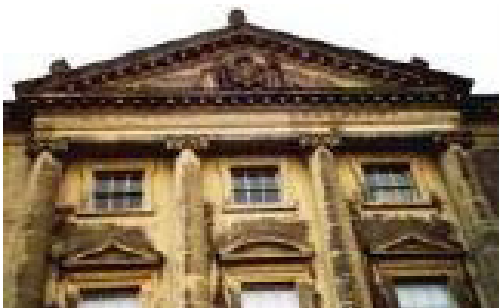
External upper beam area

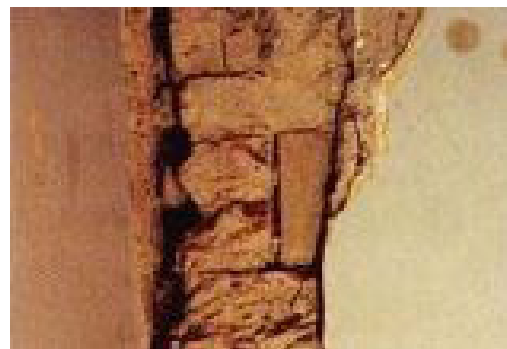
Internal damage of wooden beam

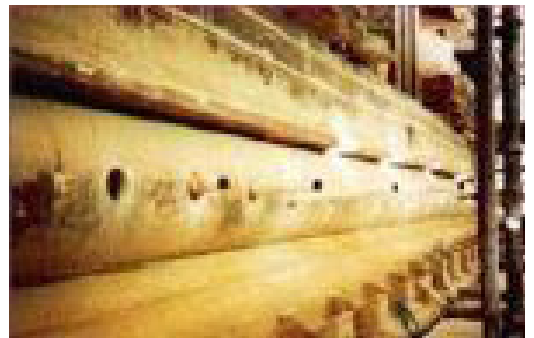
Anchor installation

Because of the failure of the beam the immediate problem of support was solved by using 15x15x1000 mm SHS stainless steel anchors both horizontally and vertically.

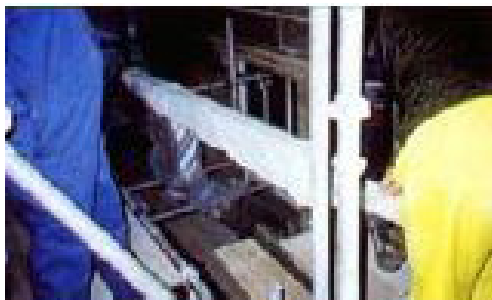
Insitu assembly of 100x100 mm stainless steel 10m anchor

These beams were constructed of 100mm x 100mm stainless steel box sections shrouded in a 300mm sock, with an outer sock for protection. These beams were slid into position and shuttering was installed to prevent grout overhang. 300 kgs of grout were pumped between the sock and the exterior of the beam to form a perfectly contoured support.

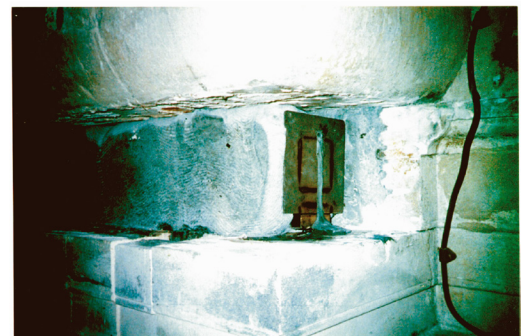
Beam after grout injection
