Christ Church Cathedral Newcastle, New South Wales, Australia

Christ Church Cathedral - The Repair

Case History

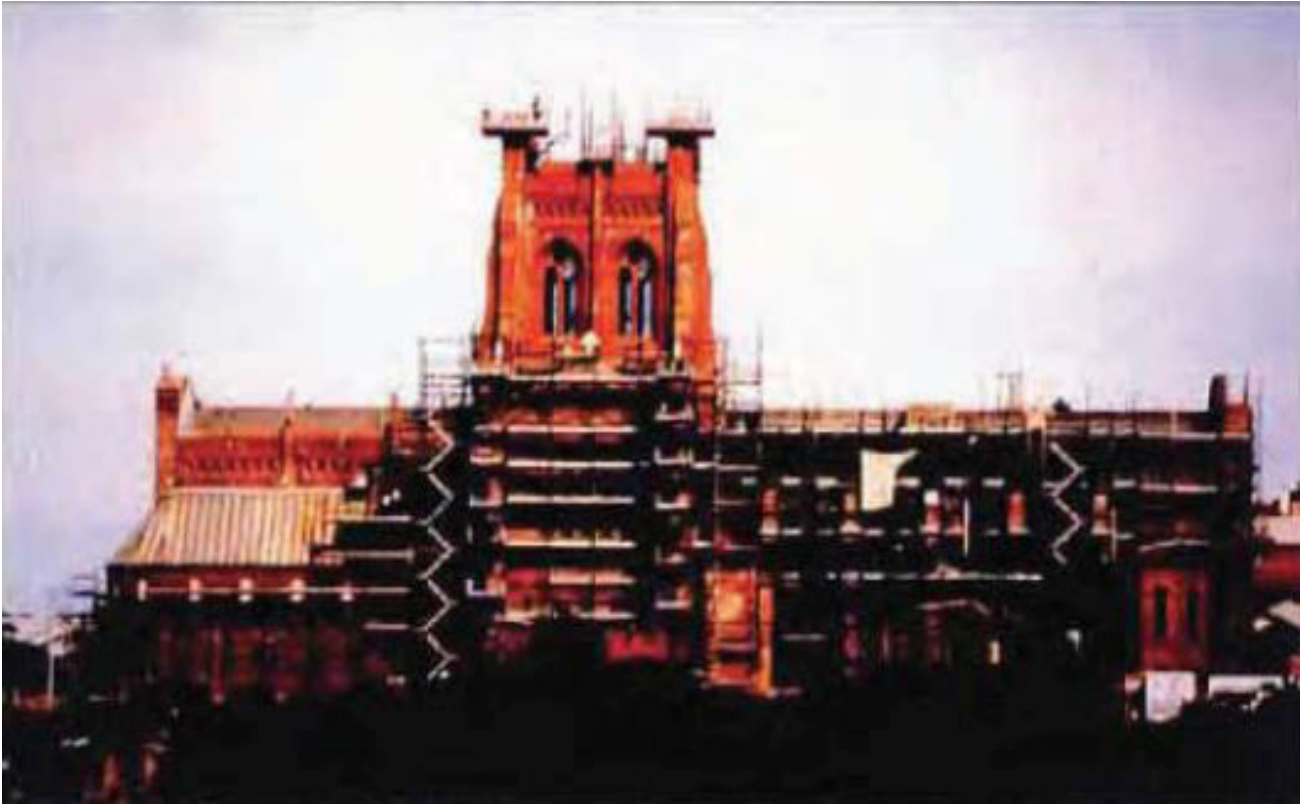
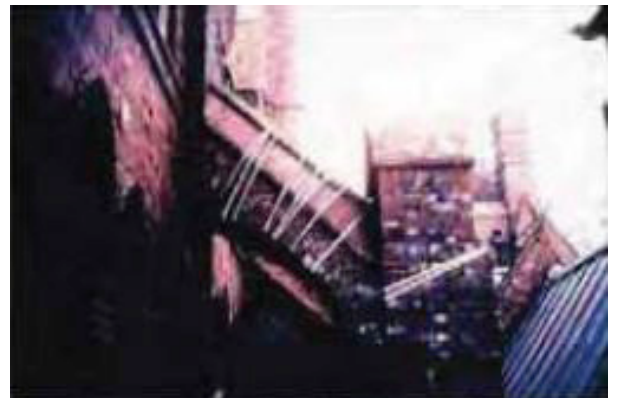
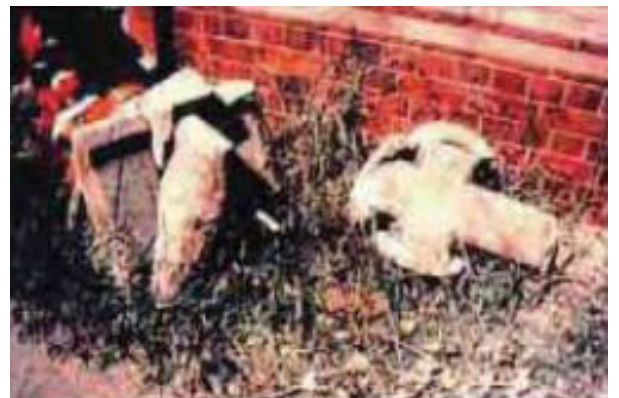
Christ Church Cathedral - The Damage

The effect of the earthquake was largely as might be expected: high set stone crosses and other decorations fell to the ground, flying buttresses were dislodged, shear cracking occurred in the north and south walls and out-of-plane movements occurred in the east wall, dislodging windows.

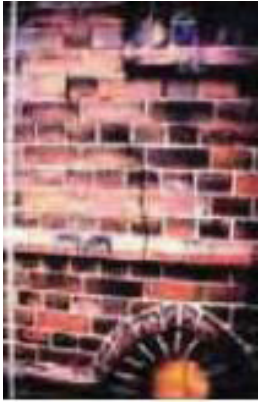
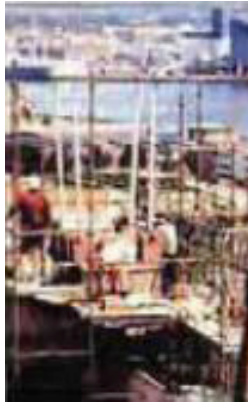
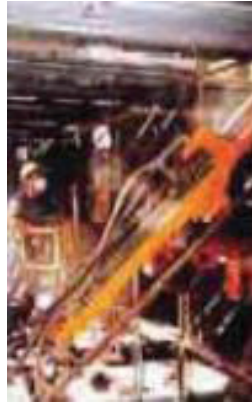
The aim of the repair and reinforcement work was to turn the building from a brittle to a ductile structure, able to resist future earthquake. Cintec anchors were used to reinforce walls and piers, horizontally and vertically. Some steel frames were used where they could not be seen, behind parapet and in the tower.

Cintec anchors used on the project ranged from 215 mm long RAC cavity ties to 32 meter long anchors in the nave walls which were manufactured from 32 mm diameter "Hi-proof" grade 316 deformed stainless steel bar. All the long anchors had to be manufactured on site, with long vertical anchors being installed by crane. The 32 meter anchors were the longest ever installed by Cintec and amongst the longest in the world.

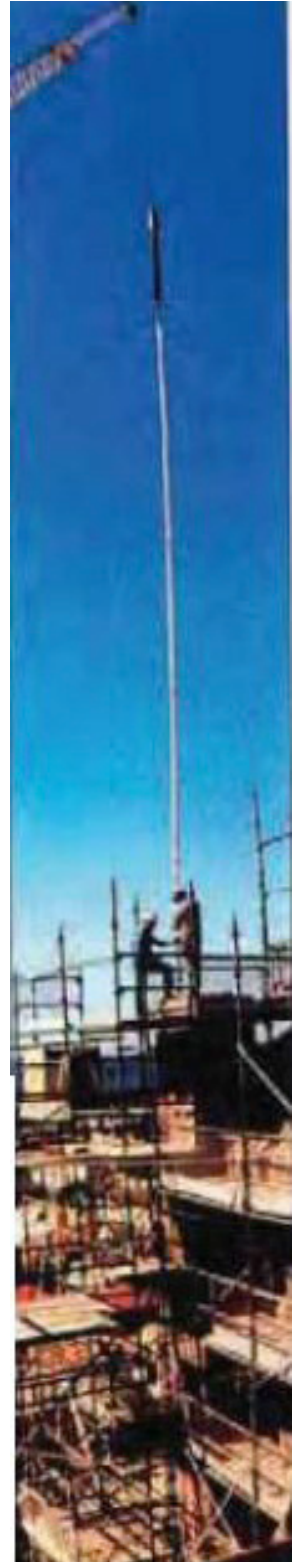
20 m vertical anchor being placed by crane in the project which saw anchors up to 32 m horizontally, Cintec's longest to date.
