Churches in Australia and New Zealand

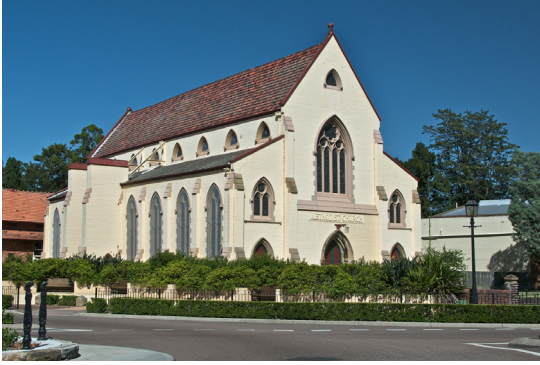
◀ Methodist Church, Maitland, NSW (1858). This building suffered damage in the 1989 Newcastle earthquake. 6 m Cintec anchors were used in the wall buttresses to provide the additional strength required to resist future seismic damage.

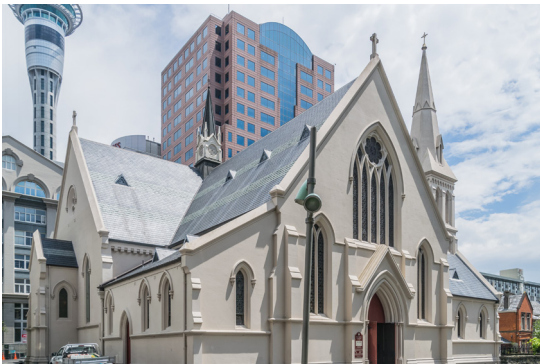
◀ St Patrick's Cathedral, Auckland New Zealand (1885/1907). Cintec anchors up to 3 m long have been used to repair cracking from foundation movement.

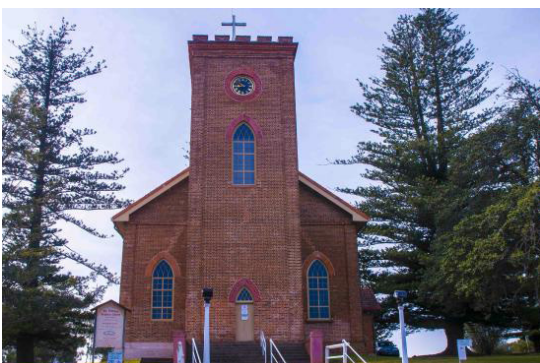
◀ St Thomas Church, Port Macquarie, NSW (1826). This church, built by convict labour from hand-made bricks has suffered foundation movement leading to instability at the corners. Following foundation stabilization, Cintec anchors up to 4 m long have been used to restore the strength of the corners of the building.
