CINTEC ANCHORS FOR HISTORIC BODIAM BRIDGE

Cintec anchors for historic Bodiam Bridge

Tim Bilson
Scott Wilson Kirkpatrick

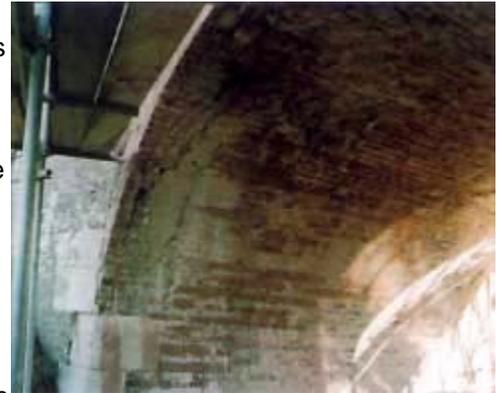
Typical damage to the soffit of the bridge

This has led to cracking of brickwork adjacent to the arch voussoirs, some movement in the spandrel walls, and delamination of the wing walls at the south end.

The current remedial work involves the repair of cracking in the brickwork. The concentration of the damage in the two side spans of the three span bridge suggests that the initial cause was possibly impact loading towards the ends of the bridge before the 'hump' was levelled out in 1982. This impact loading will have had the effect of forcing out the spandrel walls. Frost damage during the cold winters of 1986 and 1987 and washing out of mortar have further developed the initial effects.

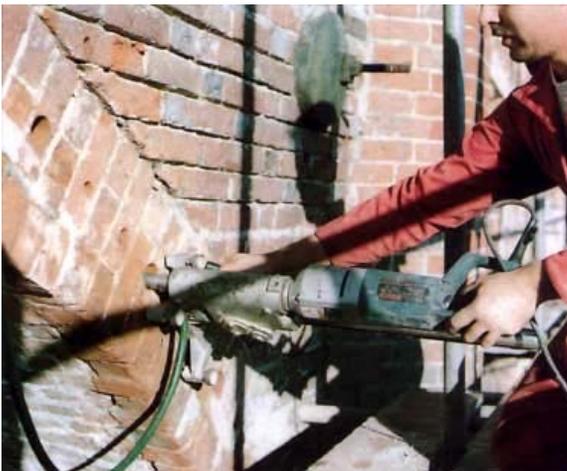
Core drilling holes for the anchors

To prevent any further spreading of the arches, it was proposed to the across the full width of the bridge. The main anchors are 20 x 20 x 2.0 SHS with the lengths, of 2.0m and 1.0m, staggered from both sides of the bridge. This ensures that the lateral stresses are not transferred to a single plane nearer the centre-line of the bridge causing new cracking at this point. Strengthening of the local edge damage to the brickwork of the arches is achieved with the installation of the 450mm long RAC anchors formed with 8 x 1.5mm circular hollow sections. The interspacing of the two anchors allowed the 15mm diameter holes for the small anchors to be used for the fixing of the stand used with the diamond drilling of the 52mm holes for the main anchors, this keeping the making good to a minimum. Following grouting of the anchors the holes were made good with coloured mortar to match the brickwork.

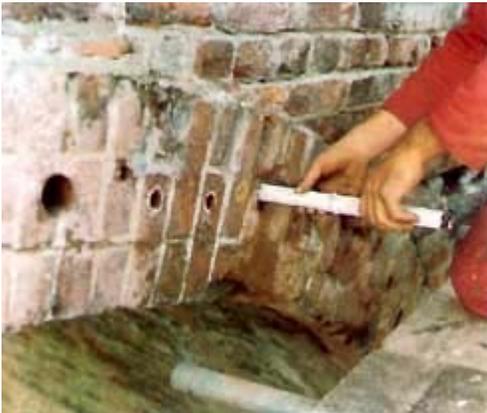
Placing the anchor in the prepared hole

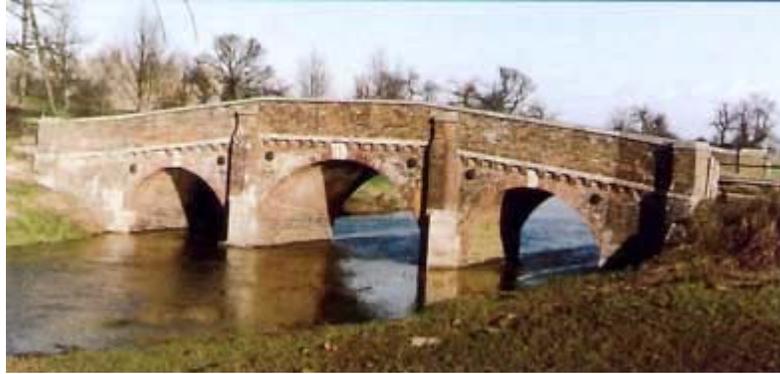
Bodiam bridge after completion with the castle behind the trees in the background.
