## Cymer Abbey, Dollgellau, Wales

### NAVE ARCADE STABILISATION WORKS

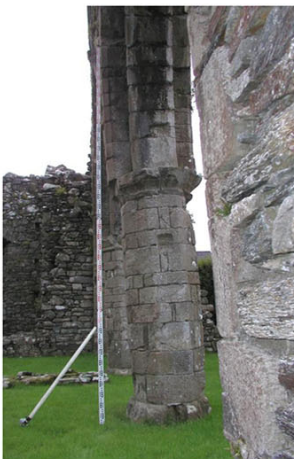
Image revealing the extent of wall and column rotation prior to stabilisation

Under the direction of CADW, structural engineers Mann Williams undertook inspection and monitoring of the abbey. This revealed progressive movement of the north arcade masonry which had become unstable to the point where propping was necessary to prevent collapse. For the long term it was decided to use Cintec structural reinforcements because in the words in Mann Williams *"The technique has been recently used successfully on a scheduled ancient monument, and has the advantage of retaining the largest proportion of the original structure in-situ. On completion of the works there is minimal evidence of the work having been implemented"*.
