Don Valley Brickworks Chimney Restoration, Toronto, Ontario, Canada

Architects:
McGillivray Architects

Structural Engineers:
Halsall Associates Ltd

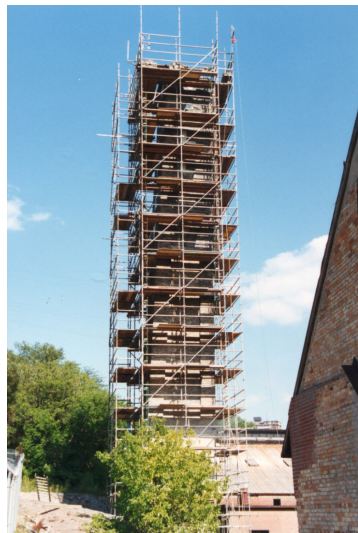
Chimney Restoration
In Progress

The Chimney, built in about 1890, had serviced three adjacent downdraft kilns. The shaft had been deteriorating through the years and had become a pigeon roost! Significant cracking appeared on the east and west elevations and it was found to be leaning almost 43 inches (1.09m) to the south and a bit to the west. The corrective action was to stitch two sides together using the Cintec Anchoring System. The Cintec Canada Company had had previous experience in similar projects obtaining excellent results in what is truly corrective surgery on buildings. The restoration work also included substantial repointing and some brick replacement.

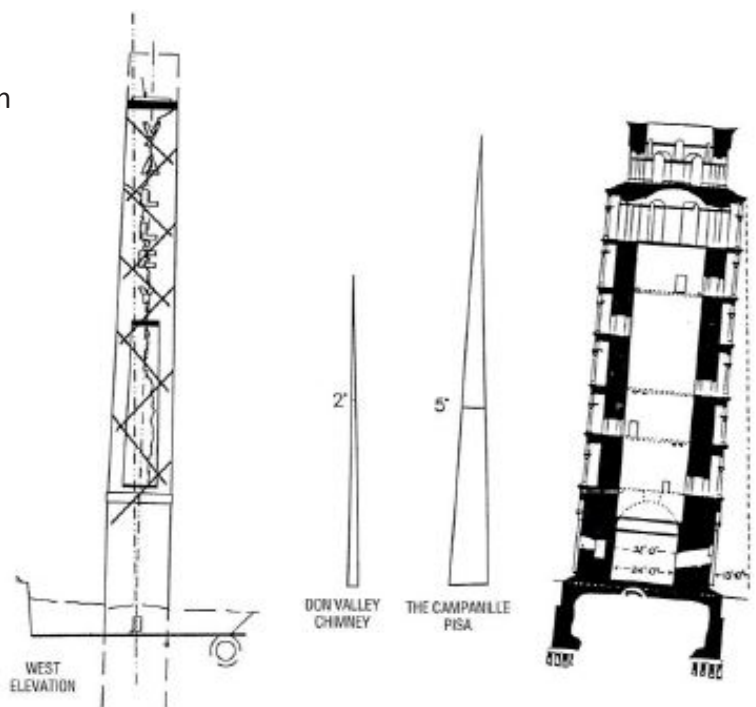
Drawing of the Don Valley
Brickworks Chimney in relation
to the Leaning Tower of Pisa
