HARTPURY TITHE BARN, GLOUCESTERSHIRE, UK

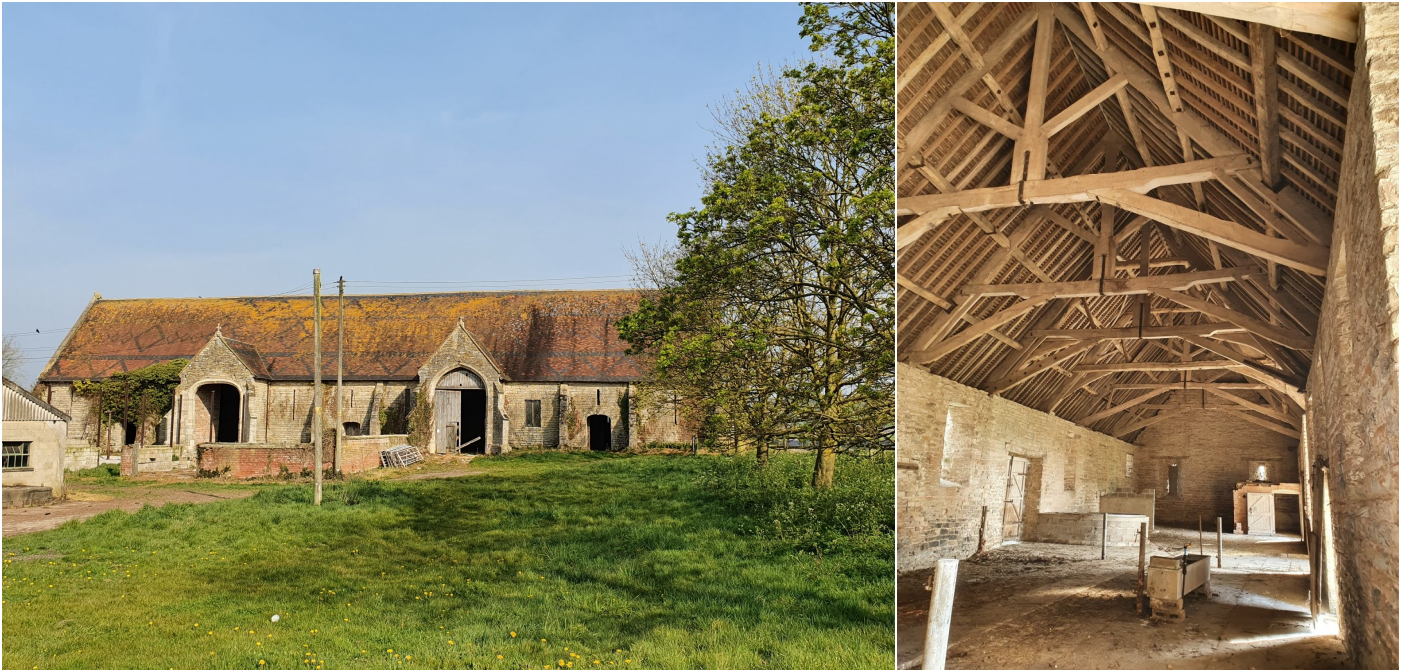
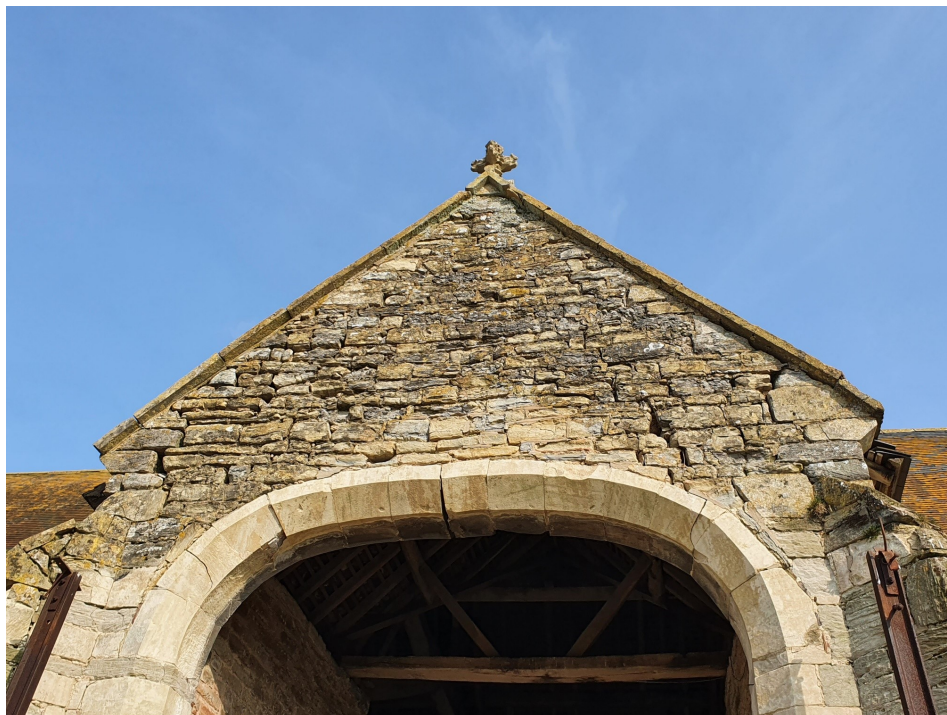
The structural integrity of one of the main arches above one of the main entrances had been compromised by settlement and rotation of left hand return wall due to older alterations to the adjacent ground.

John Topp of structural engineers O'Brien and Price, The Old Bakehouse, Monmouth Rd, Tintern, Monmouthshire, NP16 6SE, undertook a full structural survey and devised a solution using Cintec anchors to eliminate the problems caused by the movement of the wall. The arch was ambitiously flat when originally built centuries ago and the movement of the wall at the springing destabilized the arch to the extent that hinges were formed at the quarter point and the apex.

Temporary timber propping was in place to support the failing arch while the installation of anchors was carried out.

Falcon Structural Repairs Ltd of Bristol drilled and installed two Cintec anchors in excess of 5 metres in length through the failed arch stones using mining barrels which were 55mm in diameter.
