Hemsley Building 230 Park Avenue, NY, NY U.S.A

The Property

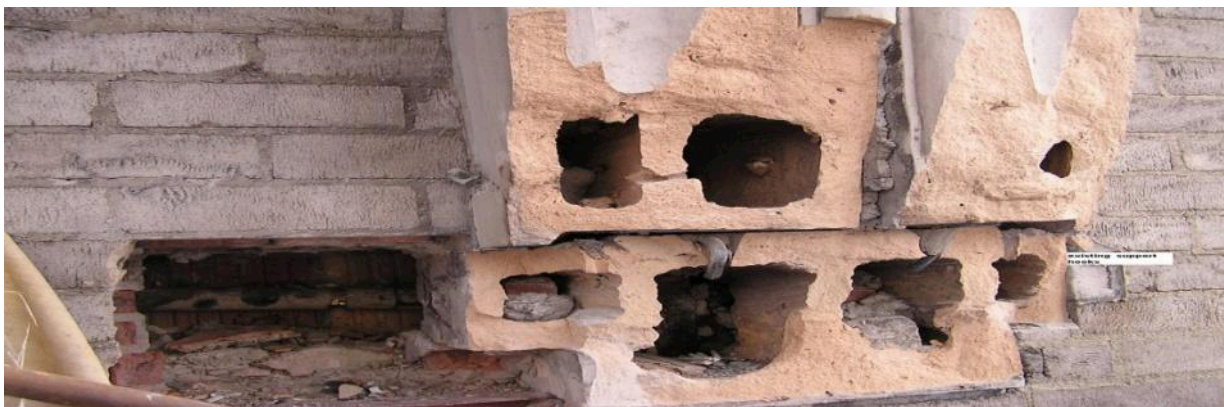
By 2009, the building had begun to show its age. At the top of the building some of the twenty-six east and south facing Terra-Cotta columns [with the base starting at the 26th floor and extending past the 34th floor] had begun to show cracking and in some areas had begun to shed large pieces of stone. The building owners/management had inquired as to replacement cost of these Terra-cotta Brackets and had been quoted prices exceeding 16 Million dollars. By employing the Cintec method of repair, the owner was able to save more than 15 million Dollars effecting by repairs for just over 1million dollars.
