Leaderfoot Viaduct, Scottish Borders, U.K.

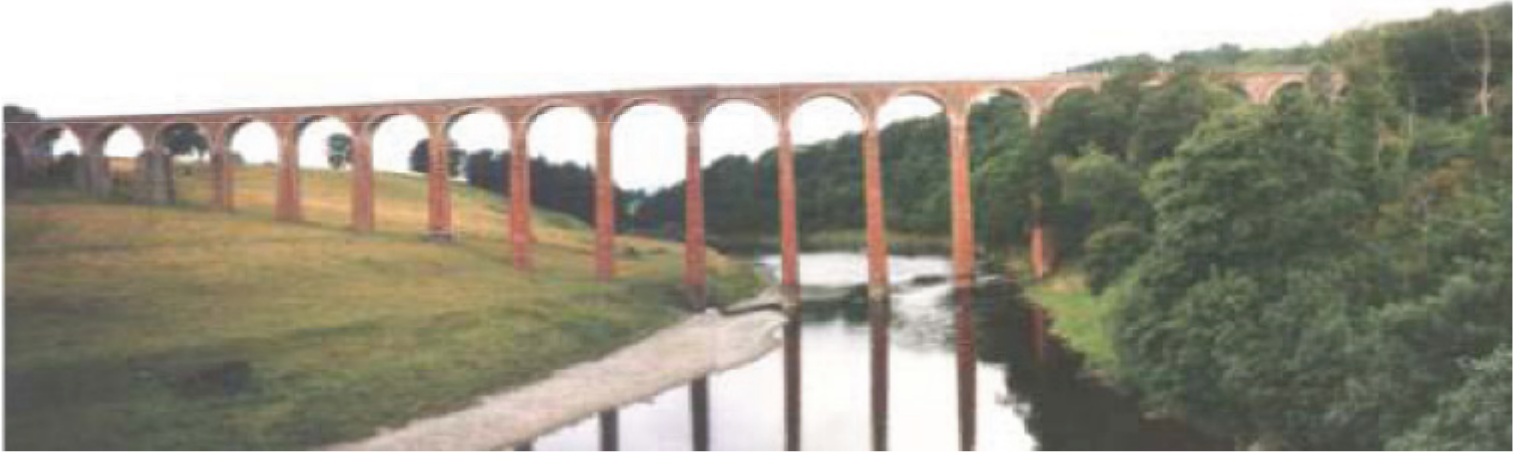
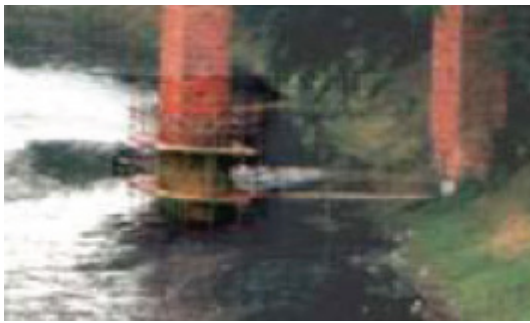
Located in the Scottish Border country, the Leaderfoot Viaduct has four of its piers with foundations in the river Tweed, the brick masonry is protected by stone block 'boots' designed to deflect water and flood debris. However in 1994, after more than a century of service, extensive cracking had developed between the stonework and the brick masonry both above and below the water line. Although not exceeding 5ft in depth, divers were required to assess the extent of damage underwater. A remedial solution for re-securing the two elements was devised by the

installation of sixteen; 2/4 inch Cintec rebar anchors, 6ft in length and four per pier.

Under the supervision of the local river authority, holes were drilled at a downward angle through the boots into the piers. These instantly filled with river water, however due to the unique nature of the Cintec anchor - filling a mesh fabric sleeve from the rear to the front, all water was fully displaced upon grout injection. The visible cracks were sealed manually by inserting lengths of sock into the fissures and expanding them. The subsequent watertight seal allowed conventional grouting to be injected into any remaining internal voids without danger of release into the water system.
