Structural  
repairs to  
high rise  
buildings

Report into the proposed strengthening of Highways  
1 Killingbeck, Leeds.

11 Storey REEMA Block

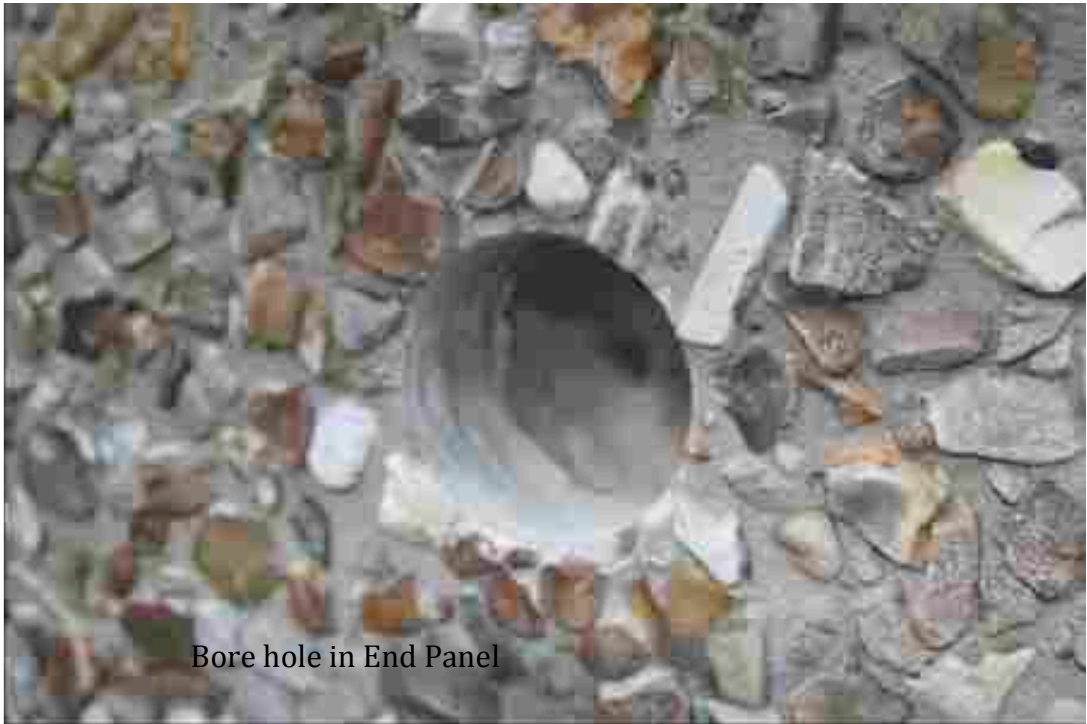
Bore hole in End Panel

The inspection took place on the second week of December 2014 following erection of the working platforms provided by the client. Scaffold access was provided to the eastern end of Highways 1 and Highways 2 up to the first floor. It was decided that the floor and wall connection on the Highways 1 was the best area to open to view the internal connections. Also, diamond drilled 60 mm core holes were drilled on a return panel to establish the form of construction on that part of the walls.

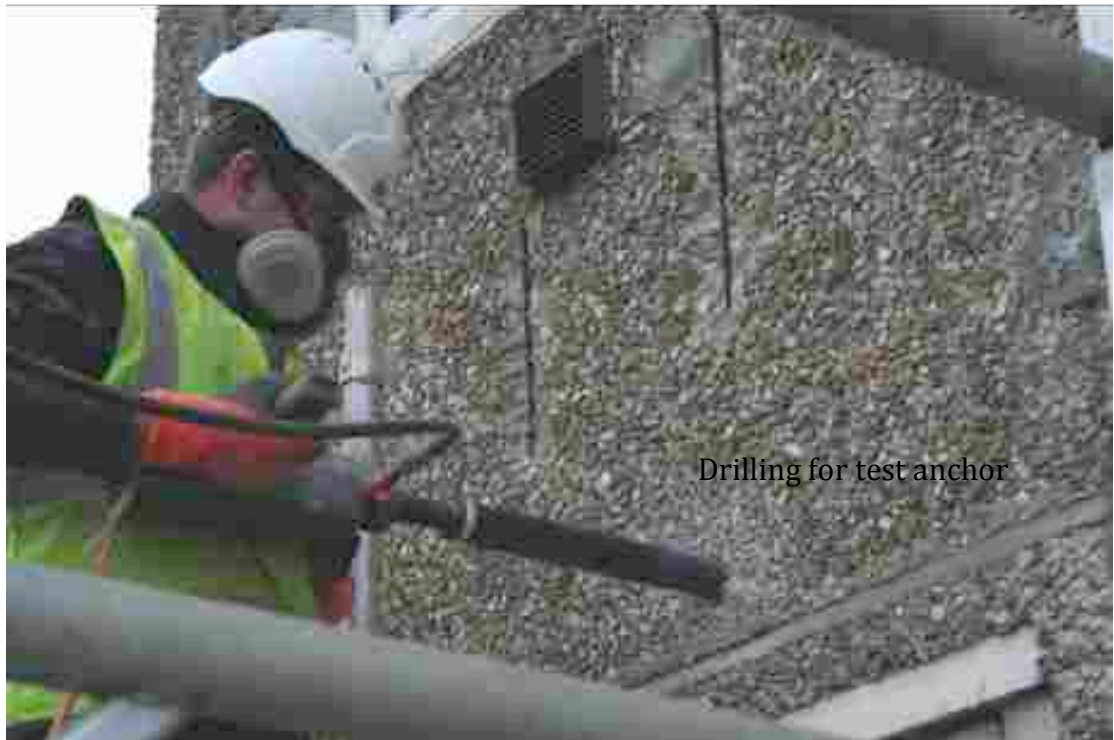
Drilling for test anchor

The results of this first investigation were discussed in full at a meeting on 3<sup>rd</sup> February 2015 with a further recommendation to immediately conduct a second investigation within the next two weeks including installing test anchors in the end of the concrete joist that formed part of the hollow floor beams. A flat was made available and opening up internally took place on 12<sup>th</sup> February 2015. With the geometry of the construction confirmed a Cintec anchor load test was carried out on site to assist in finalising the design arrangements for the structural strengthening of the refurbishment project.

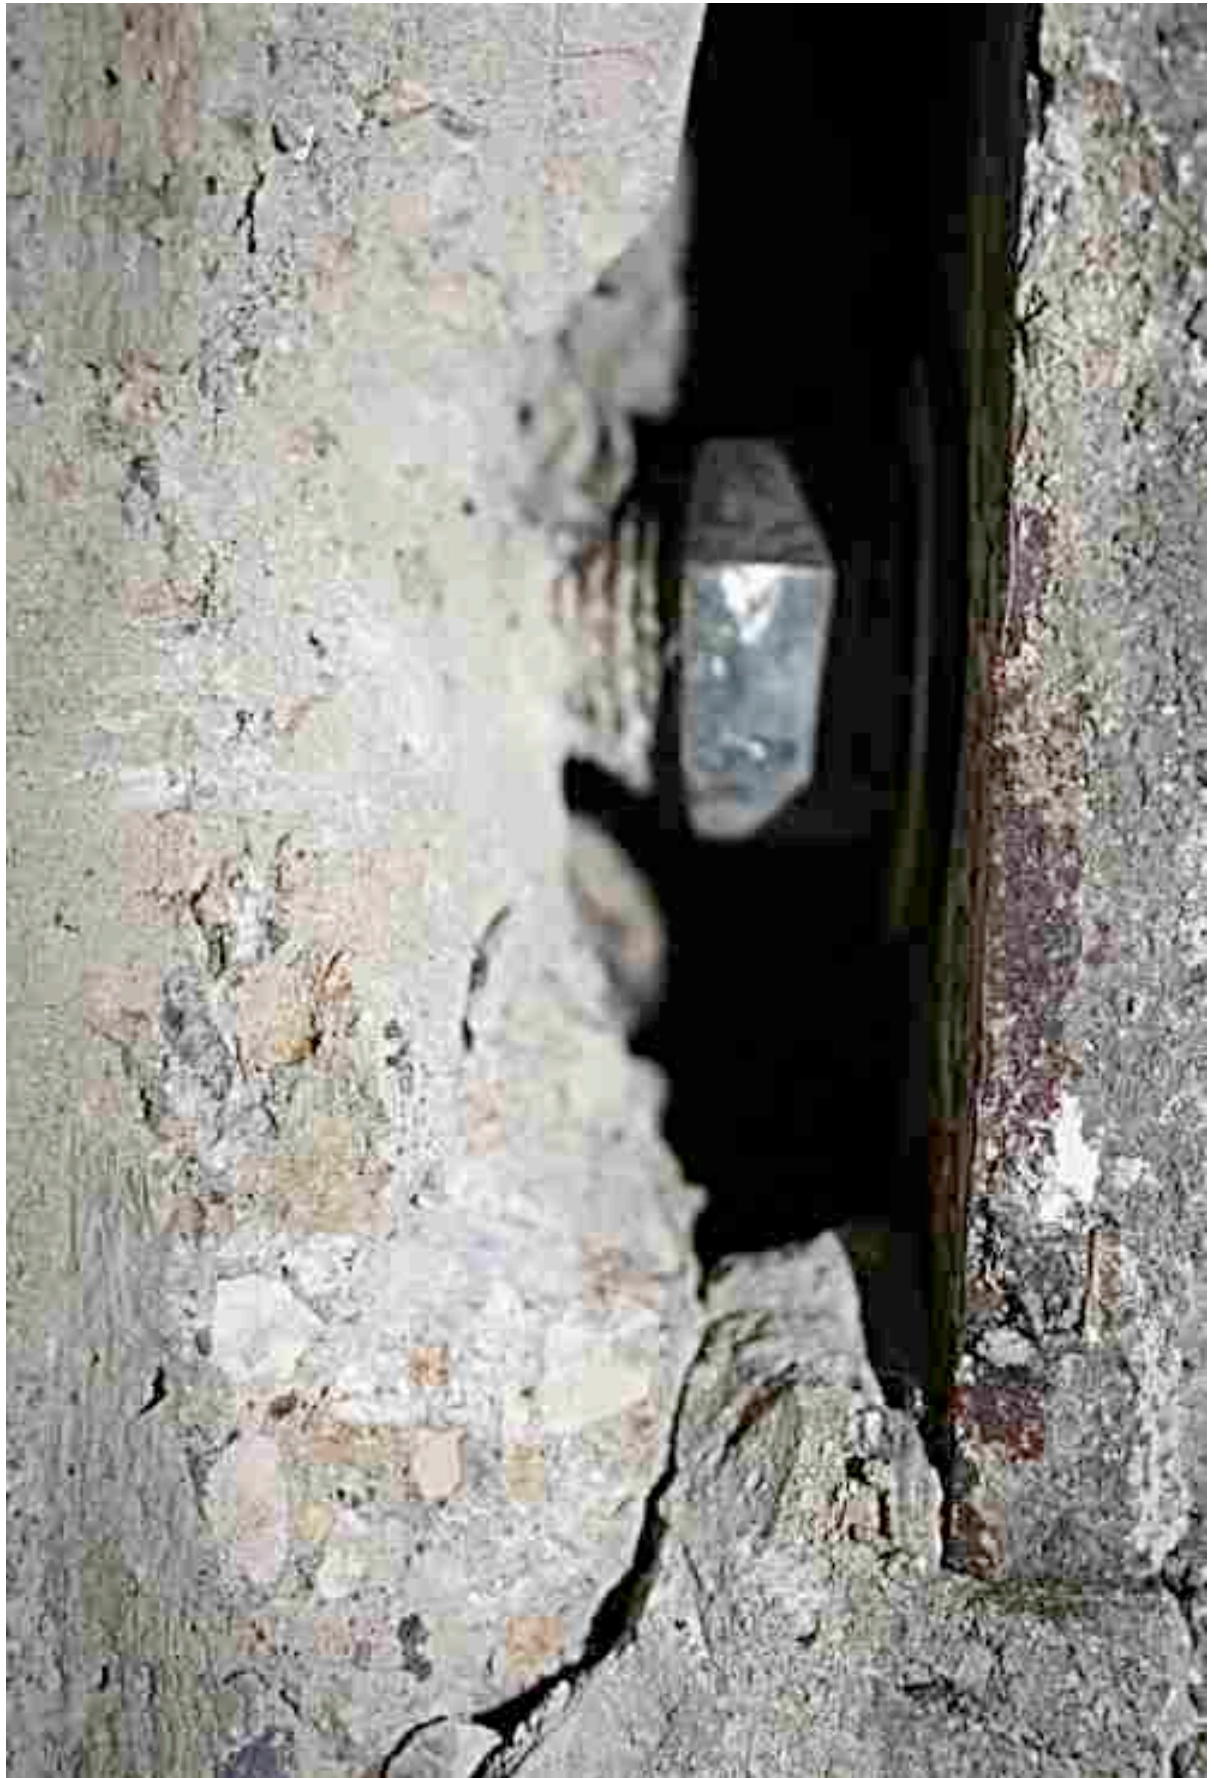
Original levelling bolt when the units were positioned. Photograph 6

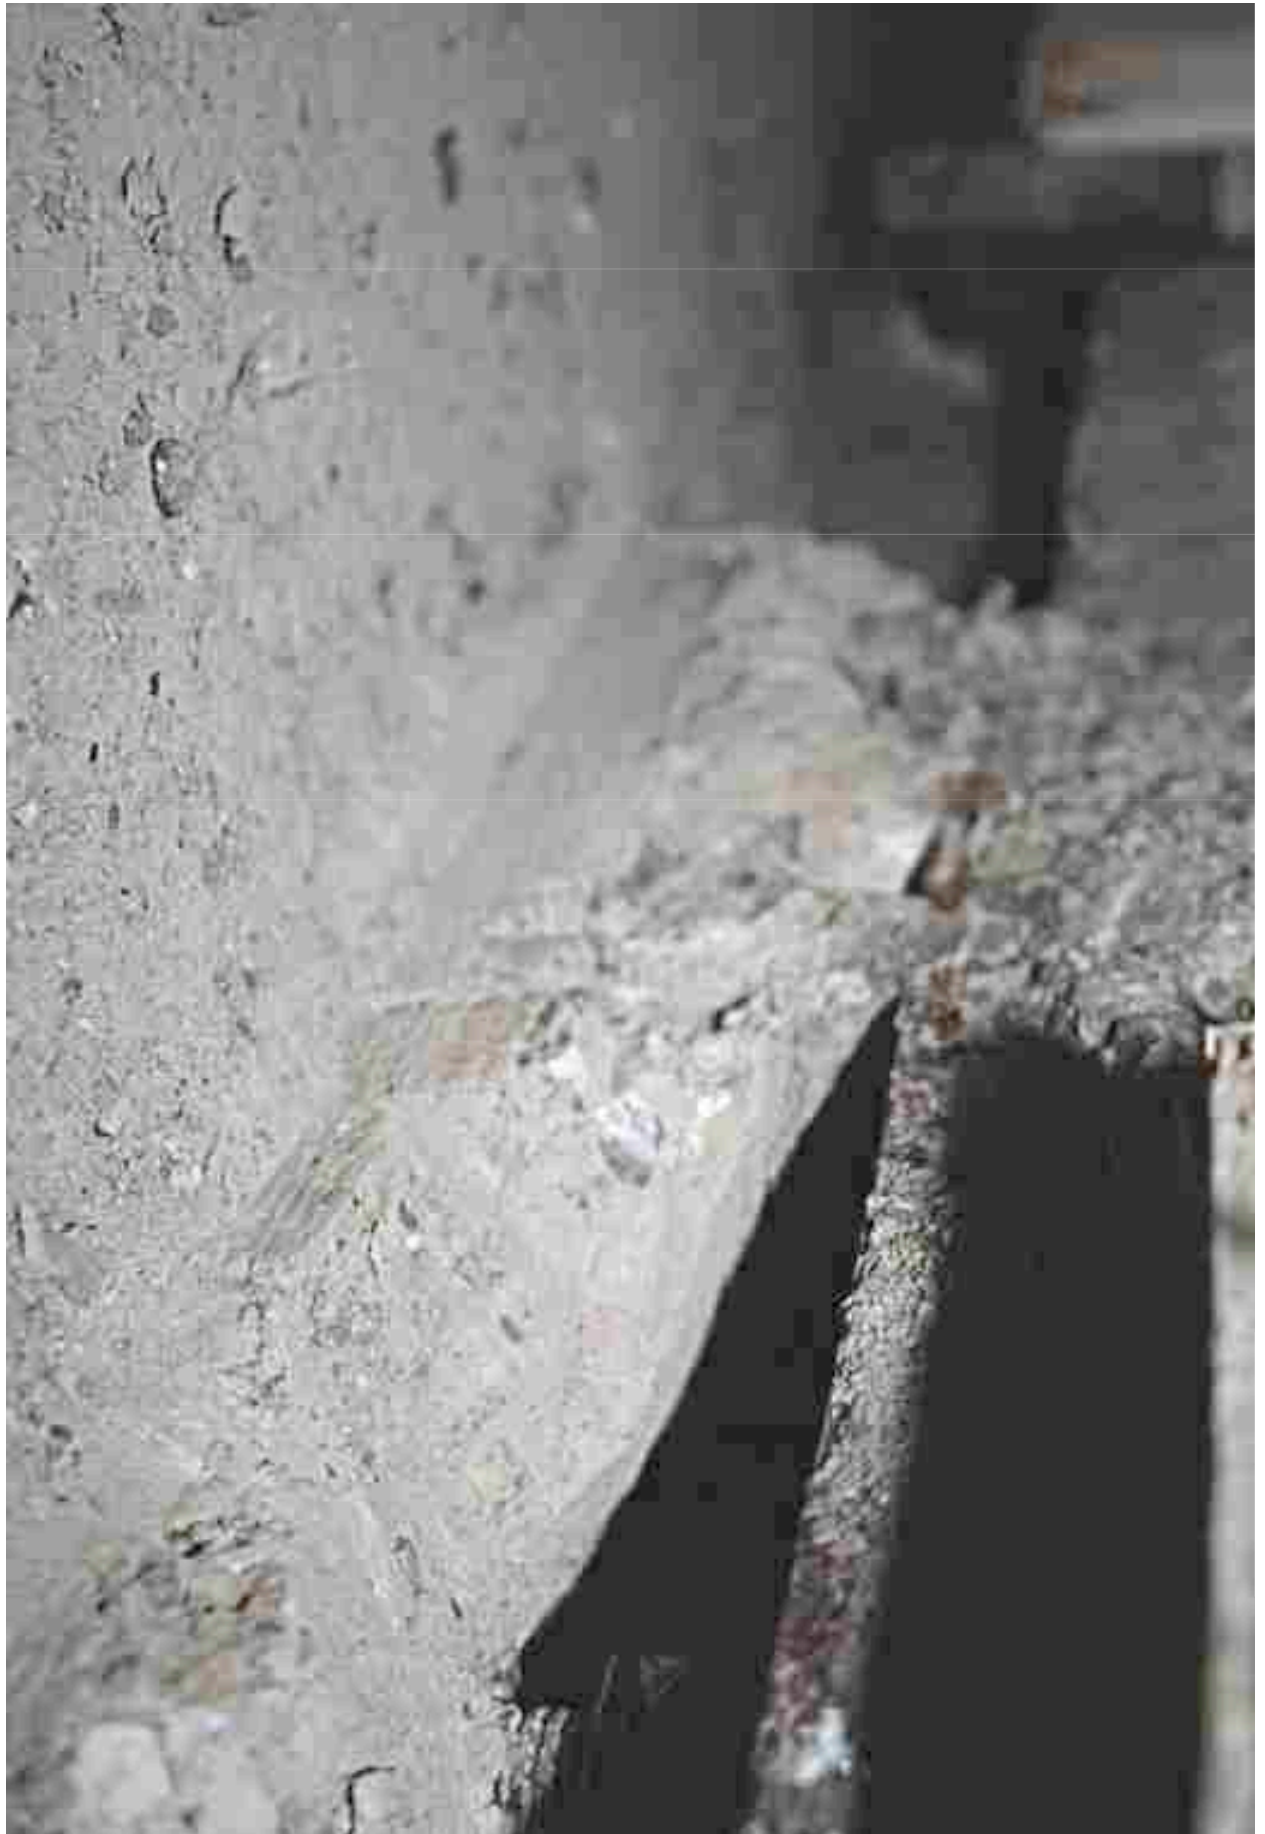
Although water services were running along the internal load bearings support wall removal of finishes revealed a much better bearing arrangement with fixing bolts and steel plates (photograph 15 and 16).

Internal end of the precast concrete beam.  
Photograph 16

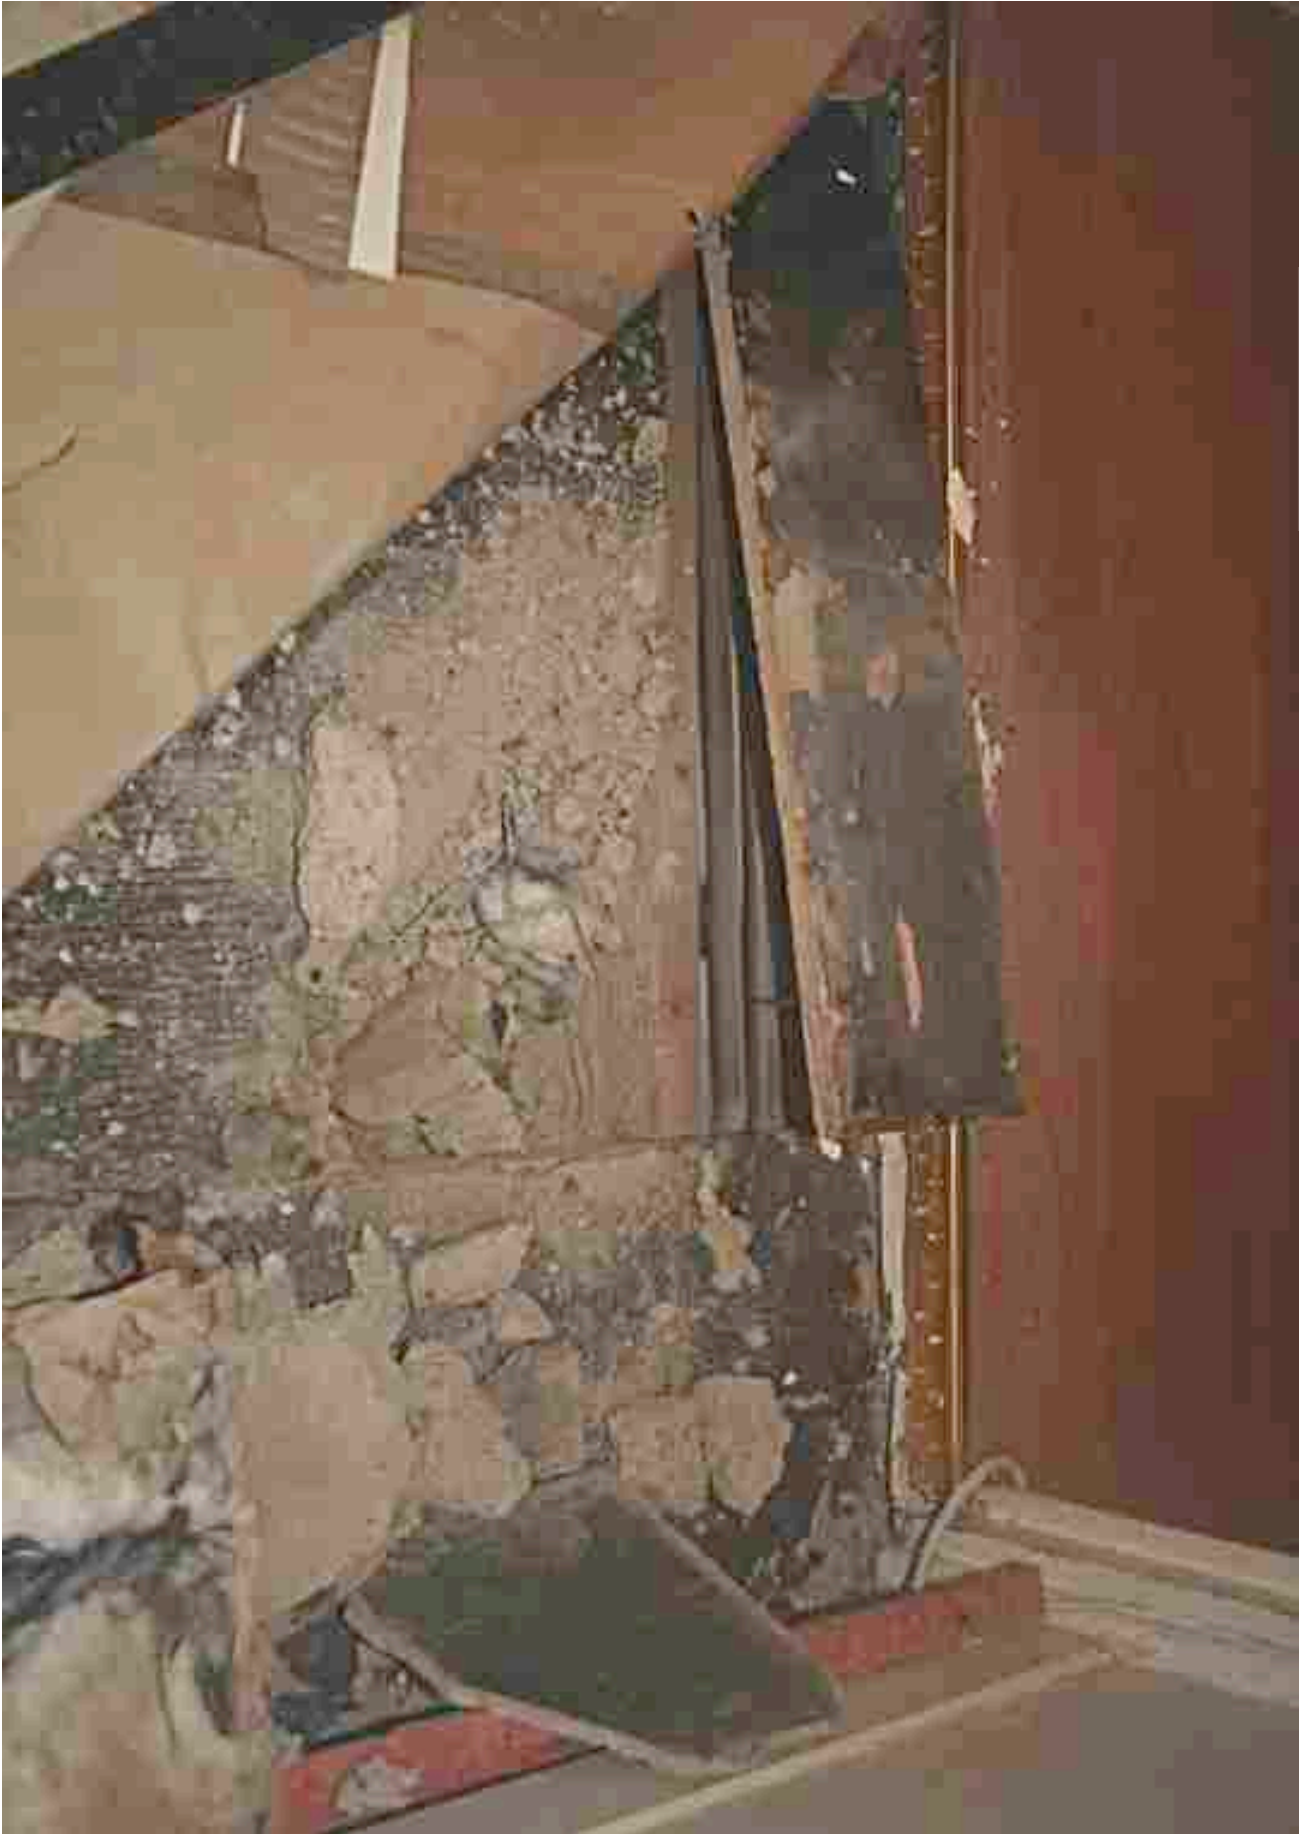
Water pipes exposed adjacent to wall. Photograph 15

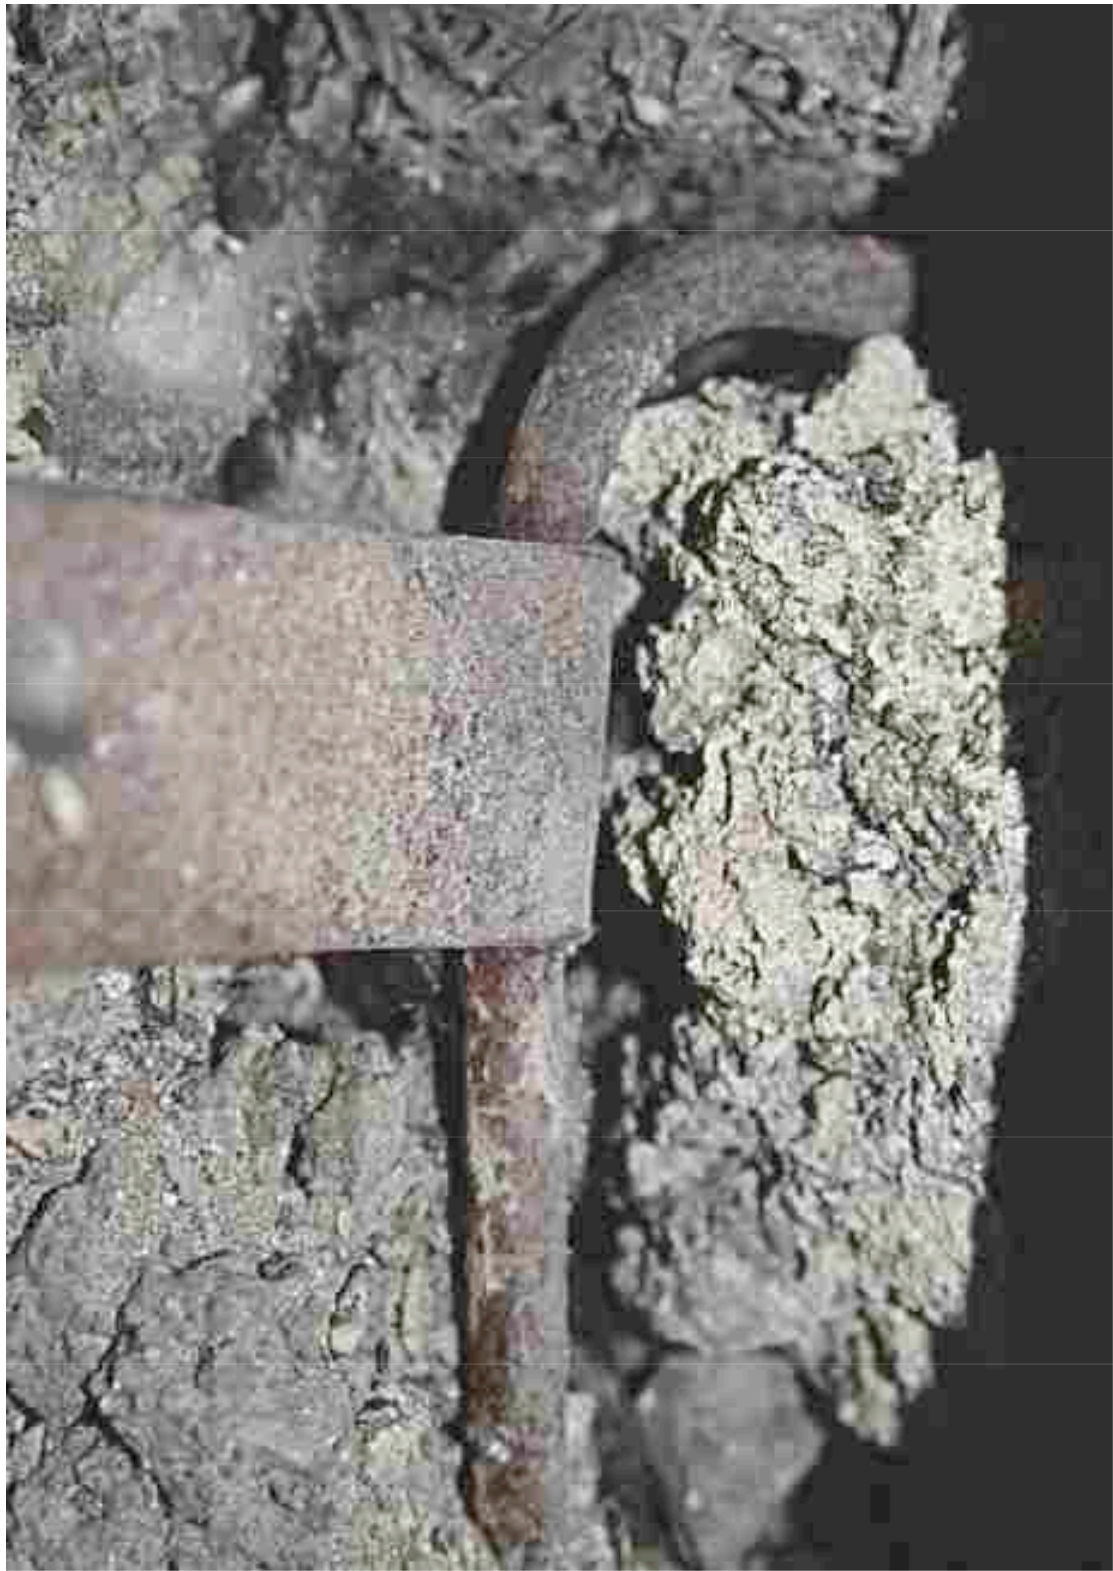
Looking beneath the floor plaster the bearing and fixing arrangement was confirmed as being minimal (photographs 11 and 12) with the precast load bearing vertical units appearing to have been cut back in a steep chamfer to be filled with a poor quality infill concrete. The transverse ends of the flooring arrangement was seen to be of a solid concrete of better quality to which the return pre-cast concrete cladding panels were secured laterally with a hooped bar into the panel and a strap looped around the hoop and intended for the strap to be bolted to the better quality solid edge concrete. However, no bolt fixings were seen (photographs 13 and 14).

Full panel straps. Photograph 14

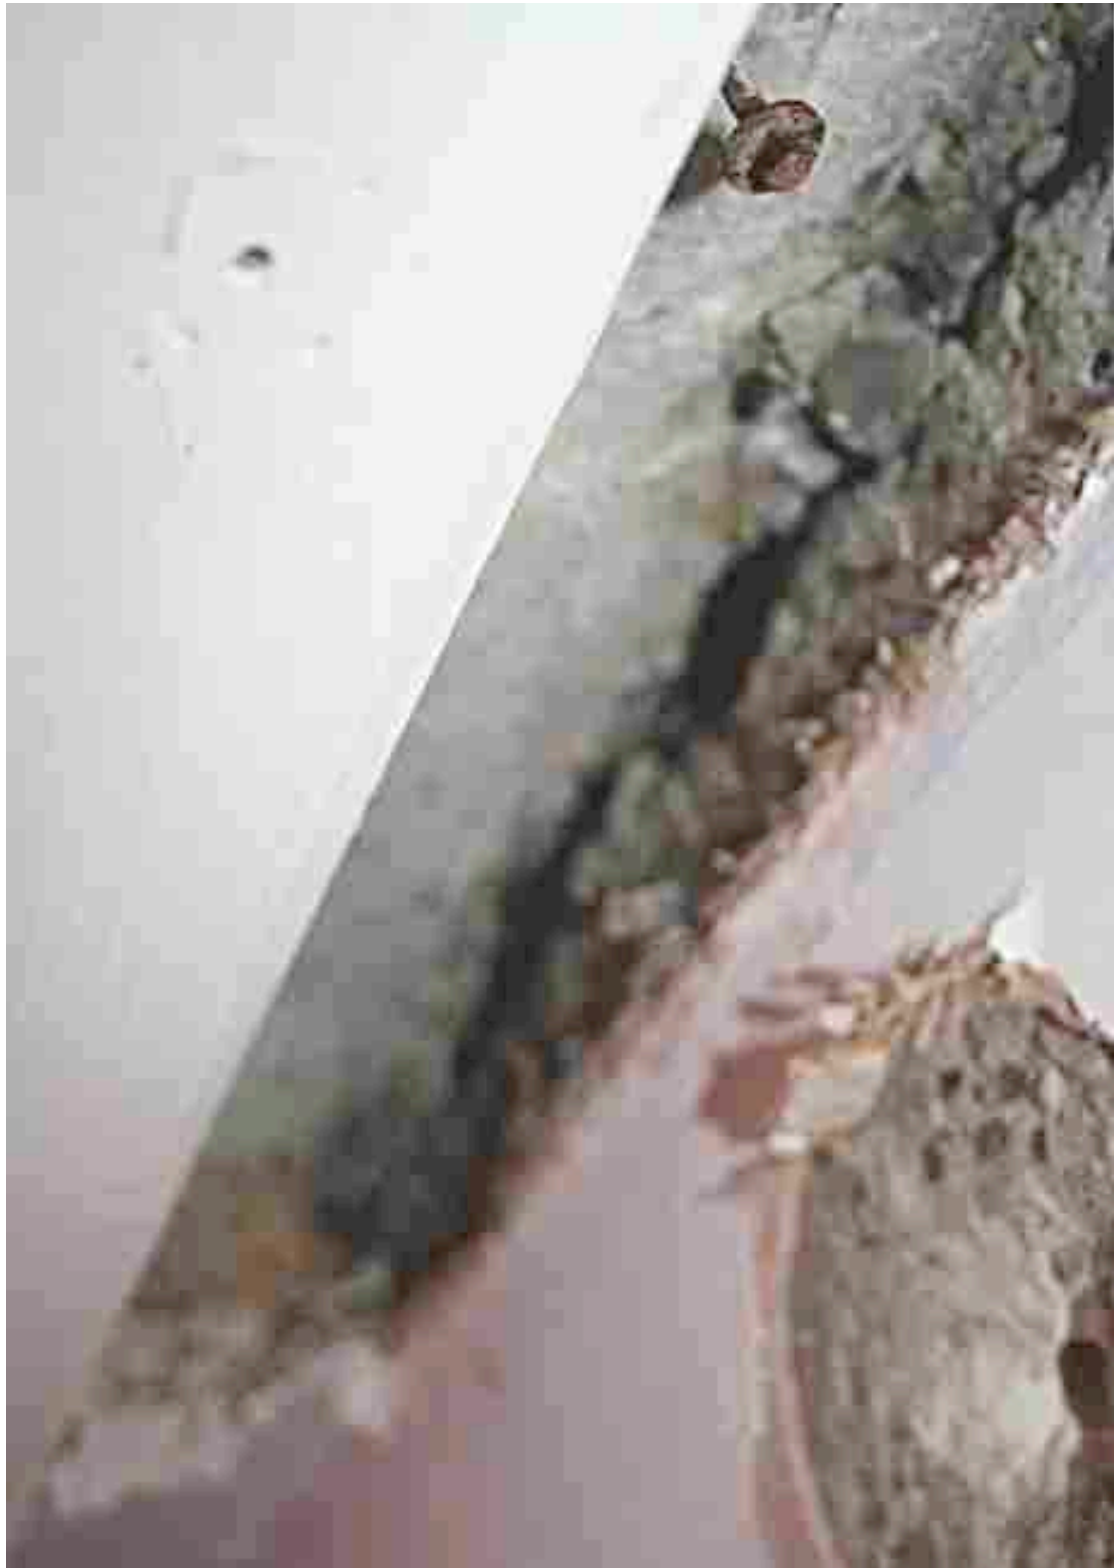
Floor slab to wall connection.

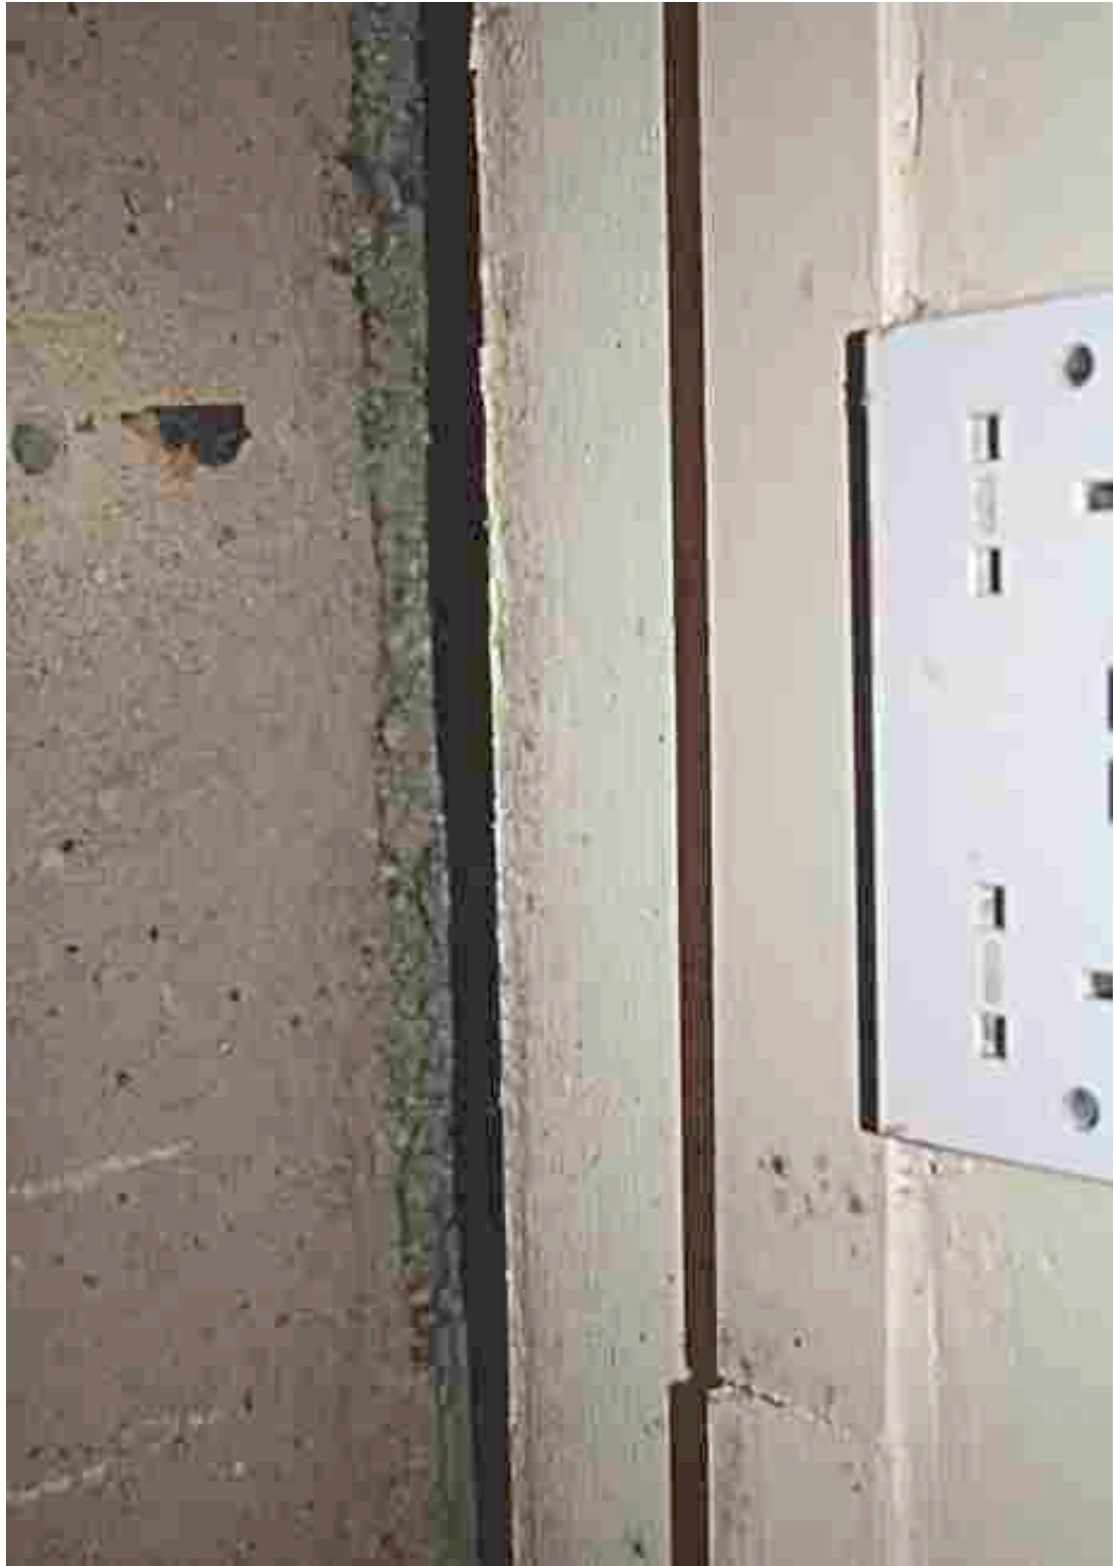
Floor slab to wall connection viewed from above. Photograph 12

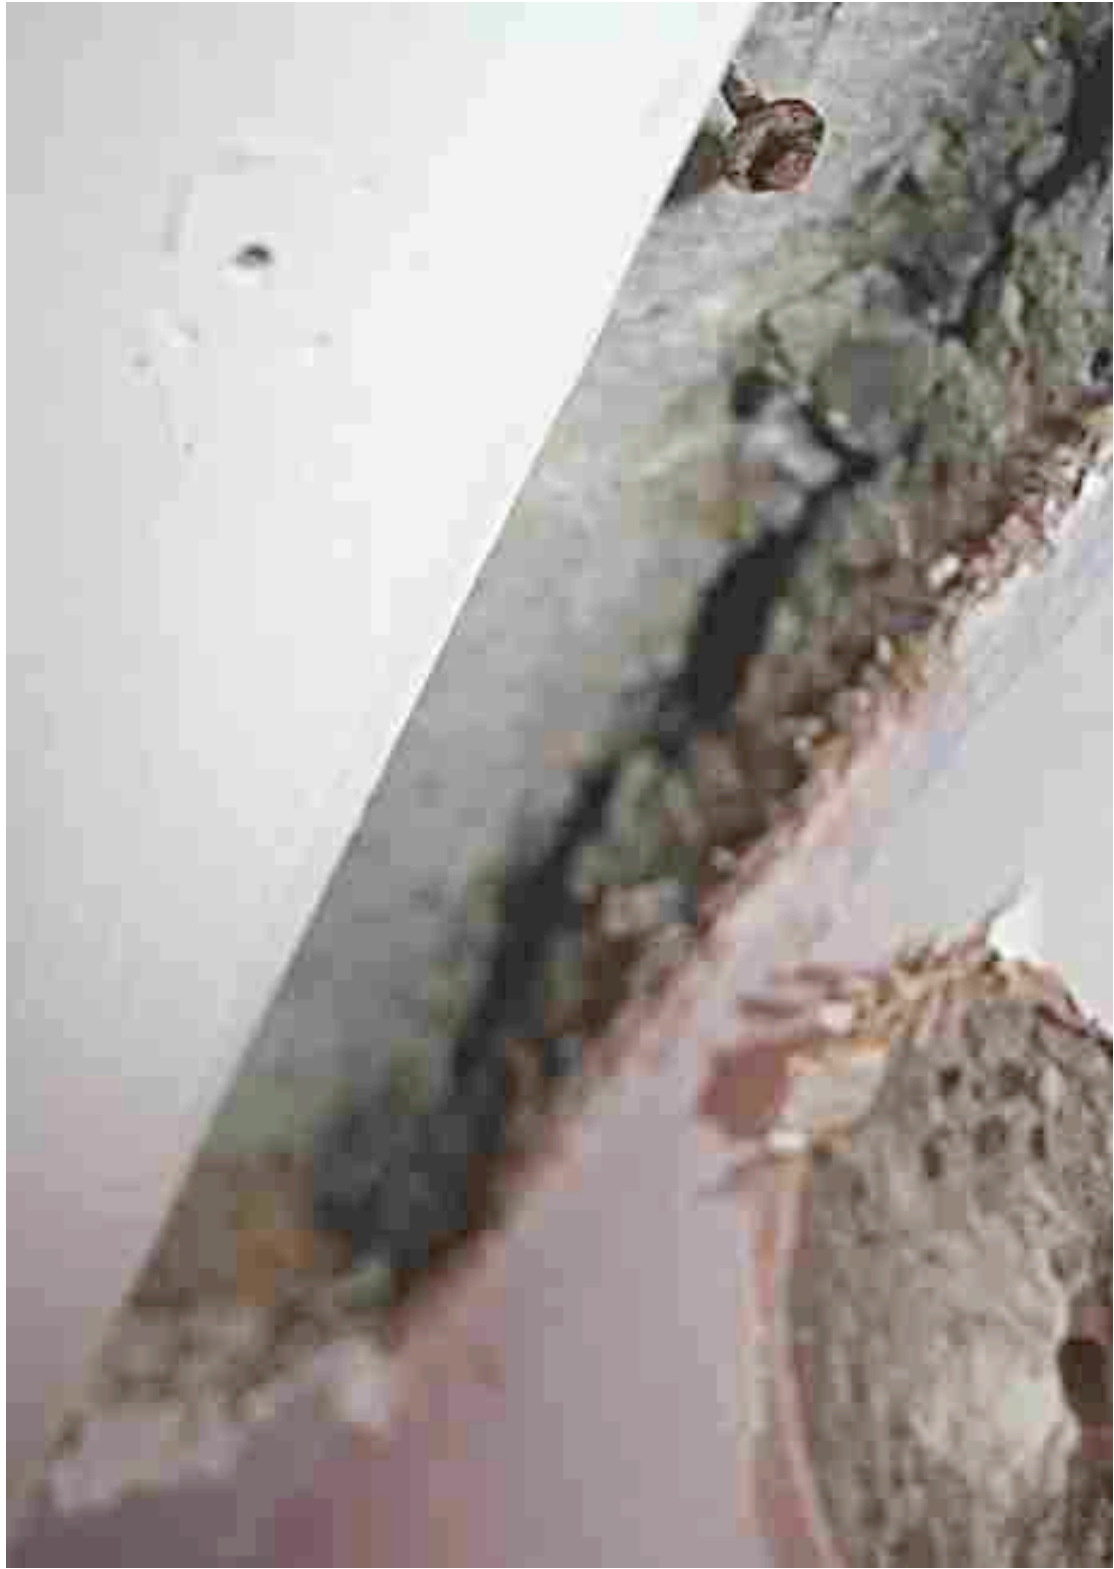
Floor slab to wall connection viewed from below. Photograph 11

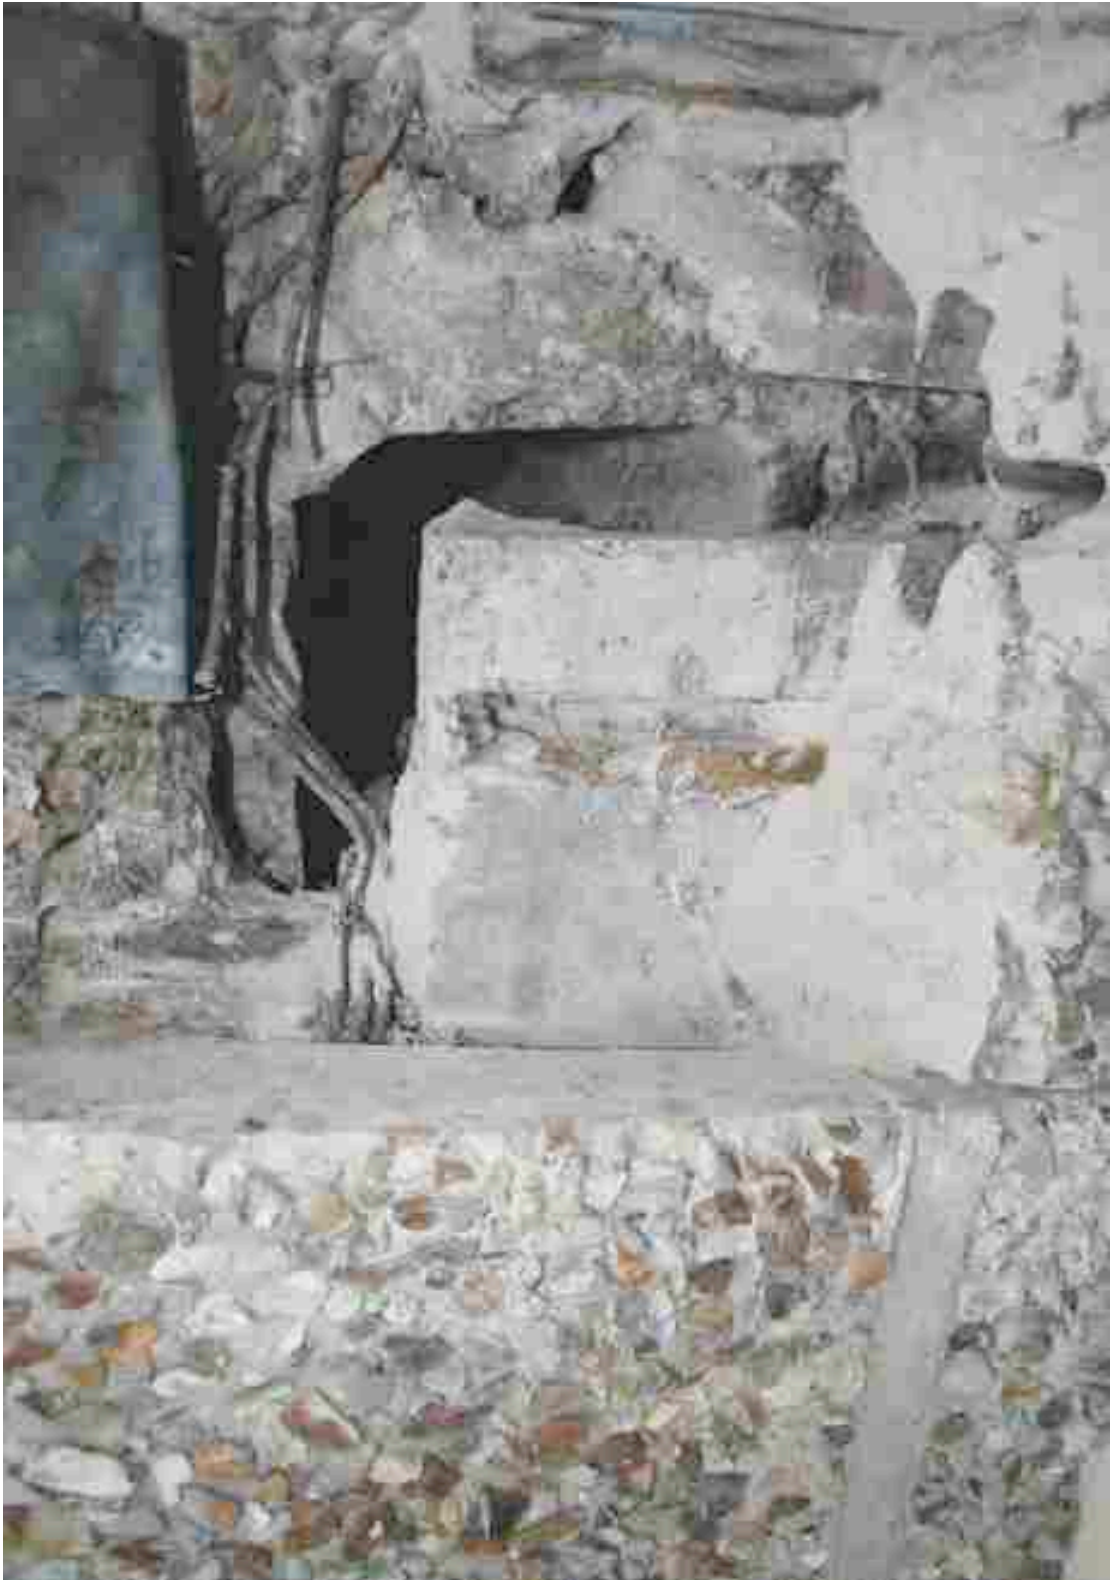
Photograph 4

Furthermore, the hoped for connecting details of reinforcement and hook bars into the floor slabs, was not present, with only three 6mm diameter (approximately) wires bent into the insitu infill concrete cast between the precast floor and wall elements shown in Photograph 4. This was seen to indicate a very poor structural joint and it is not known at this time how the construction of this detail took place. Then: appears to be no records and little information available at present. Therefore, based on this limited opening up, a significant question mark is posed over the structural integrity of this bearing connection.

Hollow pot detail.

The installation of Cintec anchors can be modified to overcome this problem by drilling into the floor ribs and utilising a larger diameter corbel anchor Cintec tie with the bracket piece on to extended thread on to the outside as shown on the Cintec Sketch. The size of the channel is shown on the drawing and were brought to site as an example. The corbel anchor will also provide structural integrity for the support weakness and any shear that could develop at this bearing area. The photographs, Photograph 5, show other elements of the concrete repair investigation to Highways I and that especially the previous patch repair are seen to be failing, there is significant spalling of reinforced concrete cover. The lack of cover has resulted in penetration of chlorides as well as pollutants in the atmosphere that also contribute to the corrosion of reinforcement so incremental dust sampling was carried out to identify the depth into the panel that these elements have reached. The results of the laboratory analysis of these dust samples are contained in Appendix Shows the core taken out of the return end panel which confirms the sandwich construction and little or no reinforcement was detectable in the surface layer. The fixity of these cladding panels is thought to be by end fixing into the structural panel and the reinforced concrete frame. However, this is only speculation at this time. A small block rubber drainage ports that have been drilled through the end return cladding panels at approximately just below floor level. The purpose of these outlets is not known but it is possible that in the past, or shortly after construction, these drainage ports were built to alleviate moisture being retained in the walls due to condensation inside the flats. photograph 6 shows that the alignment vertically of some of the panels forming these end sections which is not plumb and therefore some question marks remains over there fixity as well as geometry of these cladding panels. We also do not know at this time the geometry and extent of the insitu reinforced concrete as no drawings are currently available.

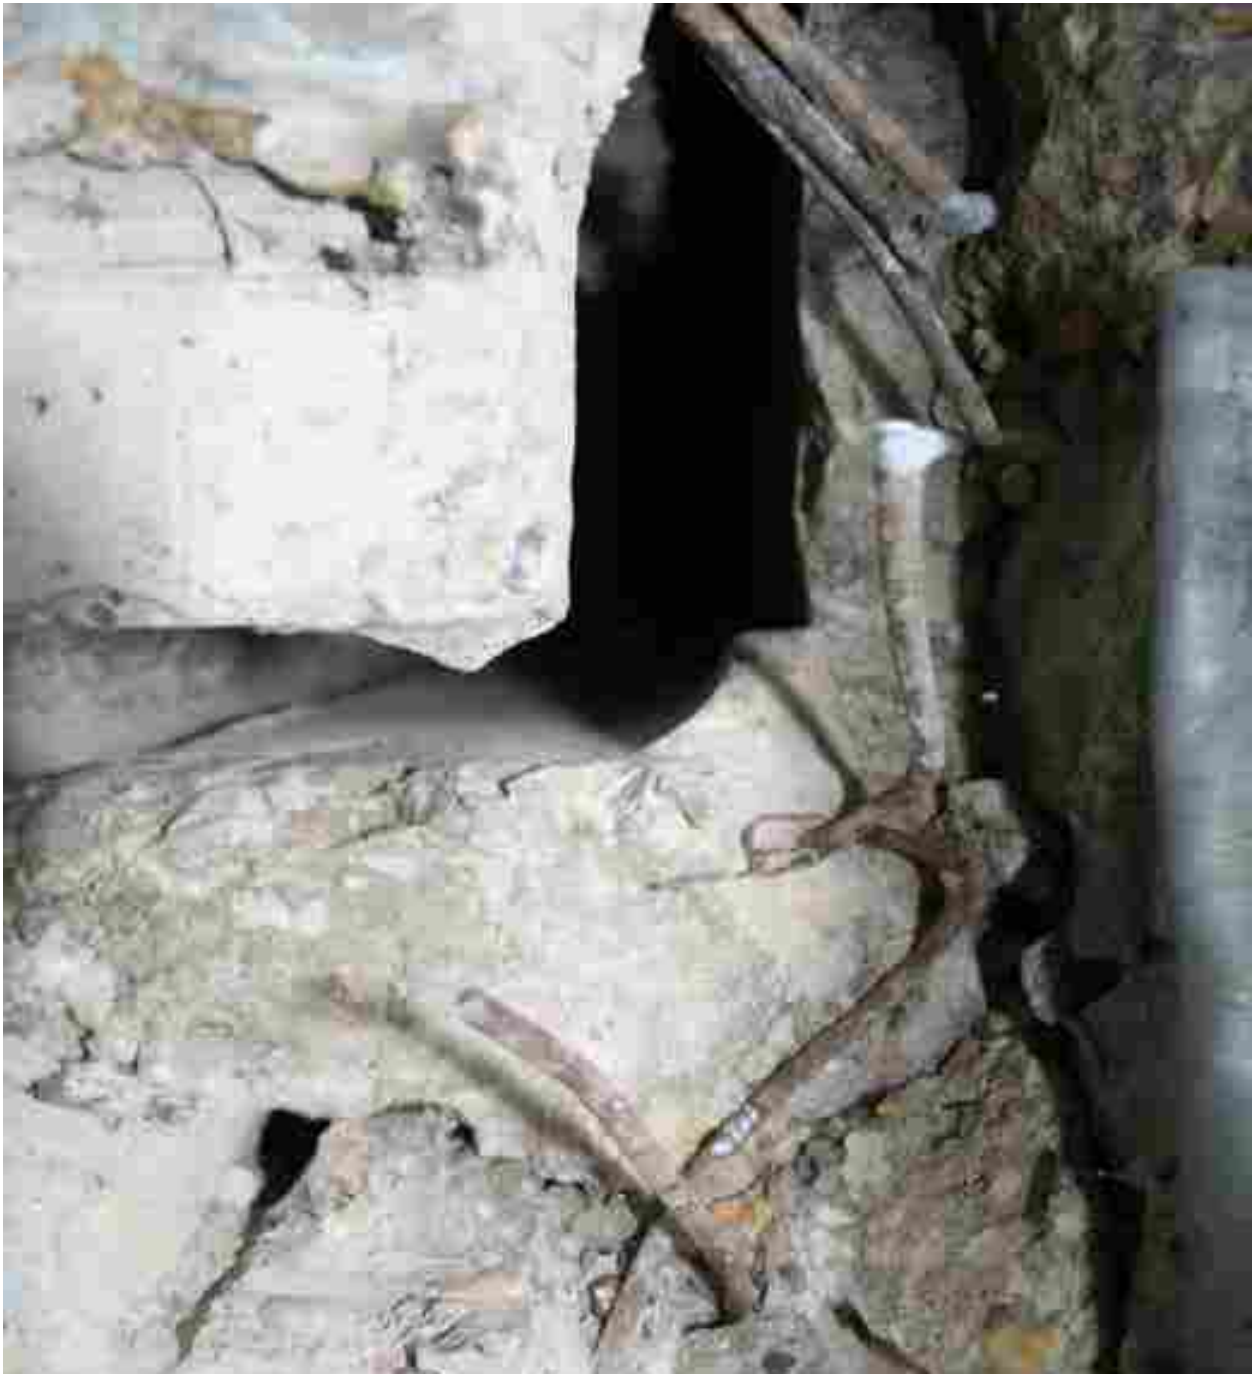
Photograph 2

The specific investigation trial hole is shown in Photograph 2, illustrating the junction between the precast concrete floor slab and the panel connection from ground to first floor (refer to the Cintec sketches). The panel connections are vertical projecting bolts into receiving steel plate for the panel above to be lowered onto. The floor precast units are positioned on the inside face of the panel below. The very limited investigation available of this detail gave concern because it appears that there is only a proportionally small structural bearing of the floor units on to the wall concrete below is seen in Photograph 3.

Hollow pot end reinforcing bar

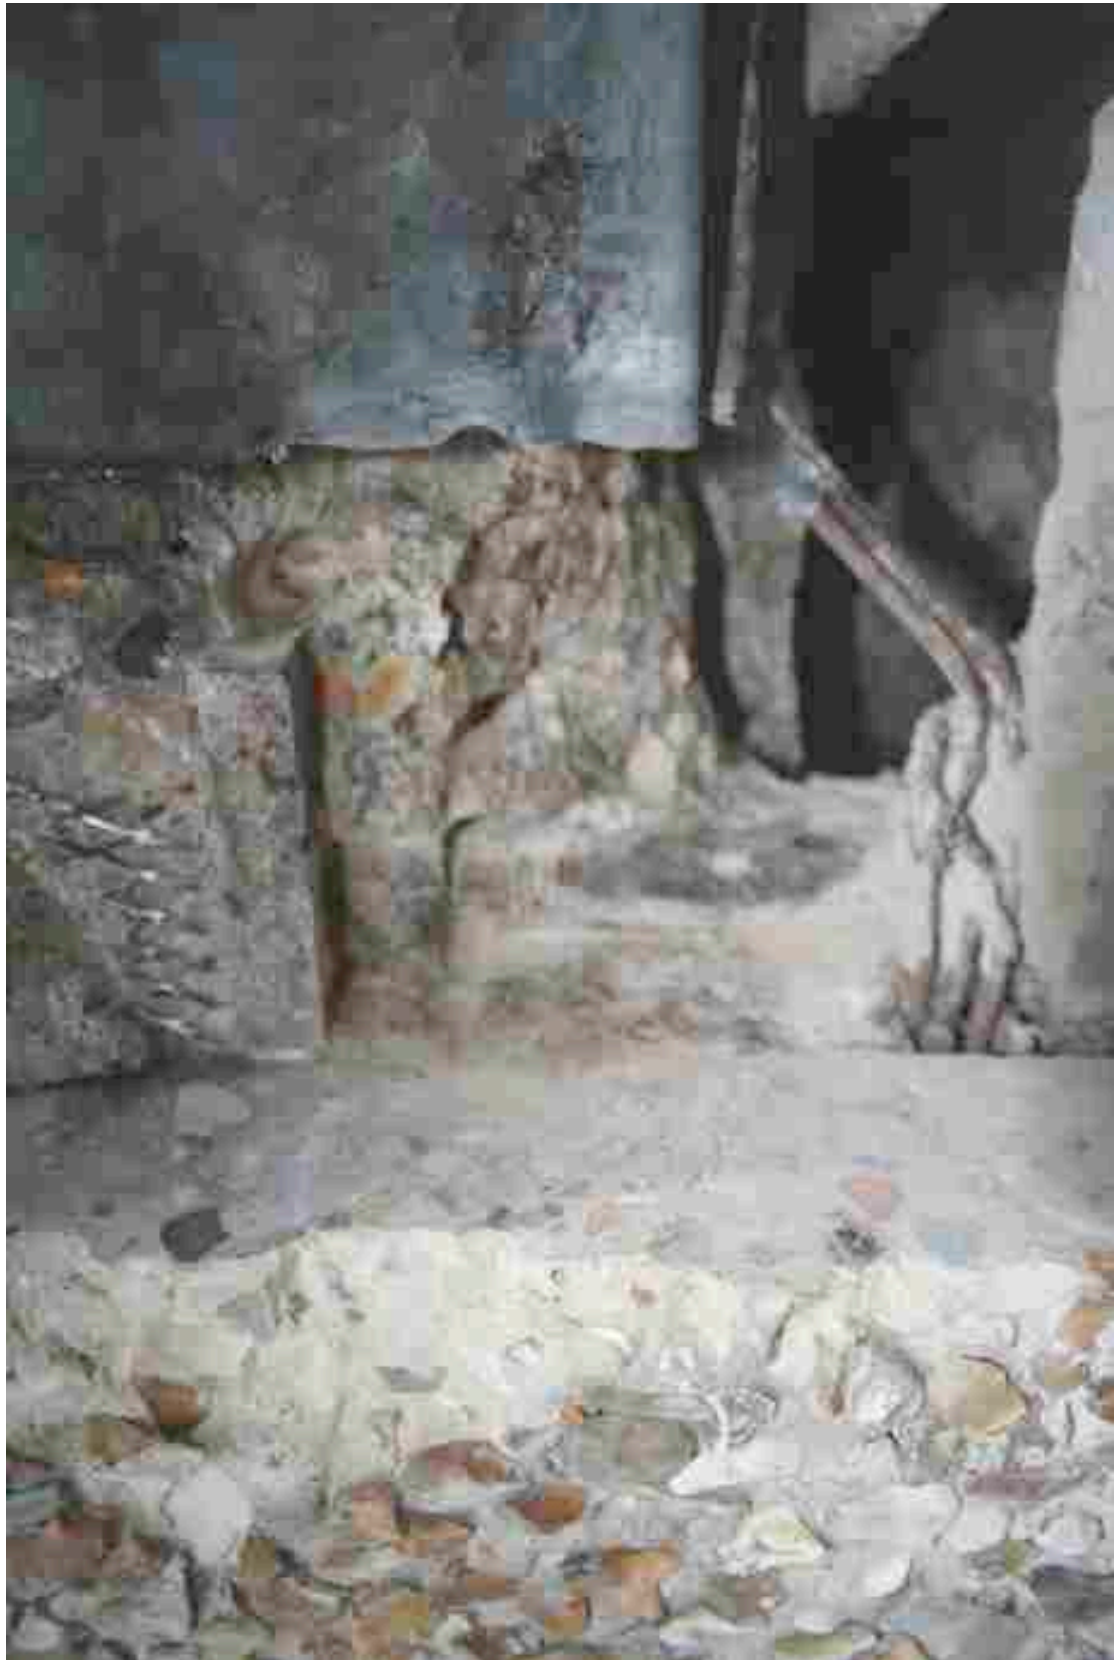
Original wall connecting bolt.
