Structural  
repairs to  
high rise  
buildings

Report into the proposed strengthening of Highways  
1 Killingbeck, Leeds.

11 Storey REEMA Block

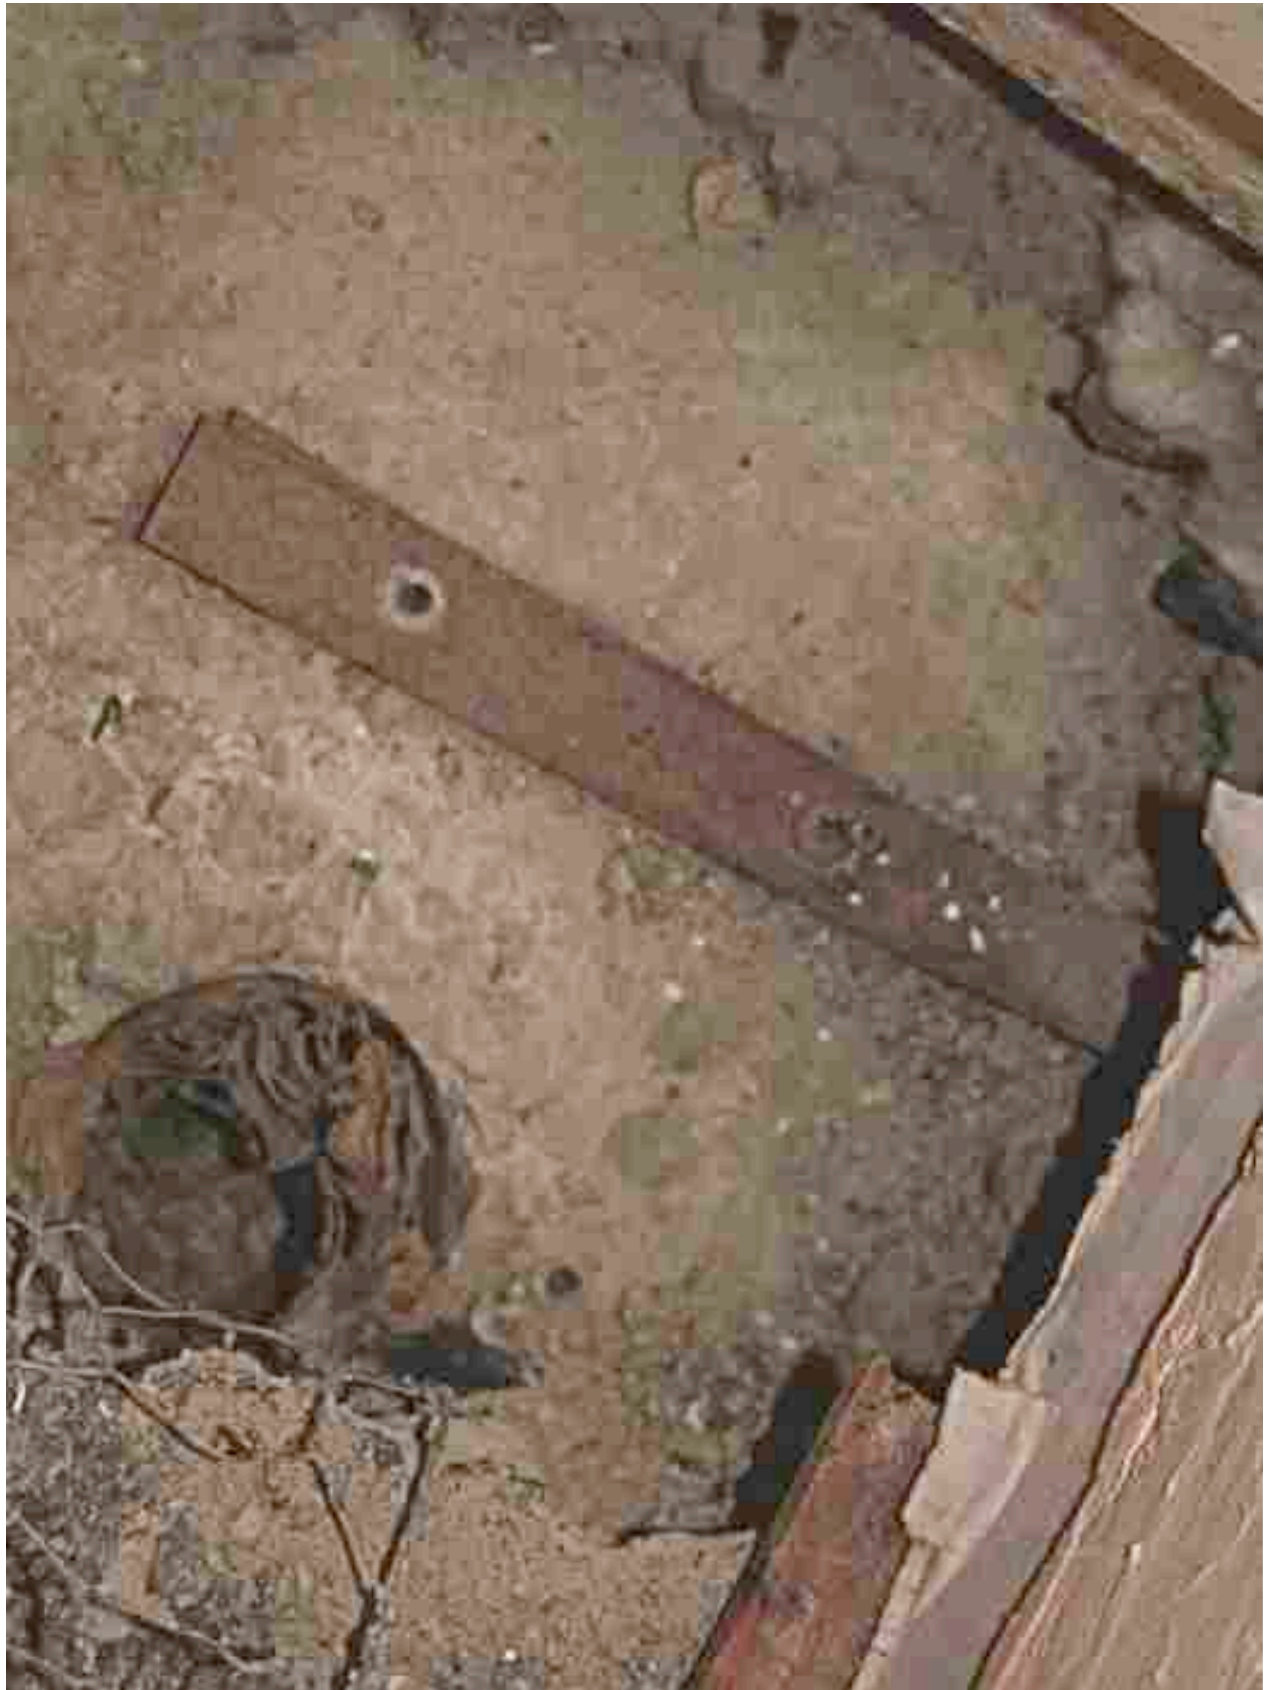
Looking beneath the floor plaster the bearing and fixing arrangement was confirmed as being minimal (photographs 11 and 12) with the precast load bearing vertical units appearing to have been cut back in a steep chamfer to be filled with a poor quality infill concrete. The transverse ends of the flooring arrangement was seen to be of a solid concrete of better quality to which the return pre-cast concrete cladding panels were secured laterally with a hooped bar into the panel and a strap looped around the hoop and intended for the strap to be bolted to the better quality solid edge concrete. However, no bolt fixings were seen (photographs 13 and 14).

Original strap. Photograph 13

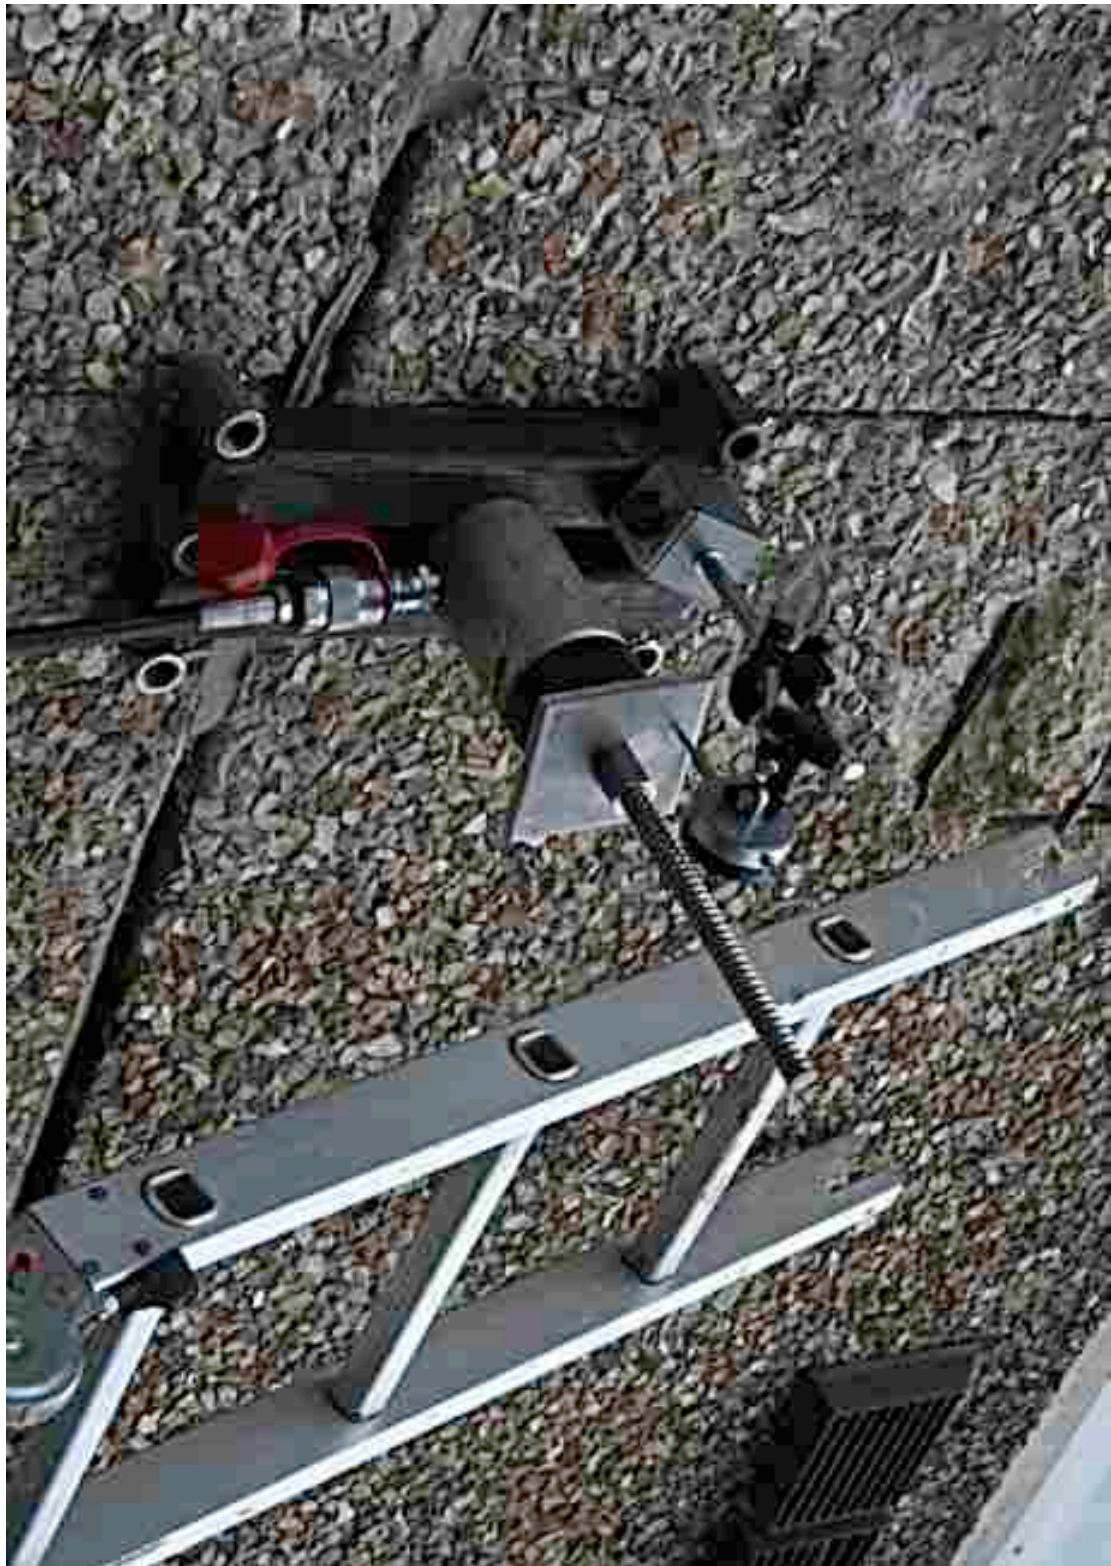
The photograph 17 in shows the load test rig and the results of two tests are shown on the test certificate. It is clear from the test anchor (which was based upon fixity in to one rib only) that the pull-out capacity is in excess of 20 kn per anchor Photograph 18.

Test rig set-up.

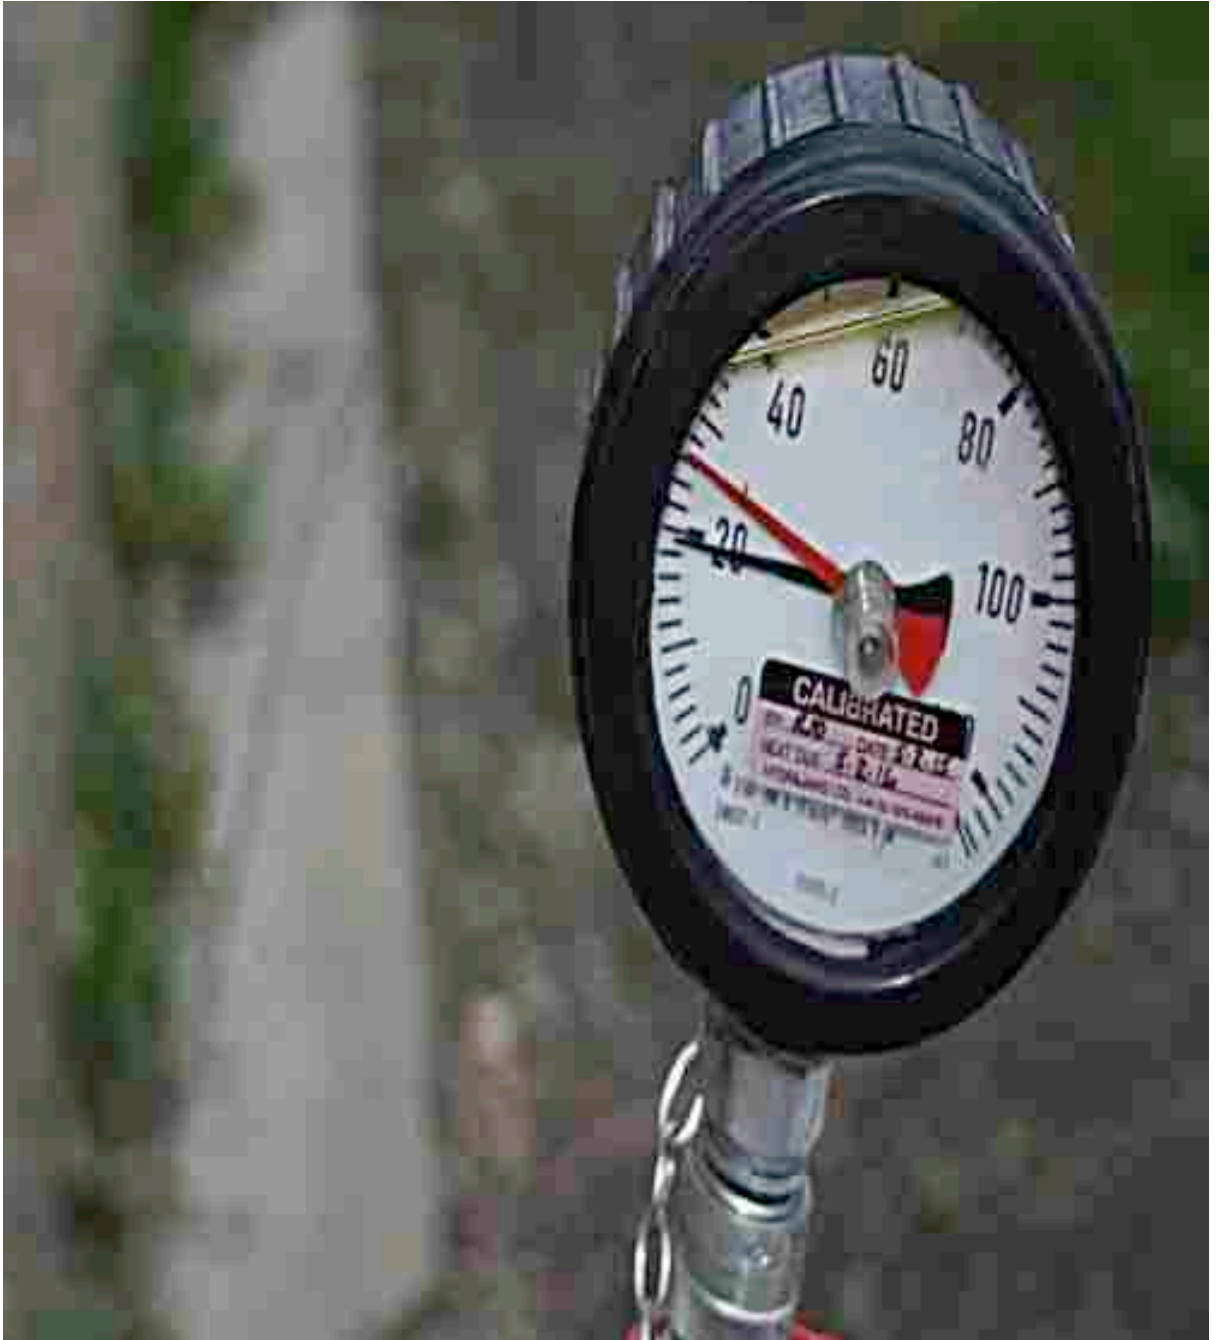
20 KN test load shown on gauge
