## Malmesbury Church Street Rotation, U.K

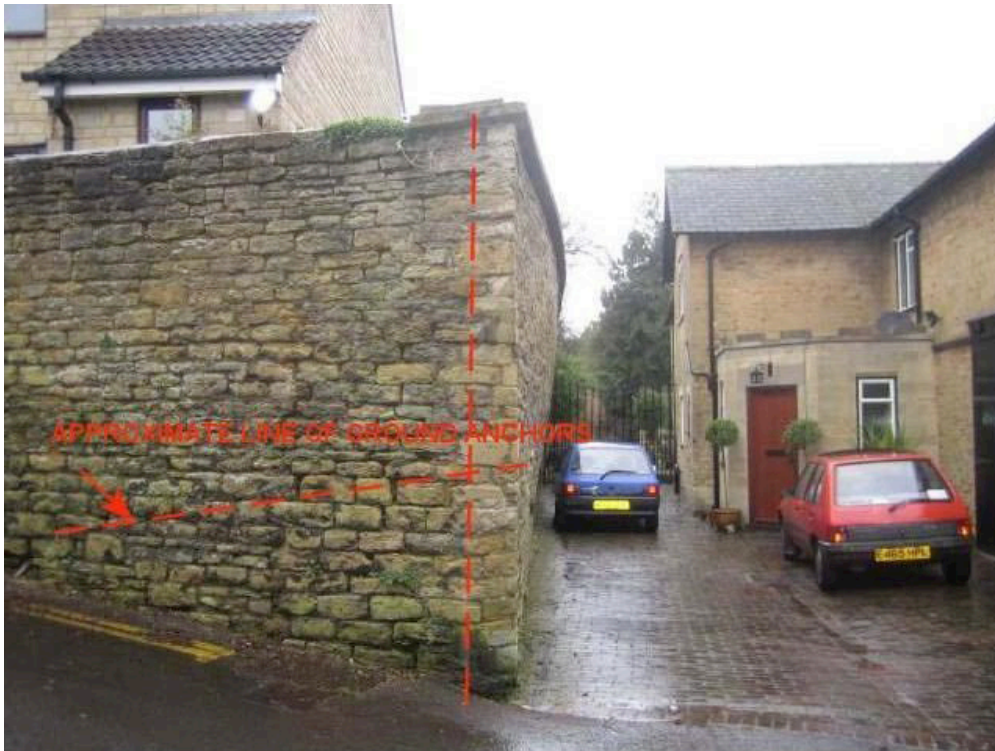
As can be seen from the photograph below, this retaining wall has seriously rotated towards the next property. Understandably the neighbors were becoming extremely concerned about its safety. The wall retained the garden and some imposed load from the house foundations.

Engineers Mann Williams devised a scheme to save the situation by installing Cintec ground anchors through the wall at one-third height together with vertical Cintec anchors to reinforce & mobilize the full height of the wall to resist the rotational effect. Anchors were located as shown by dotted red lines.
