## Nantgarw Pottery Works Wall - Glamorganshire, South Wales, U.K.

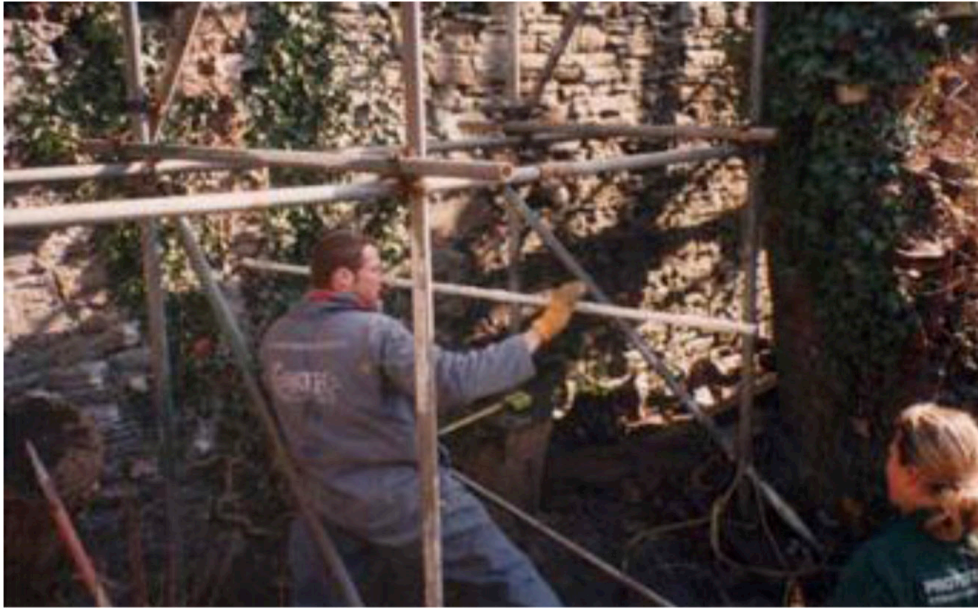
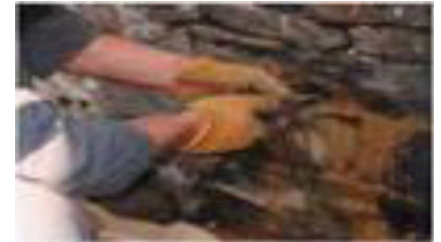
Insertion of 3m Cintec Anchor (left). Its inflation using cementitious grout, (above).

The structural engineers, ove arup working in conjunction with protechahome, opted to specify Cintec ground anchors to stabilize the wall and provide resistance to the additional horizontal forces imposed by the kiln.

Cintec ground anchors were installed horizontally through the bed joints and into the ground infill retained behind it. This infill comprised mainly of broken brick, stone, clay, pottery shards and other assorted material. The core drilling technique employed to create the holes also revealed many voids within it, a significant feature of the Cintec anchor is its ability to bridge such gaps by retaining the flow of grout with its polyester sleeve. The 3 meter long Cintec anchors were installed at 1 meter horizontal intervals and tested to a working load of 15kN each.

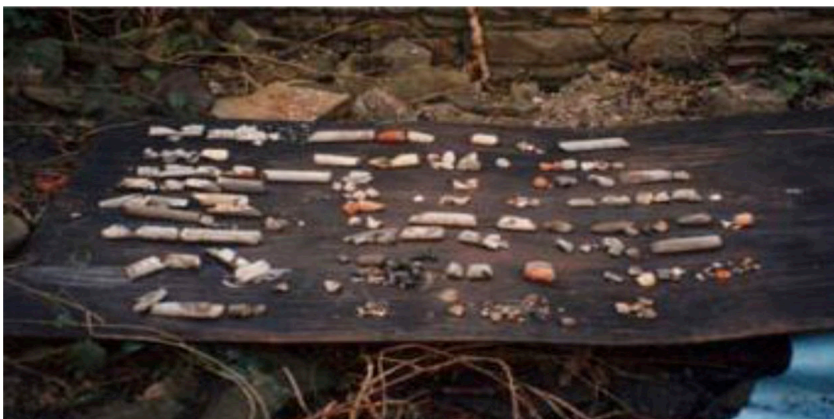
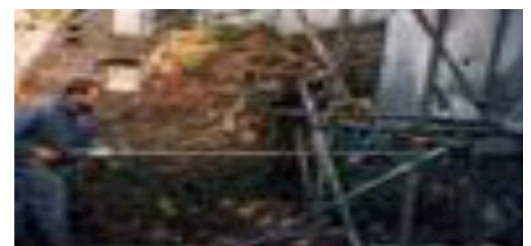
The process of diamond drilling (below). With the subsequent core samples produced, (left).
