Case History

Old Parliament House, Canberra Australia

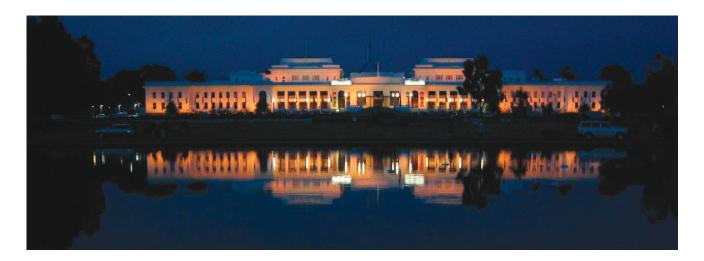
The building was built of brick, cement rendered internally and externally, with some of the render being up to 30 mm thick and in up to three layers. During the building's conservation for its new use as a parliamentary museum, it was found that much of this render had lost adhesion and was "drummy", yet it was worth preserving as a record of the techniques used in its application and the history of painting contained on its surface. The project managers were particularly concerned to ensure that the render could not fall on users of the building. Standard techniques using various proprietary adhesive injection techniques were tried on a test panel from which the render was then cut to reveal that none were adequate.

- the adhesive resins were absorbed into the bricks or the render, but often did not bridge the gap;
- the loss of adhesion in the render was at different layer boundaries which meant that a large area of "drummy" render did not have one large void but separate voids at different levels.

Eventually CINTEC came up with the option of pinning the render in place with the use of a grid of 75 mm long CINTEC RAC anchors. The anchors were inserted through the render into the underlying brickwork, but left protruding at the surface so that the sock-encapsulated grout bound the full depth of the render layers: the CINTEC "pins" were trimmed after hardening and the hole repaired. Work is continuing as the building is conserved.
