Shore Road retaining wall, Swanage, Dorset

In 2008 Dorset County Council contacted Cintec International Ltd to ask them to submit a solution to an already structurally failing retaining wall on the main sea front road in the town of Swanage. To ensure public safety without a total blockade of the highly trafficked road a traffic management system and barricades had been installed before Cintec visited the site.

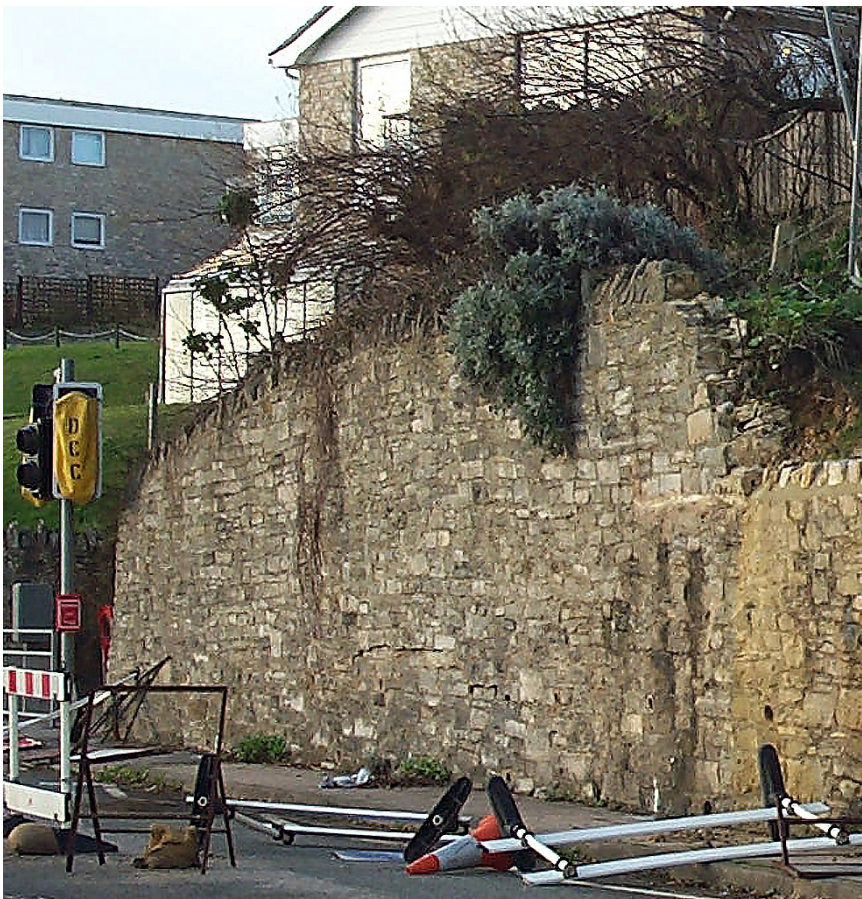
As can be clearly seen in the photograph to the left a horizontal fracture had developed in the wall approximately one metre above pavement level with the wall above trying to “fold” at that point due to the forces of the retained ground.

The wall was found to be 600mm in thickness and an average height of 3.75m.

No soils information was available at that time so assumptions were made for an anchor design entailing the use of both ground anchors to resist horizontal forces and vertical anchors to resist the shear forces.

In order to accelerate the process of restoring structural integrity to the wall the client agreed to proceed on the basis of the initial design without soils data. But to ensure the effectiveness of the solution it was decided to install the first ground anchor and carry out a load test to the theoretical working load and to the calculated test load which incorporated the safety factor.

The working load of 56kN held for 5 minutes showed a load loss of 1% and the test load of 6.5%.

Limiting the load loss to 5% gave an ultimate load of 74kN per anchor for an 8.00m long anchor. From drilling logs it was shown that there was 5 metres of undisturbed soil behind 3 metres of fill.

The anchors were required to be 9 metres long with a 6 metre embedment.

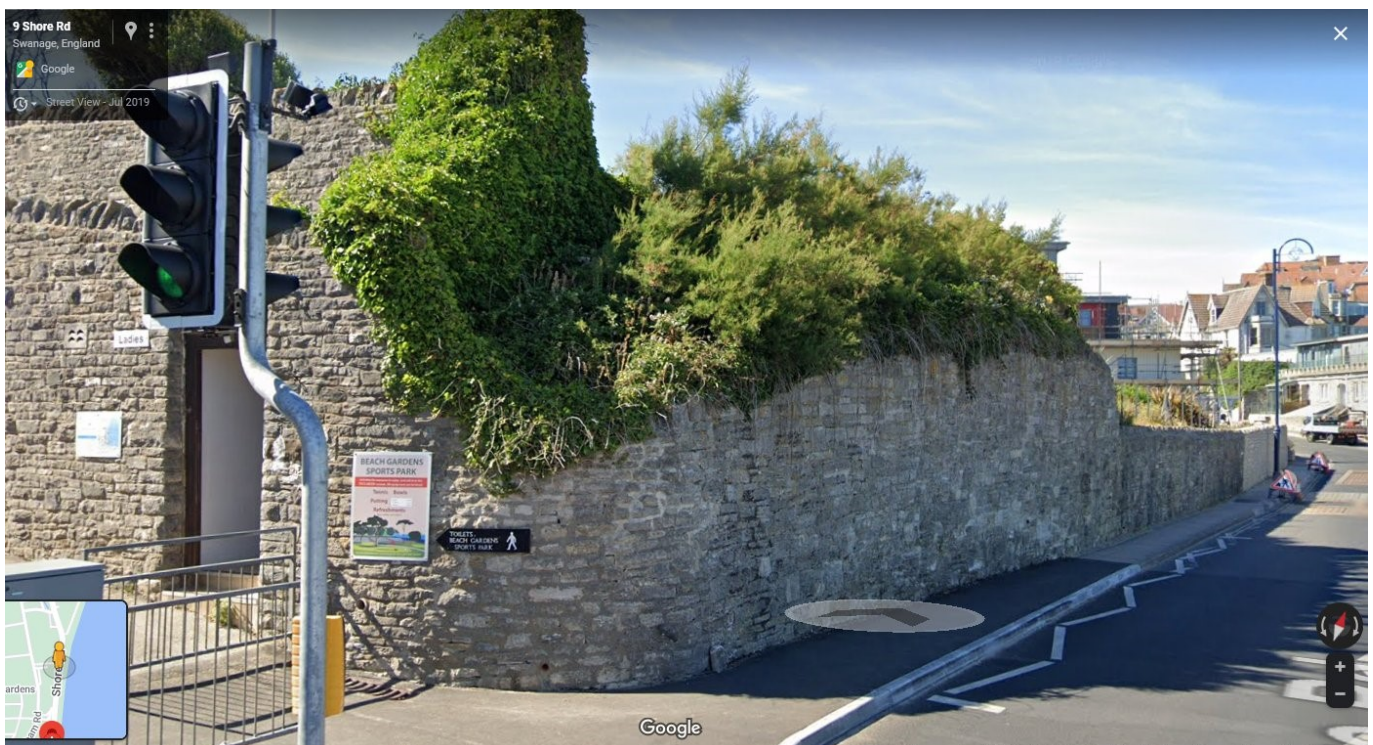
As may be seen from the photograph of the same wall below the solution was a complete success with the wall remaining in a structurally stable condition some 11 years later.
