## The rise and demise of Egypt's largest pyramids: A builders view

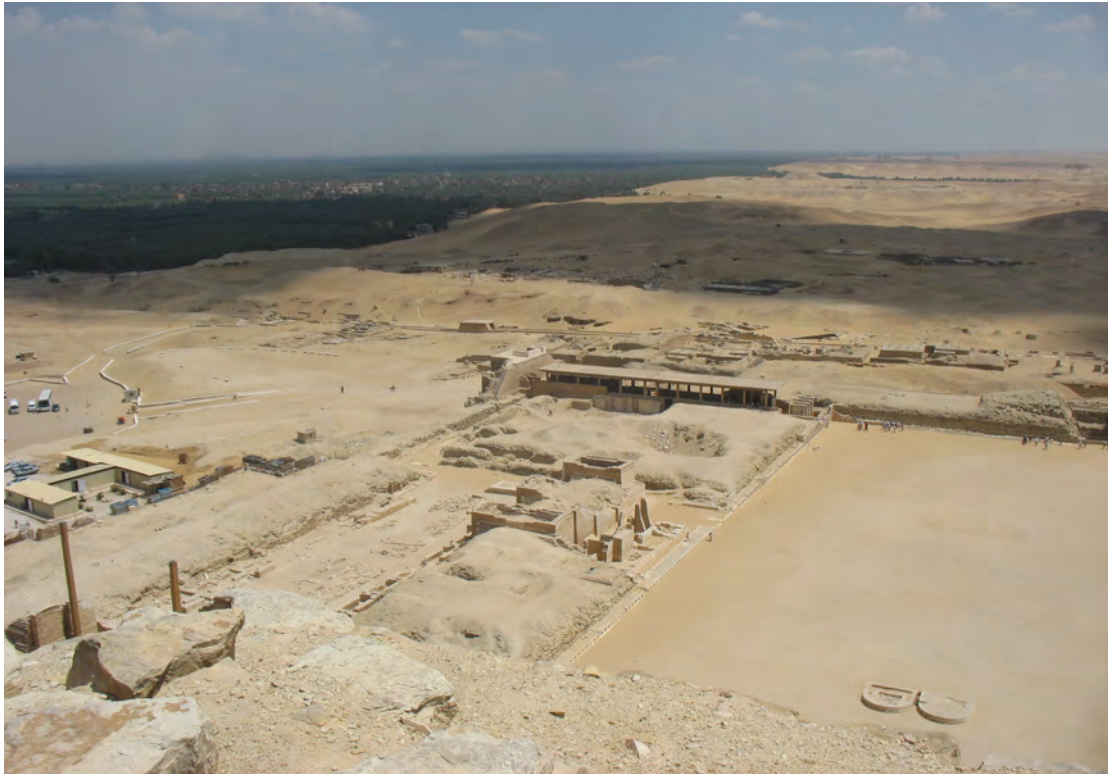
This is the view at the top of the Step Pyramid, which would have caused concern among the ancient builders who had only worked on buildings approximately 10 meters high at that time.

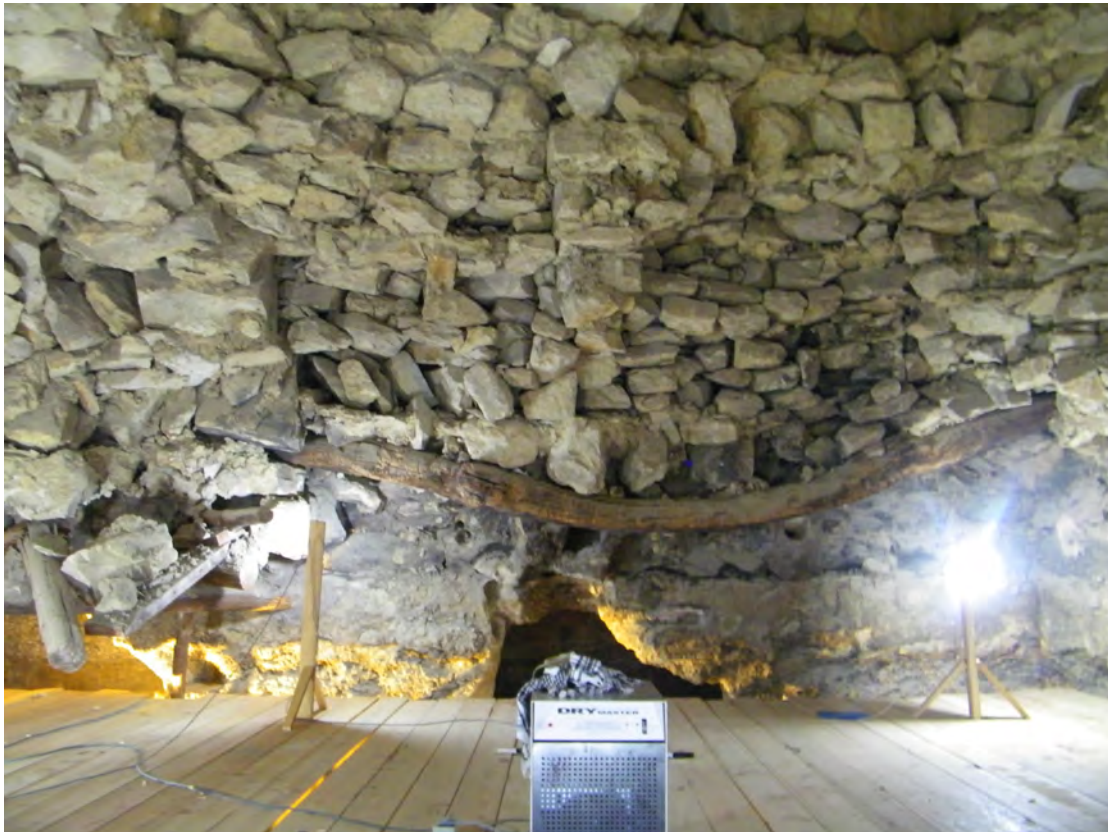
My first view of the defect ceiling was at the base of the chamber looking up some 29 meters at the damage. A matrix of small stones like a broken jigsaw puzzle would be the best to describe the view from this distance. This was going to be the most dangerous project we ever attempted and would need some delicate and innovative ideas to reduce the risk.

The issues revolved around how we safely support such a haphazard collection of unconnected stones without triggering a further collapse together with providing a solid base support at the bottom of the chamber to carry the weight of scaffolding. We were also informed that there was a good chance that there could be undiscovered tunnels below the sarcophagus made by tomb robbers. The problems were solved incrementally by tackling the issues from the top to the bottom. To overcome the possibility of a further ceiling collapse if a key component were unlocked by the insertion of traditional steel or timber being used releasing many more tons of loose stones on our heads we used another product I had developed known as Waterwall. Essentially, this product was the use of water in patented internally reinforced PVC bags to mitigate against improvised explosive devices. However, some of the more exotic applications needed columns of air using the same material to support tons of water when large spans of Waterwall were required. The great advantage of the system was it was dimensional stable particularly when inflated with air. It could be made to any shape that was needed and all the air columns could be interconnected to provide total control of the installation in this particularly dangerous environment. The final design was circular columns of varying height 1.5 meters in diameter to support the dead load with high density foam cut and fitted

around the hanging stones to transfer the load into the air columns. The work commenced with the removal of the stones from the top of the sarcophagus and consolidating the supporting piers that were damaged by the tons of falling stones. The entire area of the base of the chamber was consolidated with sand bags to cover the entire sarcophagus and provide a flat surface for the erection of the internal scaffolding. After the scaffolding was erected the most delicate work of placing the air supports was carried out.

Once these were in position and we were confident that the damaged stonework had been well supported we were then able to deep point the gaps and joints between hanging stones with a lime grout mixture to lock the stone face together.

Once the entire ceiling had been pointed we were able to slowly commence the drilling diamond drilled hole to install the stainless steel Cintec Anchors.

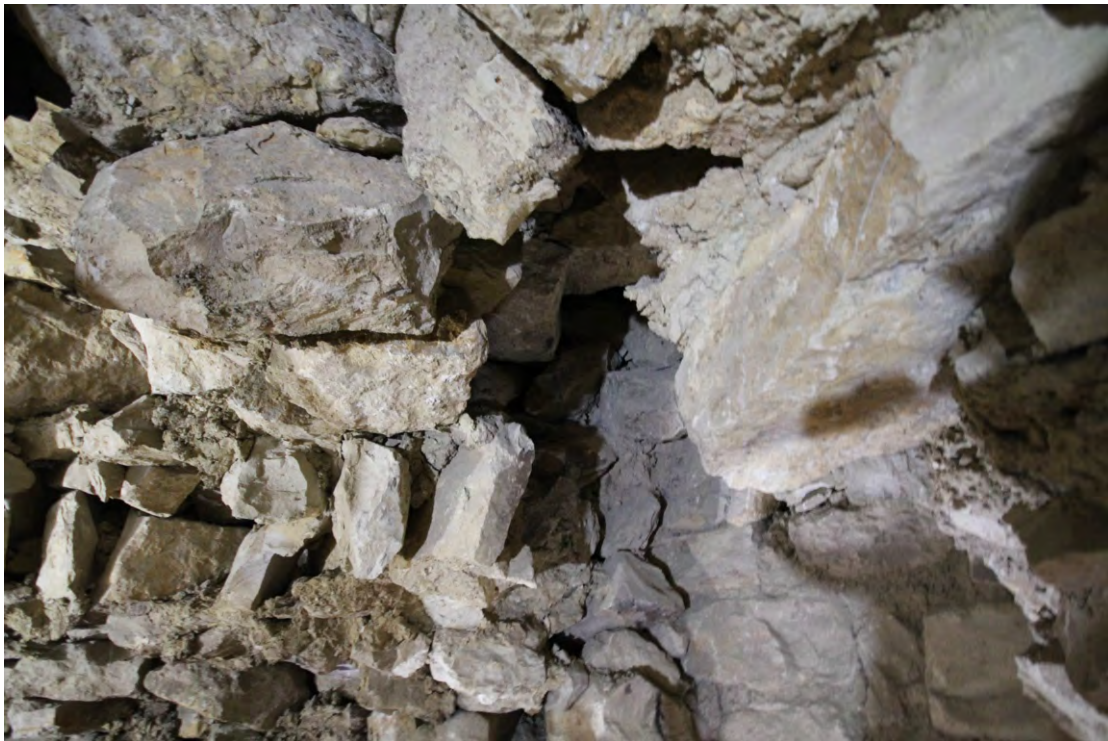
This work is still in progress at the moment but the most surprising observation was that although we were drilling up to 4 meters at roughly 90 degrees to the damaged face of the filling core of stones we never experienced drilling through stones that were more than 400mm wide. This appeared to be in direct contradiction that the stones on the outside of the pyramid were the same all the way through the pyramid. In some cases the fill was a great deal smaller and included the use of tufla grout to bond the smaller stones together.

It was this observation that prompted me to question the generally accepted theory that the entire volume of the pyramids were made of the blocks that made up the core stones on the outside of the pyramids.

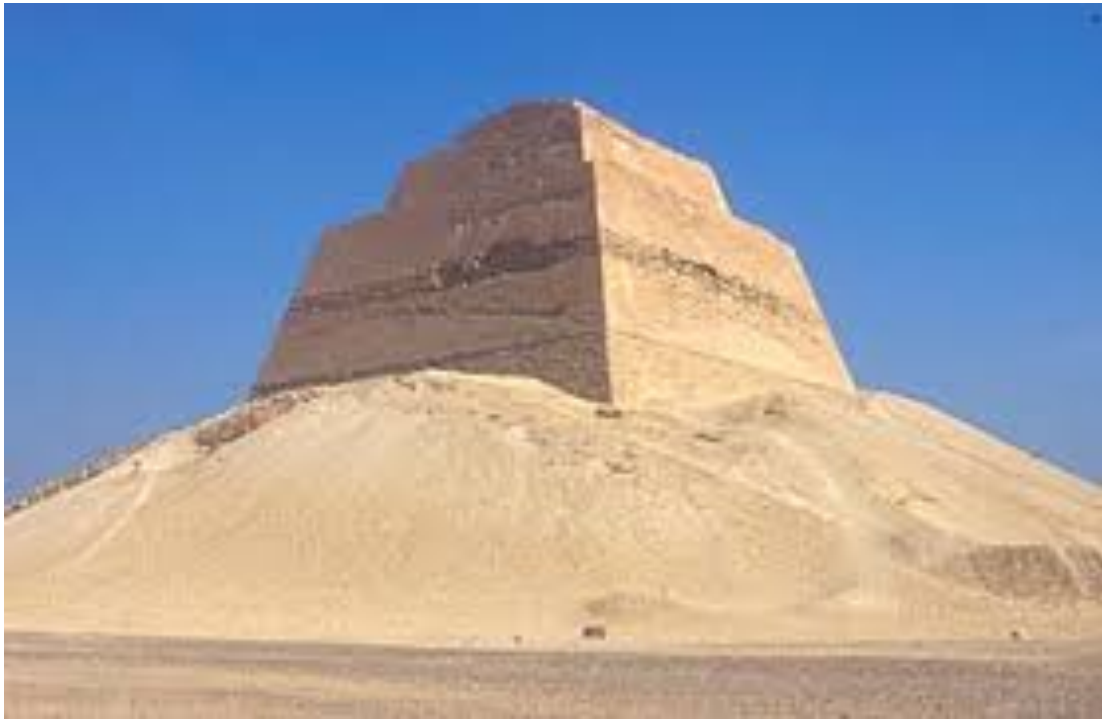
It is difficult if not impossible to surmise why the next pyramid was built in the shape and form of the pyramid at Meidum. The remaining uncompleted structure has the appearance of a truncated box sticking of the ground. It seems that the builders had built a solid internal core and added the external sloping sides to give the final appearance of a pyramid.

The resounding mass of debris at the base of the pyramid is what remains of the sloping façade that was placed externally in layers from the outside. The result of a catastrophic failure due mostly to the external attachment not being bonded to the inner core or having adequate expansion joints to prevent movement failure. It was seen that when the next set of pyramids that were built the inner blocks were stepped to secure and support the outer facing stones to carry its weight and to lock the slabs to the pyramid sides.

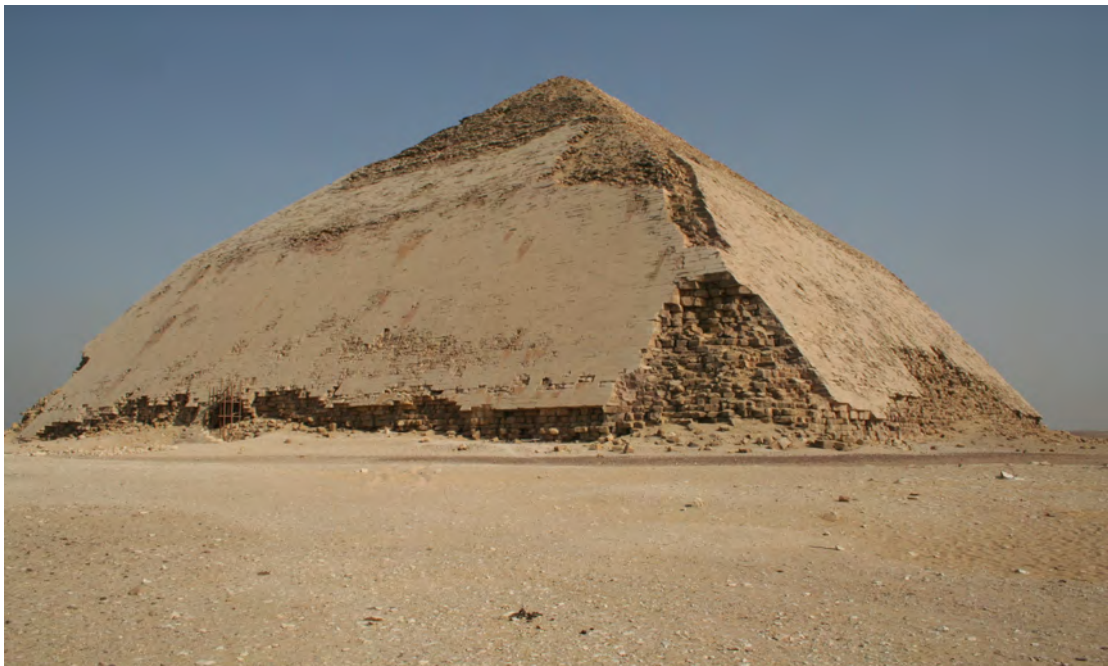
There are two major questions raised by the pyramid. The first one was why was it built at an angle of 53 degree for two thirds of its height and then bent over to an angle 43 degrees?

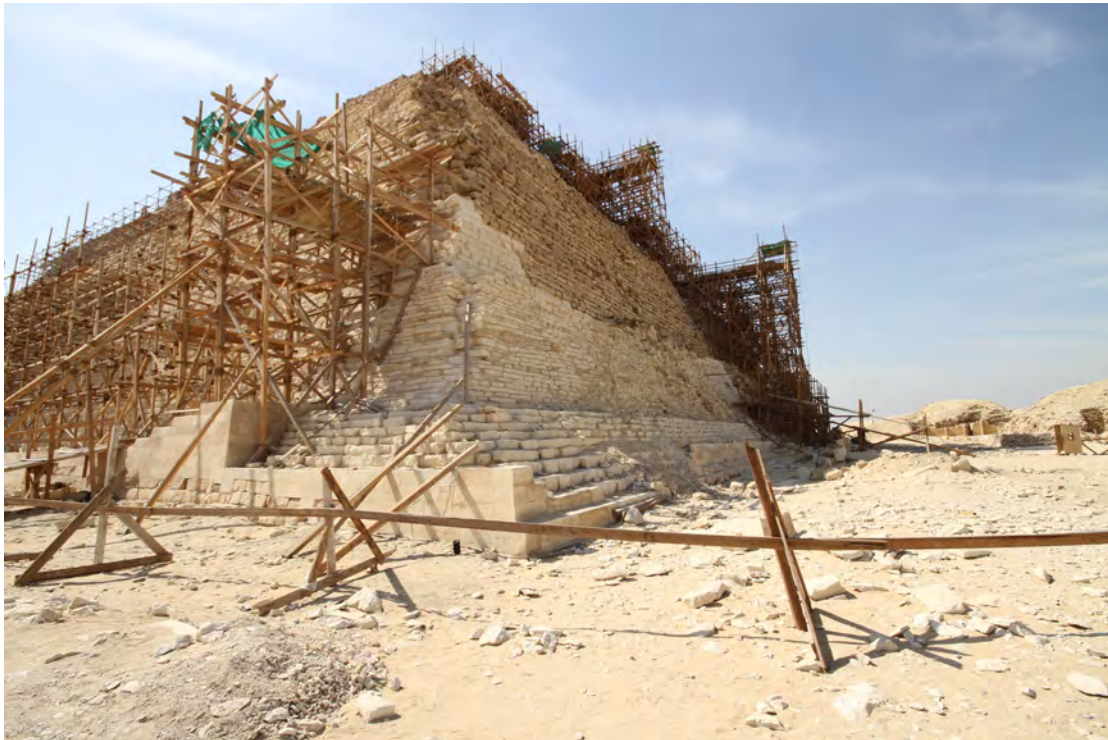
It was more than possible to use scaffolding to construct the pyramids as can be seen in this photograph showing the current work being undertaken on the Step Pyramid with only traditional timber and rope lashings to replace the damaged outer façade. I believe that this would have been the preferred method of building the pyramids together with internal ramps and not with any external ramps that have been suggested by many archeologists.

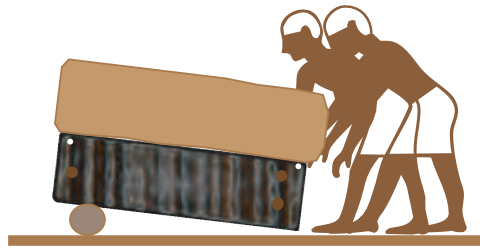
Core slab is lifted onto a sledge near a half lift scaffold.

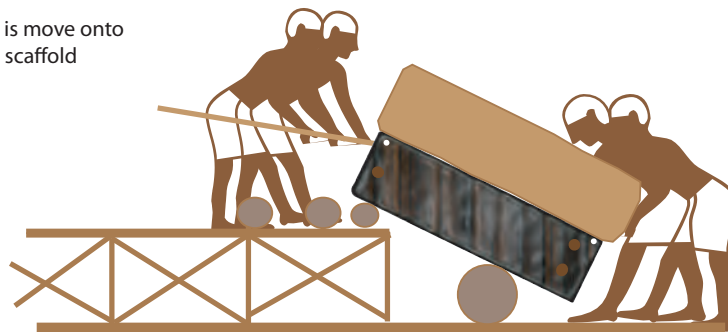
Sledge is move onto half lift scaffold

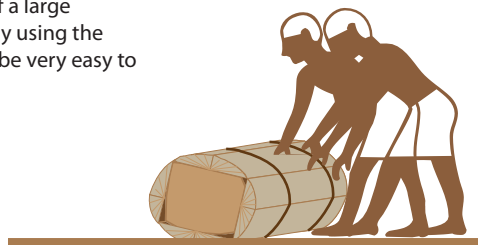
Another way of rolling the core slab would be to fit segments of a large tree to the edges. Effectively using the core as an axle. This would be very easy to move with levers.

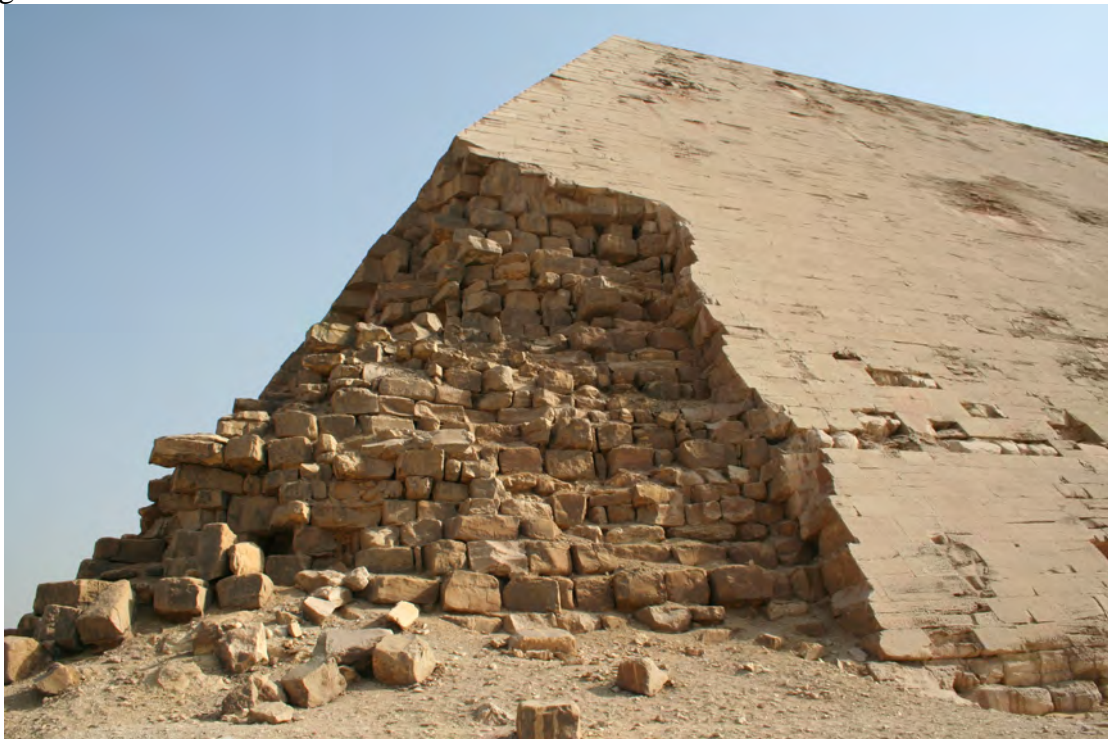
Typical damage caused by thermal expansion as two opposite edge meet.

Limestone has a coefficient of thermal expansion of  $8 \times 10^{-6}$  proportional to the change of temperature and to the original dimensions and many natural stones retain a minute proportion of the expansion when they cool down and do not return to their original size.

Let us say that  $8 \times 10^{-6} \times (40-3) \times 100\text{m run} = 0.0296 \text{ m}$  of movement per 100 metres run in all directions. However, this is also dependent on the size of the gaps between each stone. So the outer casing would expand to say 40 degrees in the day and cool to say 3 degrees at night. All the movement would be taken up initially in the joints but the limestone does not go back to its original position. This expansion will create dust and stone particles that would detach from the stones, filling the voids and gaps between the stones. This would have the effect of reducing the amount of contraction at night in addition to its nature desire not to go back to its original size and so the whole cycle will start again. Multiply the number of days the Pyramid has been

erected by this endless movement and you have the reason why all the outer casing has moved to the extremities where it has buckled or displaced against other blocks moving in the opposite direction and then it has fallen off and probably then picked up by opportunists and removed from site. I believe that this is the mechanism of failure on this and all the other Pyramids.

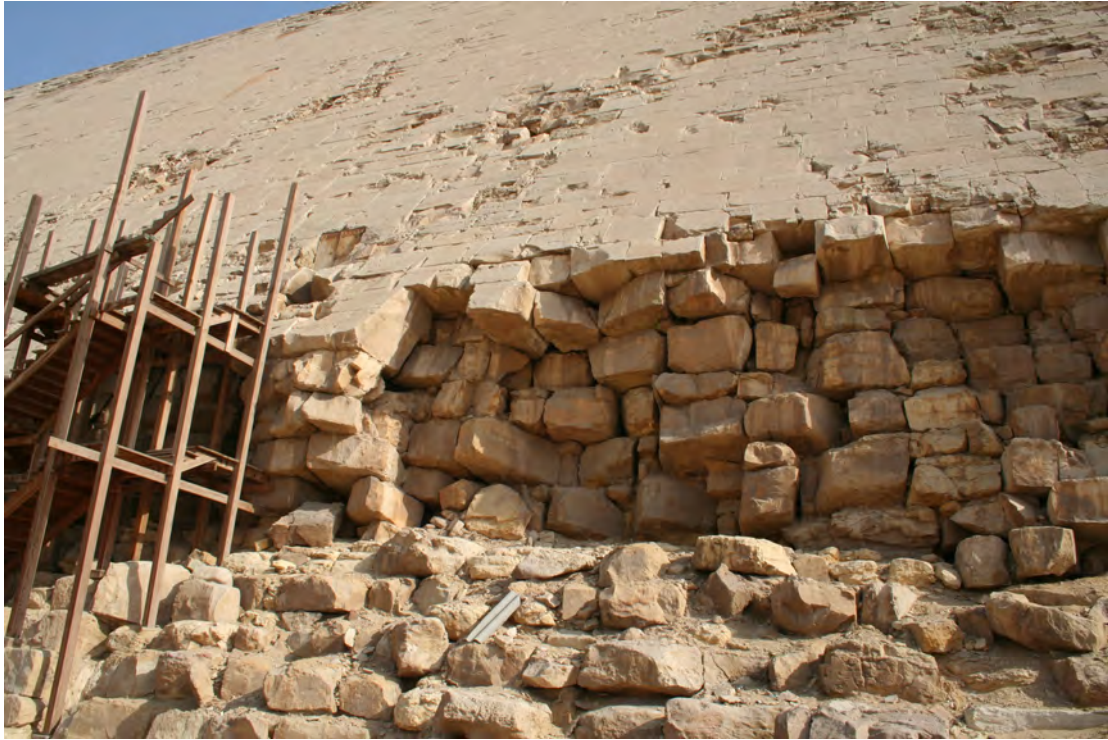
If we consider that in the day time the temperature rises to 40 degrees across the face of the outer casing and then at night cools to 3 degrees because of the lack of cover and exposure to the prevailing winds.

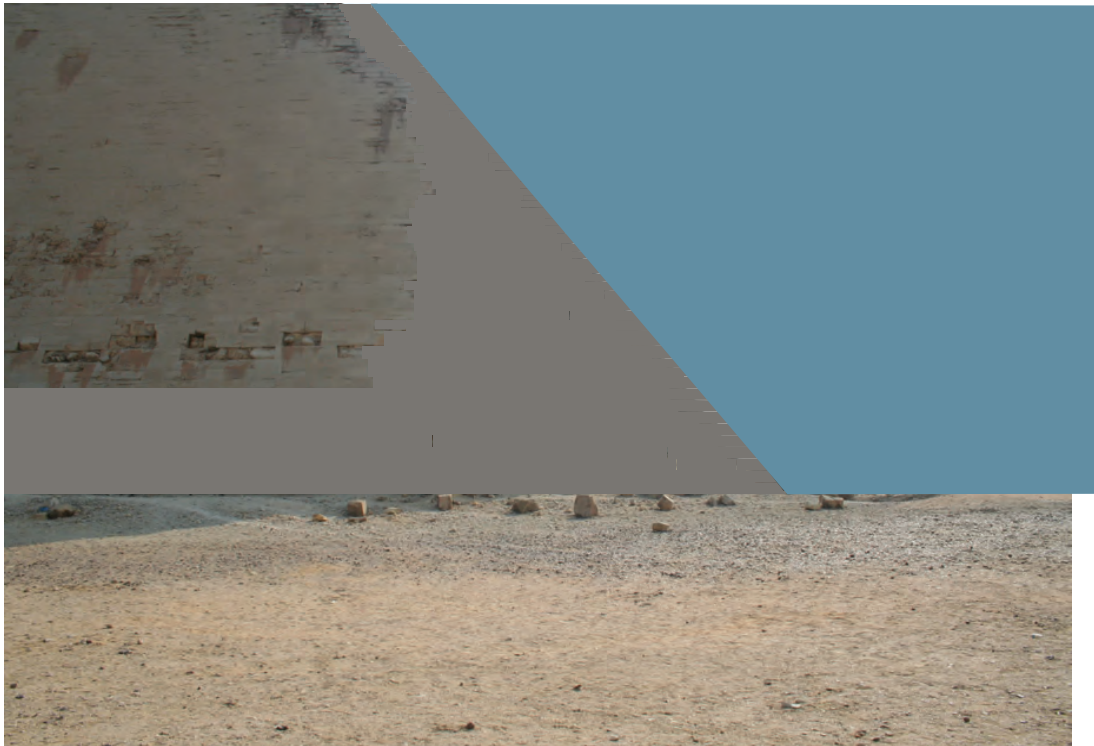
This photograph was taken in 2006 but the missing blocks have been drawn in to show what the pyramid would have looked like as built.

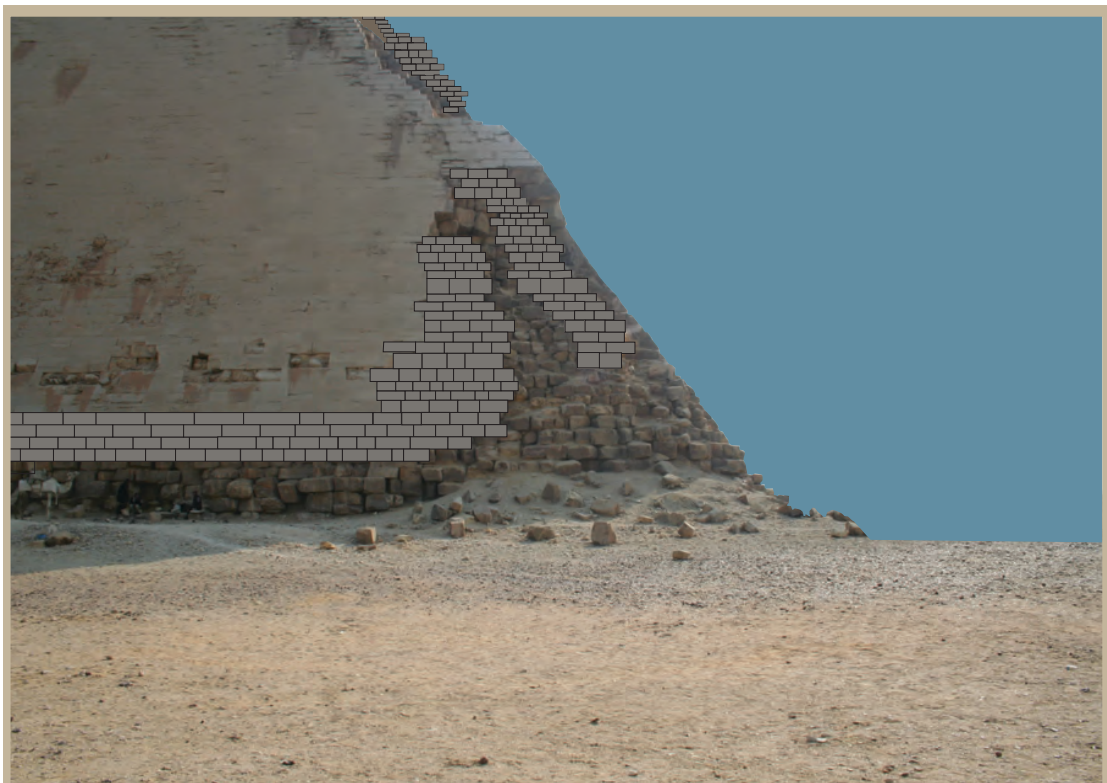
The pressure has moved some blocks out as far as a meter.

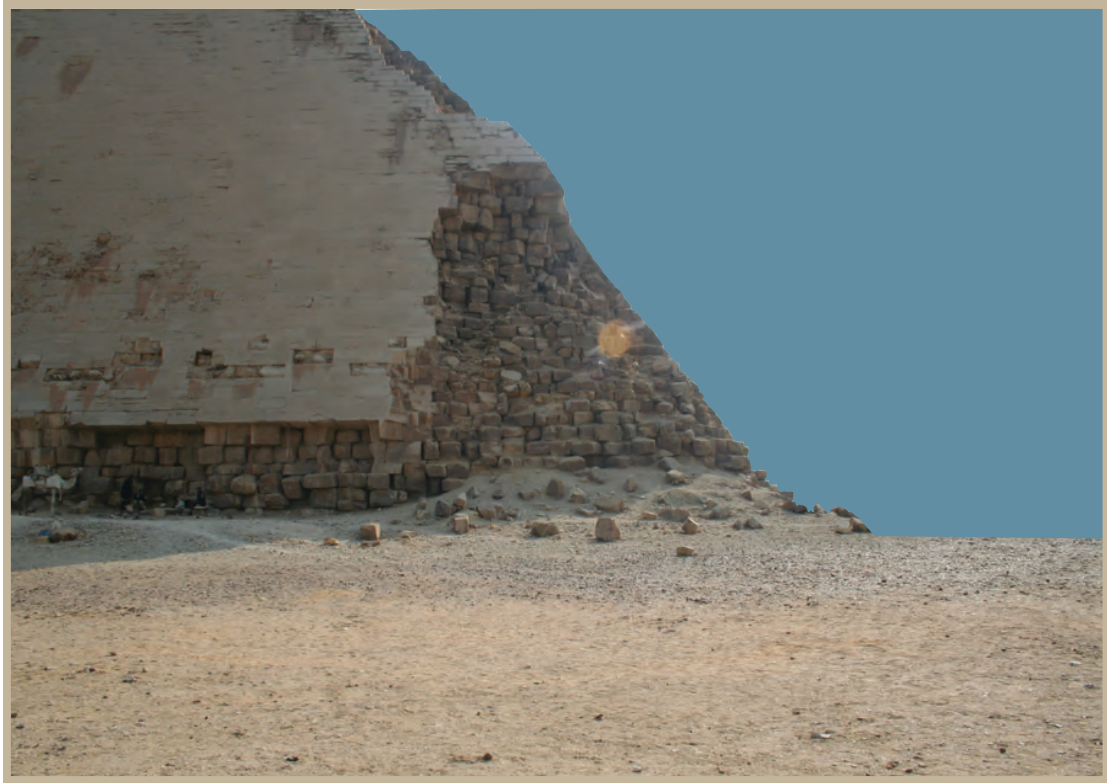
This is the photograph taken in 2006 showing the total amount of movement that has taken place in 4600 years.
