Windsor Castle - The Brunswick Tower

WINDSOR CASTLE – THE BRUNSWICK TOWER – THE REPAIR

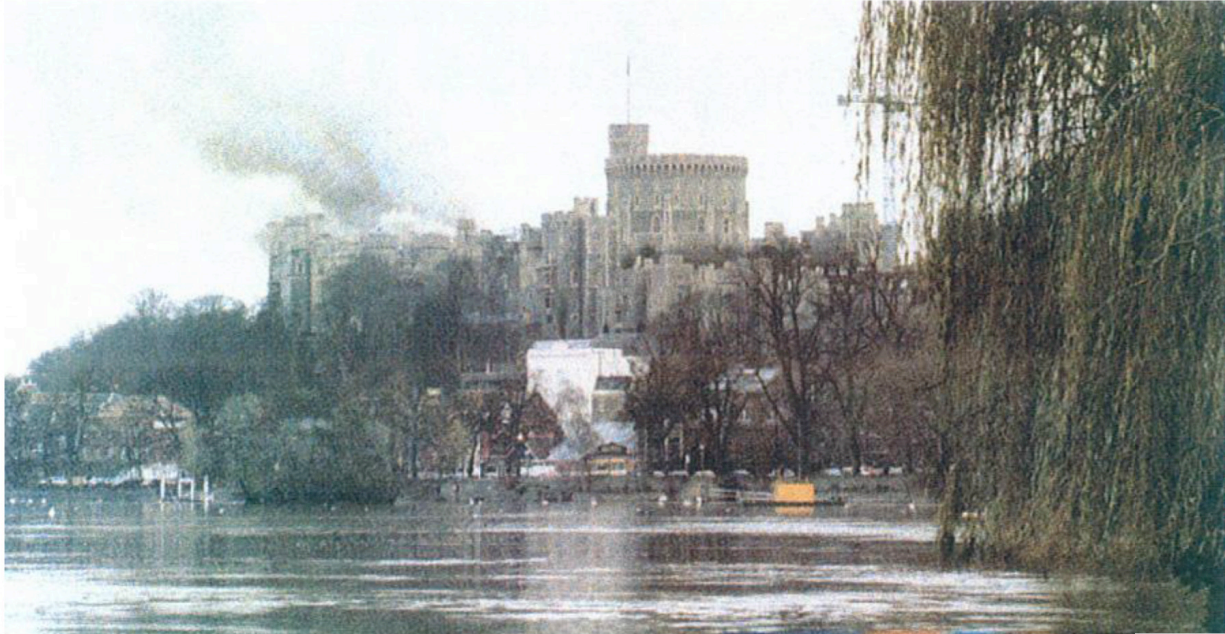
At 11.37 am Friday November the 20th, 1992, fire broke out, and much of the castle was devastated by the raging inferno that ensued.

The fire raged all day and at 6:30 pm the Brunswick Tower was engulfed. The intense heat caused the castellated section of the tower to fracture, with the possible risk of collapse.

Initially there seemed little choice but to dismantle and rebuild the top section of the tower. However the versatility of the Cintec Anchoring System enabled the Engineers to design a repair solution that restored the structural integrity without further disruption to the unstable stonework.

Throughout the damaged areas of the castle Cintec Anchors were used to restore the integrity of the walls and provide repair and strengthening solutions to this magnificent Heritage Building.

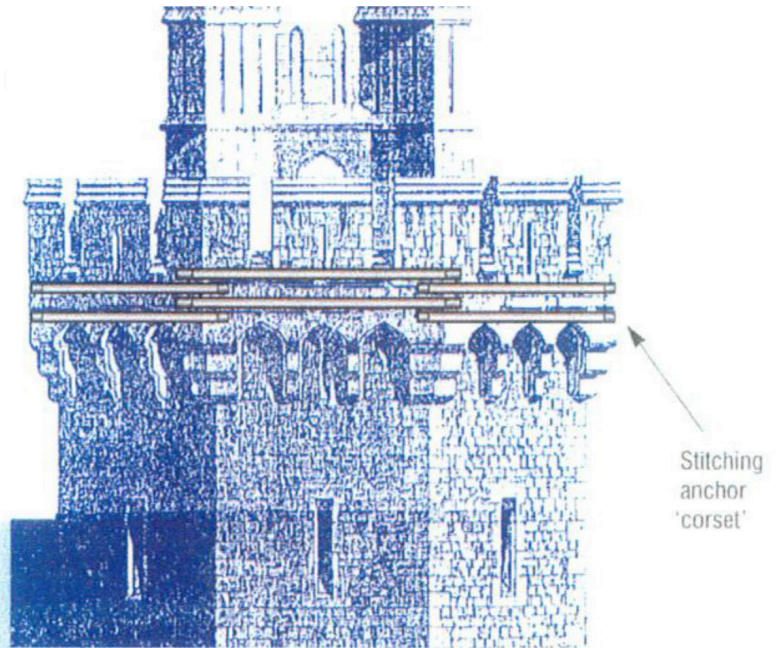
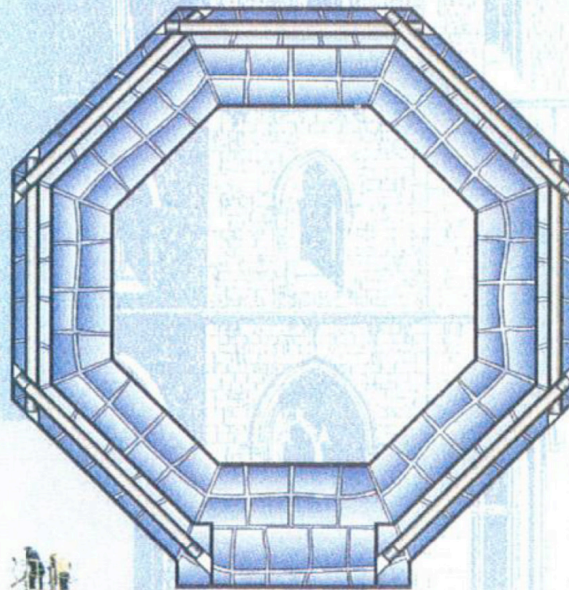
The latest Diamond Drilling Techniques were used to create a network of holes within the stonework.

The Cintec Anchors were then installed creating a reinforcing ring, within the fabric of the stonework, maintaining the original appearance of the tower.
