## Windsor Castle - The Brunswick Tower

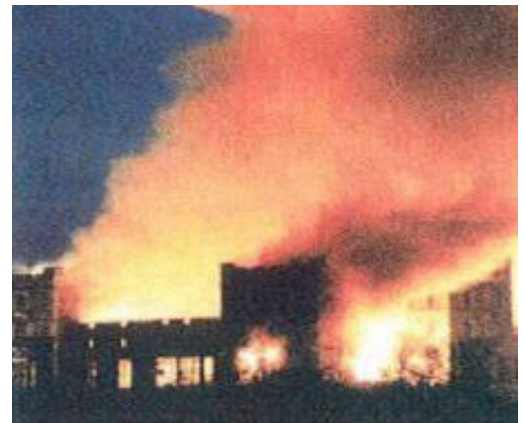
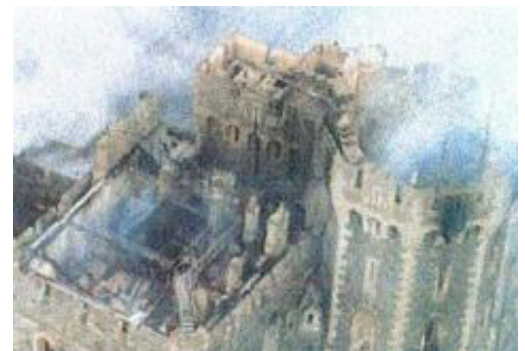
The 900 year old Windsor Castle is the home of her Majesty the Queen of England, and is the repository of the many of the Royal artifacts, including priceless art treasures. At 11.37 am Friday November the 20th, 1992, fire broke out, and much of the castle was devastated by the raging inferno that ensued. The fire raged all day and at 6:30 pm the Brunswick Tower was engulfed. The intense heat caused the castellated section of the tower to fracture, with the possible risk of collapse.

Initially there seemed little choice but to dismantle and rebuild the top section of the tower. However the versatility of the Cintec Anchoring and Reinforcement System enabled the Engineers to design a repair solution that restored the structural integrity without further disruption to the unstable stonework.

Throughout the damaged areas of the castle Cintec Anchors and reinforcement system were used to restore the integrity of the walls and provide repair and strengthening solutions to this magnificent Heritage Building.
