Windsor Castle - The Brunswick Tower

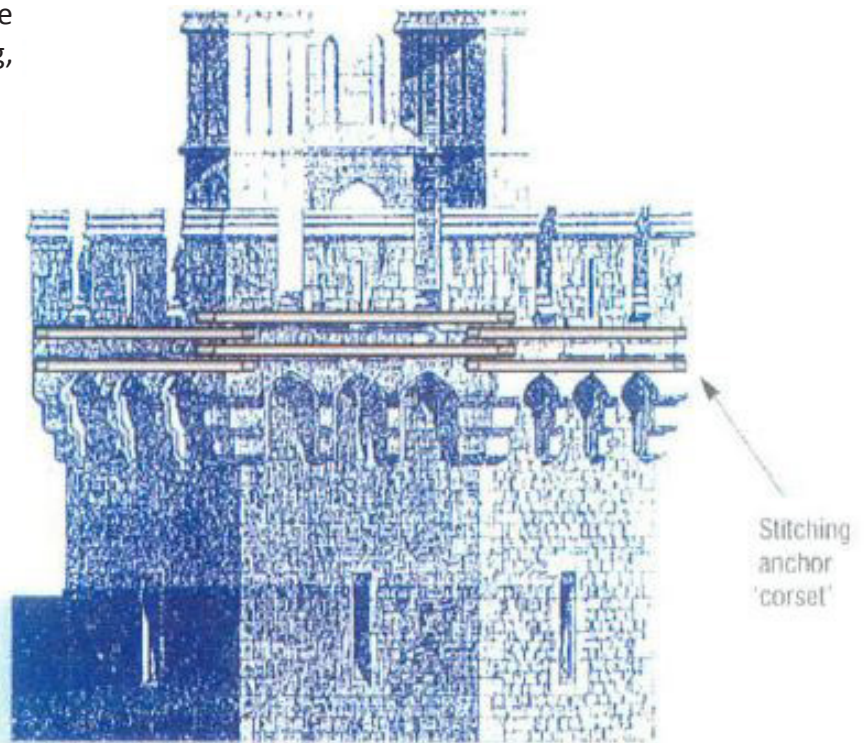
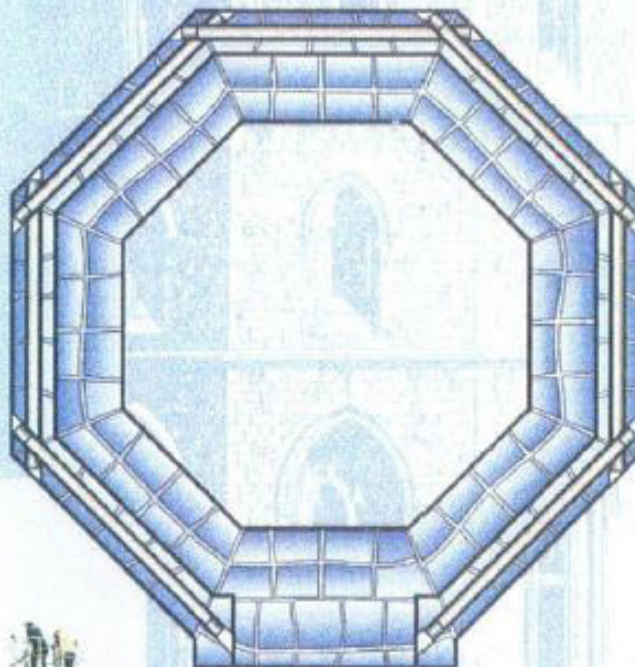
Windsor Castle - The Brunswick Tower The latest Diamond Drilling Techniques were used to create a network of holes within the stonework. The Cintec Anchors and reinforcement system were then installed creating a reinforcing ring, within the fabric of the stonework, maintaining the original appearance of the tower.

Initially there seemed little choice but to dismantle and rebuild the top section of the tower. However the versatility of the Cintec Anchoring and Reinforcement System enabled the Engineers to design a repair solution that restored the structural integrity without further disruption to the unstable stonework.

Throughout the damaged areas of the castle Cintec Anchors and reinforcement system were used to restore the integrity of the walls and provide repair and strengthening solutions to this magnificent Heritage Building.
