Report No. B1660A/V16/R03  
May 2004

**POP BOTTLE BRIDGE SUPPLEMENTARY LOAD TEST**

**SUMMARY REPORT**

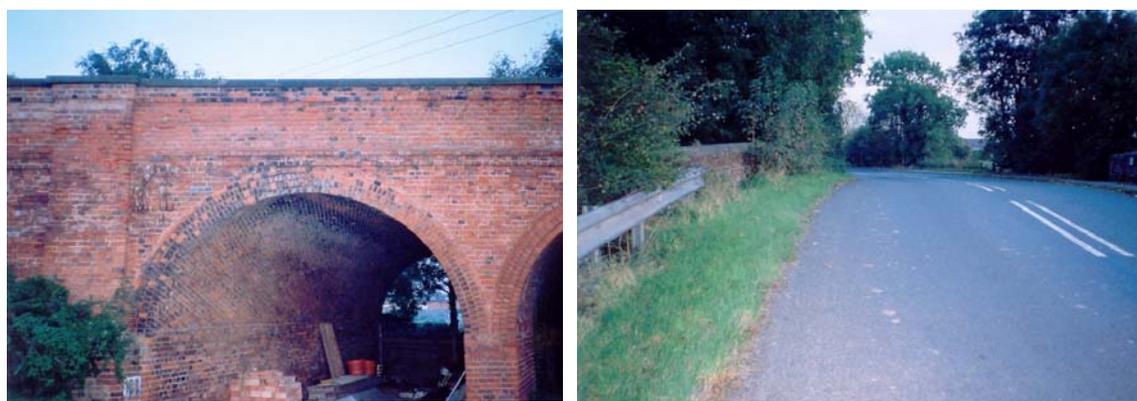
**Figure 2.1 Pop Bottle Bridge**

Pop Bottle Bridge (National Grid reference TF 439 223) is a skewed two-span brick masonry arch bridge. Each span is approximately 5.0m measured in the skew direction and rise at their crowns 2.3m. The barrel is built from three rings of brick with bricks laid to the English or Helicoidal Method and has a skew angle of 25°. The overall barrel thickness is 355mm. The central pier is 800mm wide and approximately 2.1m high. Figure 2.1 shows an elevation and the road above.

*Part of side elevation*

*Road above*

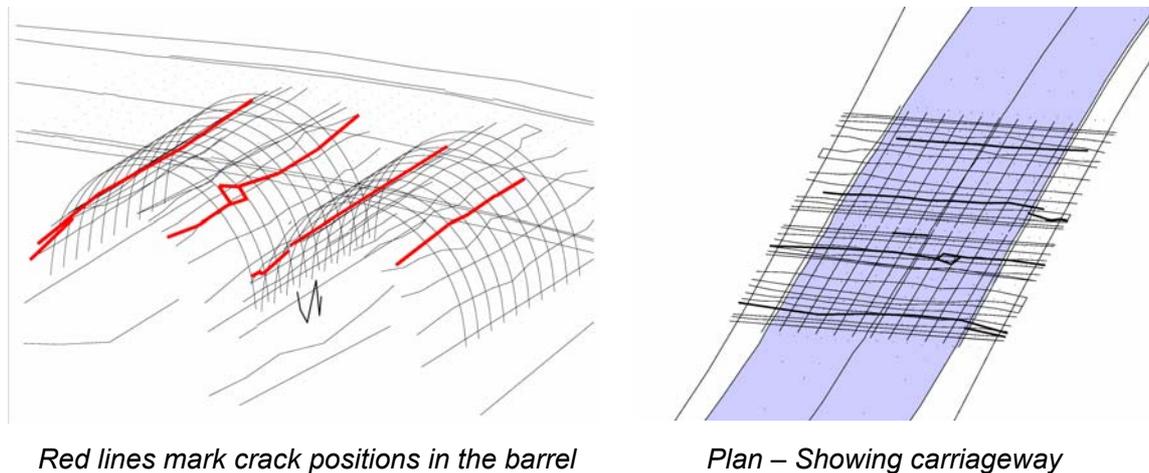
**Figure 2.2 Archtec Survey Contours**

Using modified MEXE and mechanism analysis the live load rating of the bridge was originally calculated to be 13 tonnes<sup>(2)</sup>. Later, a Special Assessment was undertaken by Gifford<sup>(3)</sup> using the DE technique and the rating increased to 40/44 tonnes. However, the presence of four transverse cracks warranted the recommendation that an Archtec strengthening scheme be developed. These four transverse cracks at approximately quarter span locations are shown in Figure 2.2 together with the Archtec bridge survey contours. Cracks are shown in red.

The transverse cracks at the quarter points of the arches were of some concern and suggest the beginning of hinging failure at the quarter points due to live loading effects, possibly as a result of frequent heavy longitudinal braking. Archtec strengthening would provide additional capacity to achieve the required load rating and provide stitching across the hinge locations.

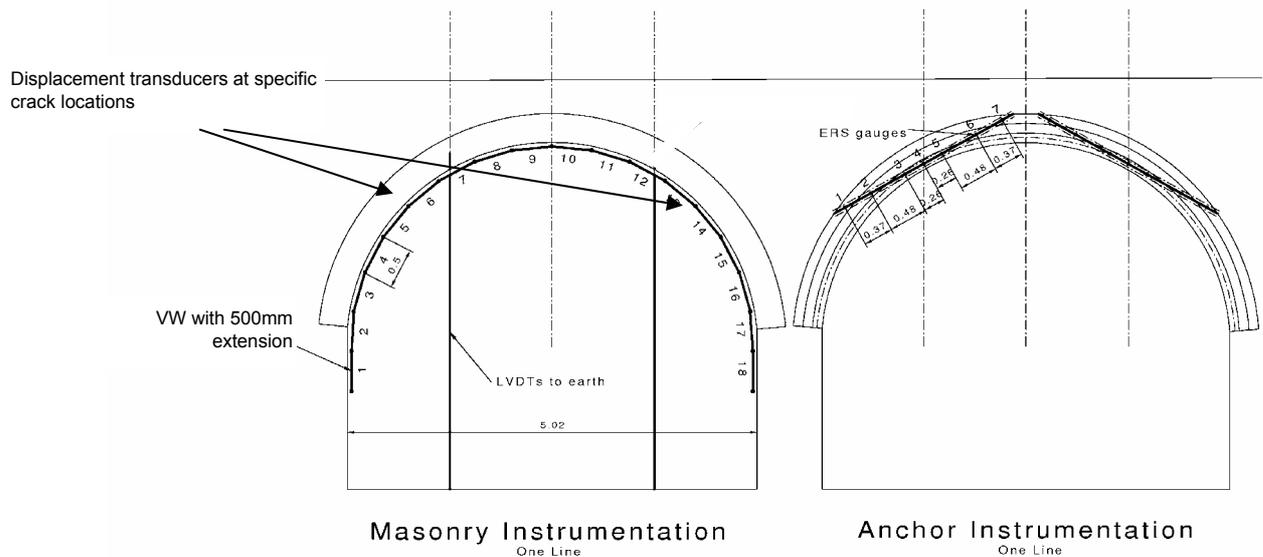
**Figure 4.1 Instrumentation**

The bridge and strengthening anchors were instrumented, as indicated in Figure 4.1 to monitor the following key parameters;

- i) Vertical displacements at quarter points using LVDTs.
- ii) Strains around the intrados of the arch barrel over 500mm gauge length using VW gauges with extensions.
- iii) Displacement transducers at locations of specific cracks around the intrados.

iv) Electrical Resistance strain gauges attached to the strengthening anchors.

Eighteen VW strain gauges with extensions to provide a gauge length of 0.5m were set out on the intrados of each arch on each instrumented section as indicated in Figure 4.1. All 72 gauges were read for each live load position to build up a picture of intrados macro strains (average strains across bricks and mortar joints).

Macro strain results, positive values are tensile, are plotted against gauge numbers that mark the relative position around the intrados, see Figure 4.1.

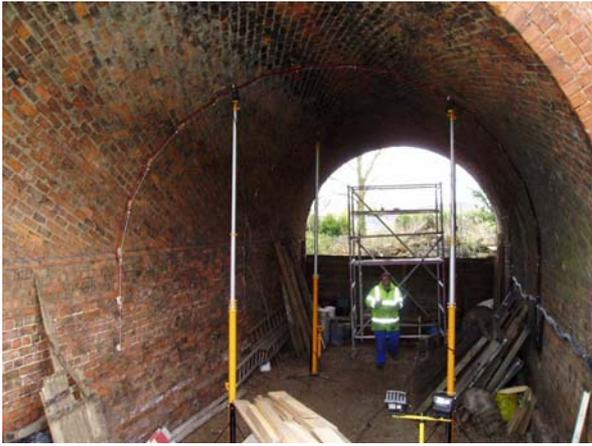
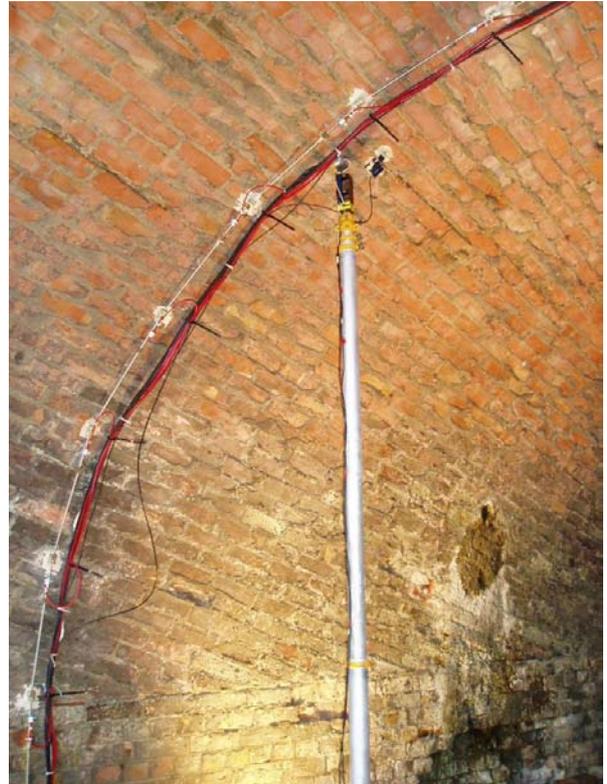
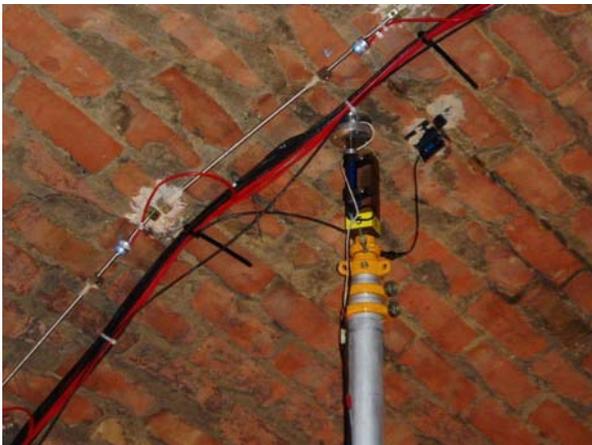
**Figure 4.2 General View of Instrumentation**

*a. South span*

*c. Pole supporting displacement LVDT and part of a line of VW strain gauges*

*b. Typical crack and displacement LVDTs*

The instrumentation outlined above was installed on two longitudinal sections through the bridge as indicated in Figure 4.3. The instrumented sections were aligned under the centre of each of the two loaded lanes. Full details of instrumentation arrangements are contained on the drawing included in Appendix C and illustrated in Figures 4.2.

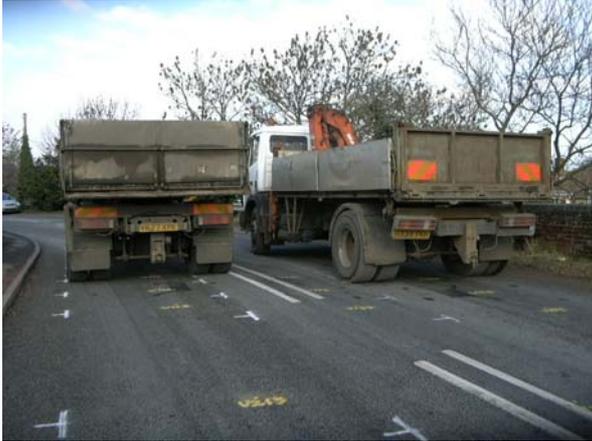
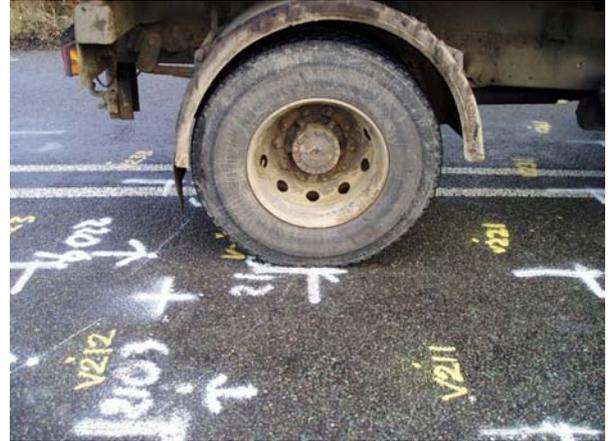
**Figure 4.3 Application Of Test Loads Using Ballasted Lorries**

The loads were applied using two ballasted two axle lorries (18 tonne gross weight, similar to vehicle reference RE as defined in Annex D of BD 21/01). Only the rear axle, with a nominal weight of 11.5 tonnes, was of interest in each case. The front axles were far enough away to have no significant effect. Each axle load in the two axle vehicle is statically determinant and, as the axle loads were not varied in the tests they were measured before each test on a Department of Transport weigh bridge.

Trucks side by side – LC7

Positioning of 11.5 tonne axle

The lorries were positioned in a variety of locations along the two instrumented lines, including cases where both vehicles were maintained effectively in line and others with only one vehicle on the bridge to provide data in relation to transverse distribution. In total 28 load cases were applied to both the unstrengthened and strengthened bridge. Photographs of typical load case arrangements are shown in Figure 4.3. Full details of all Test Load positions are provided in Appendix D.

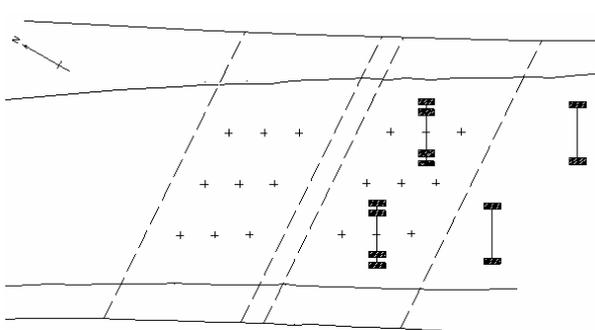
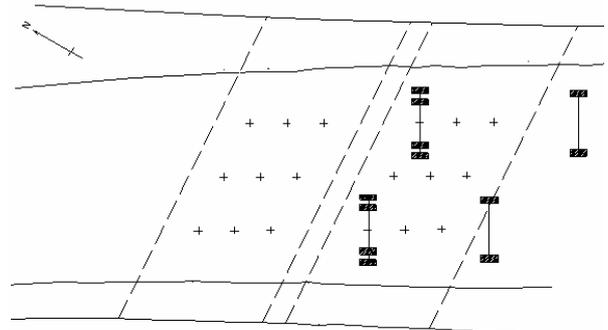
**Figure 4.4 Selected Load Case Arrangements Used on the South Span**

This report focuses on the six most extreme load cases where the largest measured displacements and strains were recorded. These cases are those with two vehicles positioned side by side with the 11.5 tonne axles lined up in turn with span quarter points, (ie North span first quarter, mid span, second quarter and ditto South span) see Figures 4.3 and 4.4 for representative cases.

Load case LC8 – Pair of axles at mid-span

Load case LC9 - Pair of axles at the pier quarter point

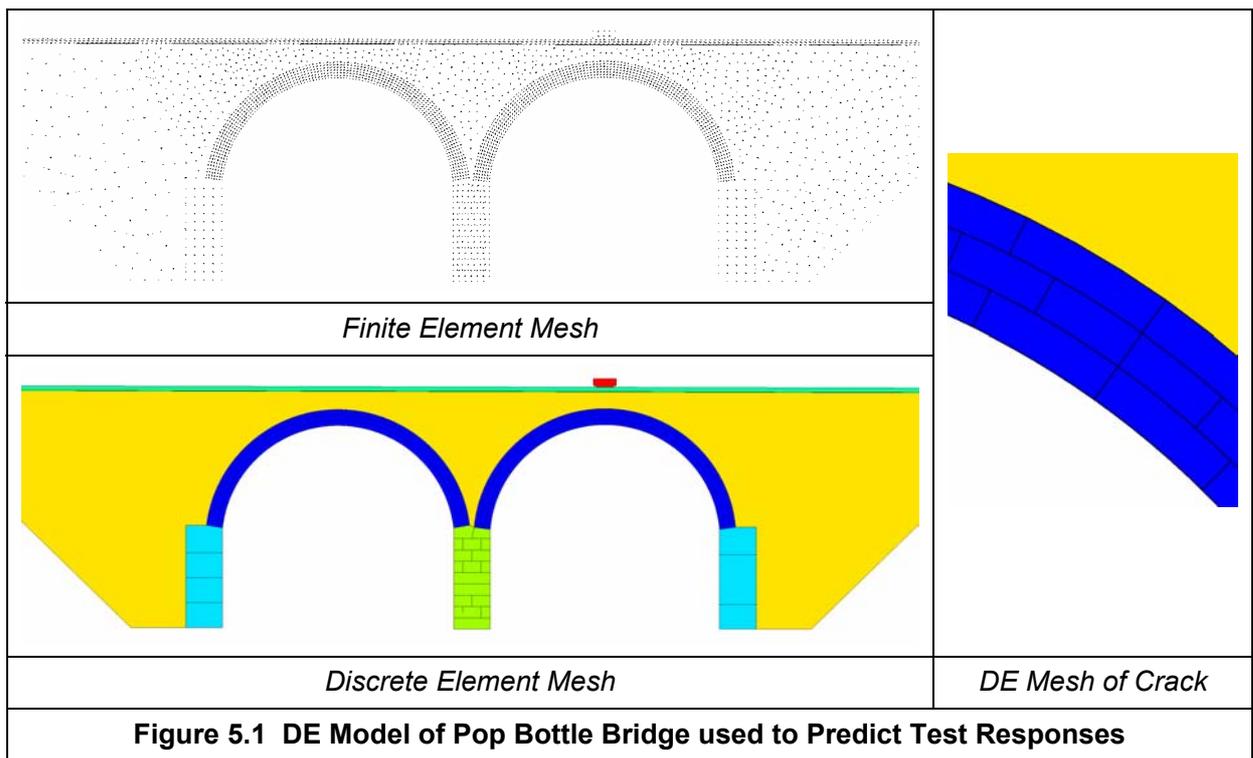
- i) The four transverse cracks were explicitly represented in the modelled barrel by including a frictional cohesionless joint in the barrel through all rings at the crack locations. These cracks at approximately the 1/5 span, have been represented as being closed under permanent loads, prior to the application of the live load.
- ii) In place of the codified live load cases used for assessment each of the 28 load cases used in the tests have been modelled by applying 11.5 tonne axles.
- iii) The rules in BD 21 for distributing wheel loads transversely through the surfacing and fill have not been used. Instead axle loads have been applied over a 2.5m wide strip of barrel.

Figure 5.1 shows the DE model of Pop Bottle Bridge and the modelled transverse cracks.

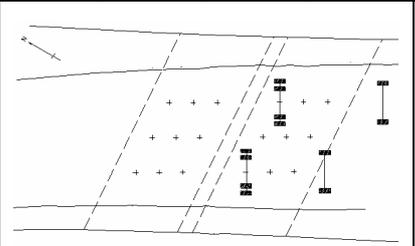
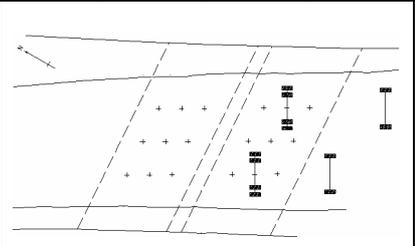
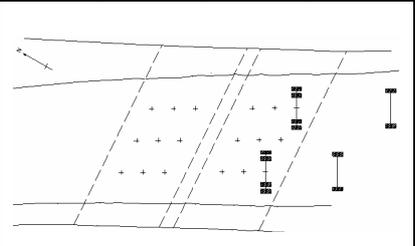
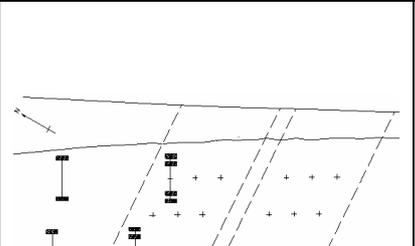
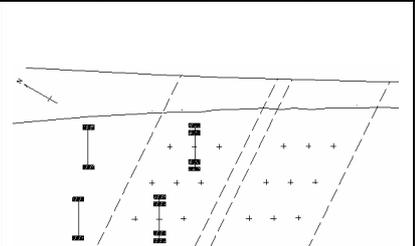
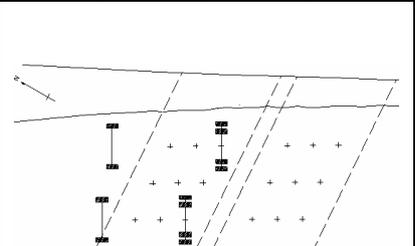
Figure 6.1 – Displacements Across Cracks During Load Tests

Displacements across the four transverse cracks which were monitored during both tests are summarised in Figure 6.1. Positive values indicate cracks opening. Plan inserts showing the vehicle arrangement used for each load case are included, and viewed in plan the values for crack displacements appear adjacent to the approximate crack locations. Exact crack positions are shown in Figure 2.2. No results were obtained from the North East gauge in the South span.

Crack Displacements [mm x 0.001] – RED Unstrengthened, BLUE Strengthened											
South Span – Double Vehicle Load Cases											
2	1		2	2	0		3	2	0		2
-3	-2		-11	-2	-2		-27	-2	-2		-14

Significant movement across the four pre-existing cracks was recorded. Movement across the cracks was significantly reduced following the installation of the strengthening anchors demonstrating their effectiveness in tying the masonry across such discontinuities. Referring to Figure 6.1, the maximum absolute crack displacement for the unstrengthened case was 0.046mm compared with a corresponding value of 0.009mm for the strengthened case indicating a reduction of approximately 80%. At many locations strengthening virtually eliminated movement with readings close to the gauges resolutions.

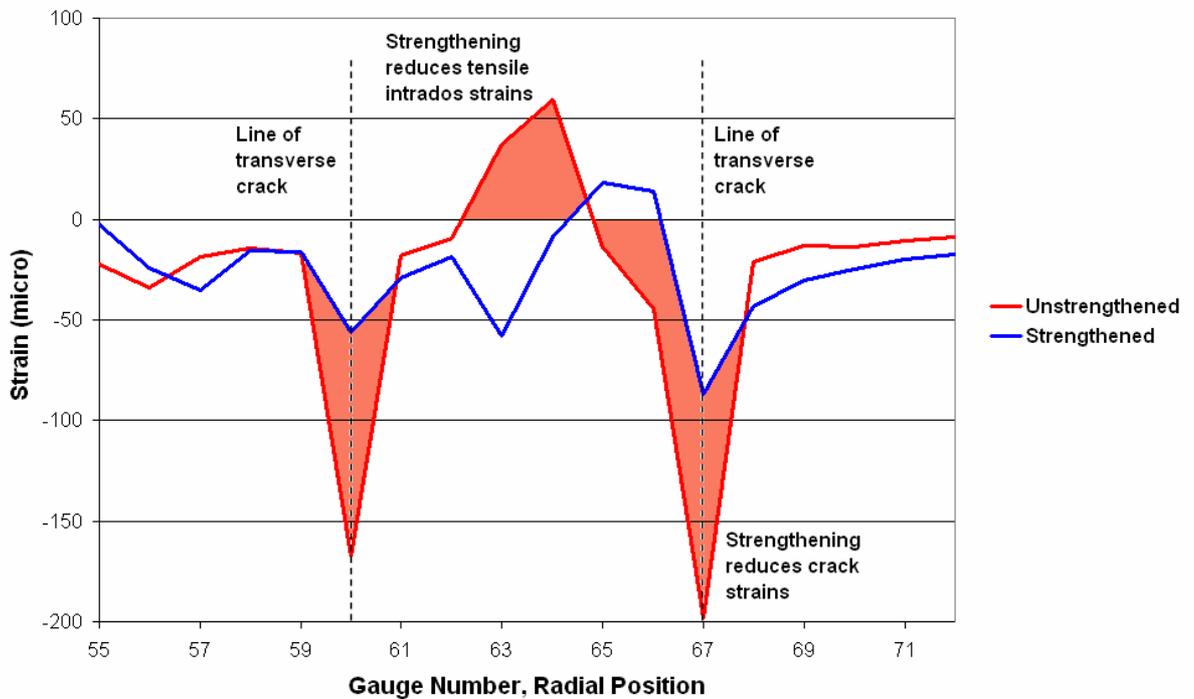
Figure 6.2a Representative Intrados Macro Strains

Representative results are illustrated in Figure 6.2a and 6.2b for load cases LC8 and LC9 respectively. The results are presented for the eighteen gauges around the intrados of the south span on the east instrumented line; approximately along anchor line 8, see Figure 4.3. Macro strains are plotted against gauge number for the unstrengthened (red curve) and strengthened (blue curve) tests. The position of gauges 55 and 72 mark the north and south springings of the arch respectively and gauges 63 and 64 are at mid-span. Positive values indicate tensile strains. Vertical dotted lines mark the location of the cracks and indicate the gauges that would therefore span cracks.

Load case LC8 – A pair of 11.4 tonne axles at mid-span of the south span

Away from the cracks there has been a general reduction in tensile strains. For the two cases illustrated in Figure 6.2, this trend is most notable at the centre of the span between the quarter points. This is particularly important as by reducing tensile strains Archtec strengthening lessens any susceptibility to further cracking and loosening of bricks which is clearly beneficial to the bridge's serviceability.

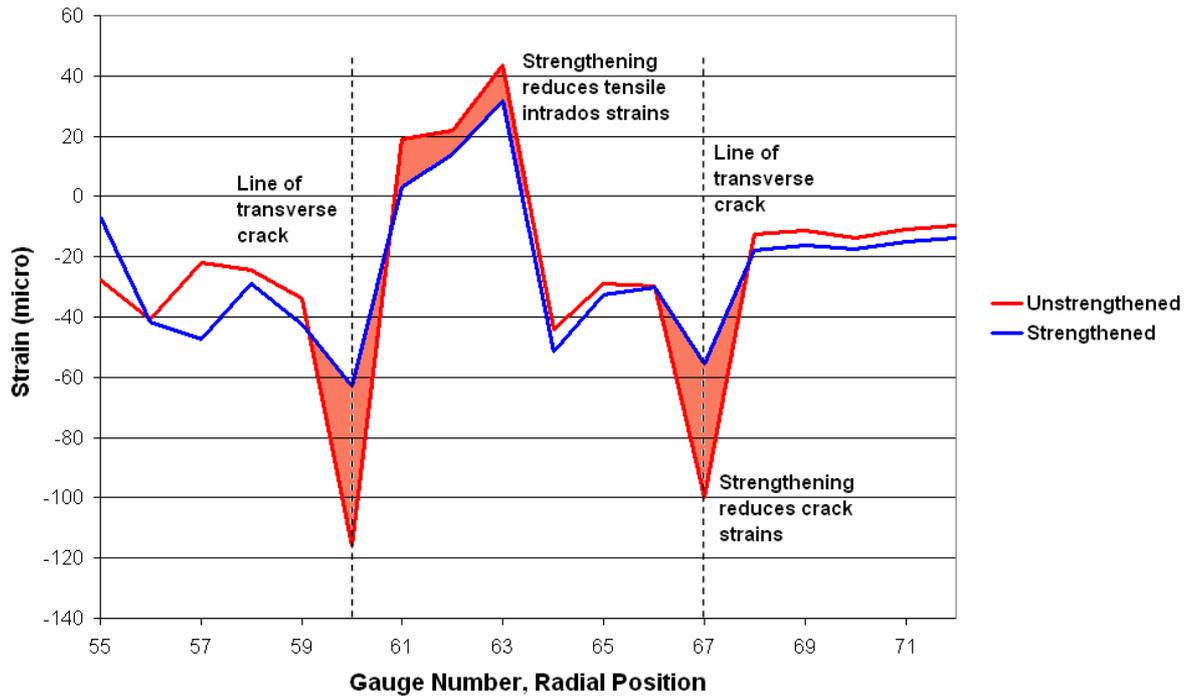
**Figure 6.2b Representative Intrados Macro Strains**

Load case LC9 - A Pair of 11.5 tonne axles at pier quarter-span of the south span

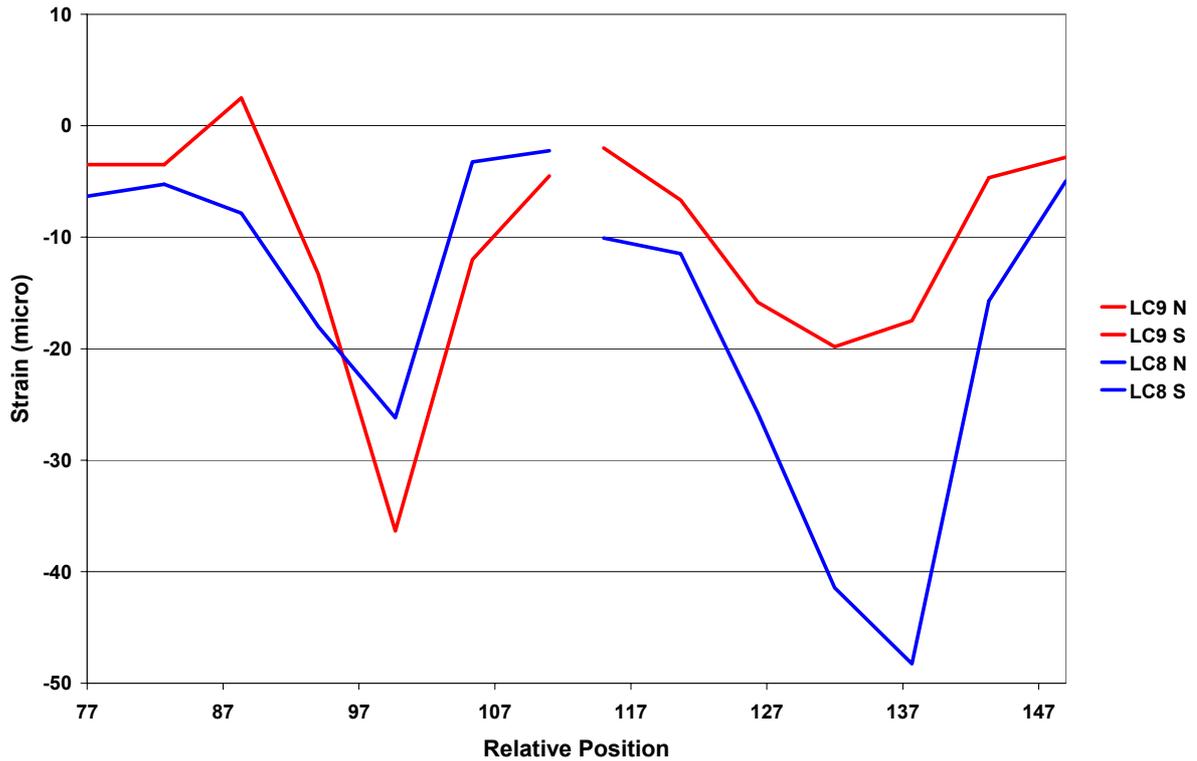
**Figure 6.3 Representative Anchor Strains – East side of South Span**

Anchor strains along the length of the eight instrumented anchors were recorded for the strengthened tests and all 28 load cases. The 112 gauges were arranged in pairs and a total of 9% failed to operate correctly or were damaged during installation, leading to no significant loss in recordings. All measured results lay between a minimum value of  $-51 \mu\epsilon$  and a maximum value of  $30 \mu\epsilon$ .

Figure 6.3 shows the measured strains for the south span, east side corresponding to load cases LC8 and LC9. Micro strains are plotted against their relative position along the two anchors, see Figure 4.1; numbers 77 to 111 relate to the anchor in the north half of the span, numbers 115 to 149 to the anchor in the south half.

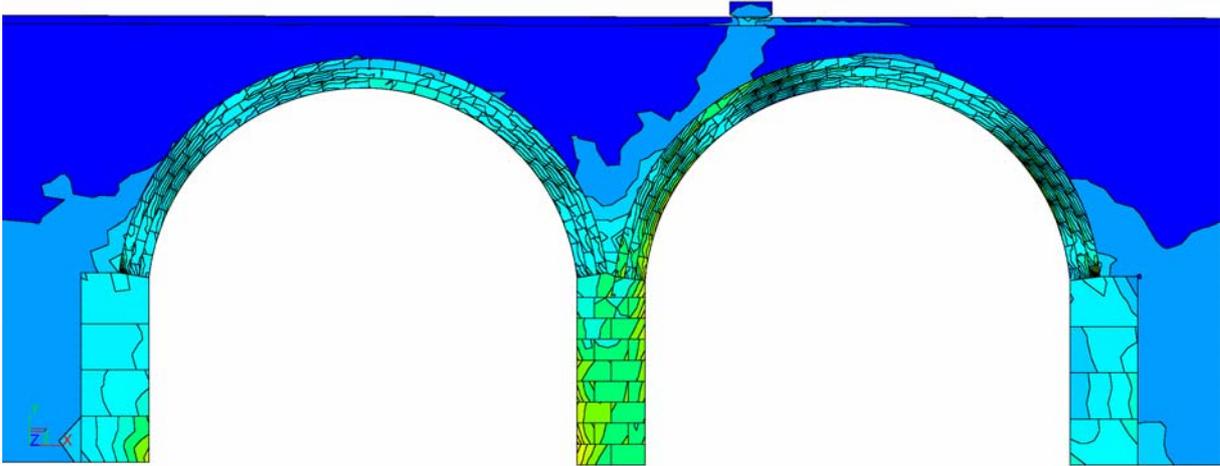
**Figure 6.4 Typical Predicted Results – South Span, Load Case LC9**

Figure 6.4 shows the results of a typical test simulation and in this case illustrates principal compressive stresses in the barrel and file.

Show principal compressive stresses; blue, green, yellow show increasing levels of compression

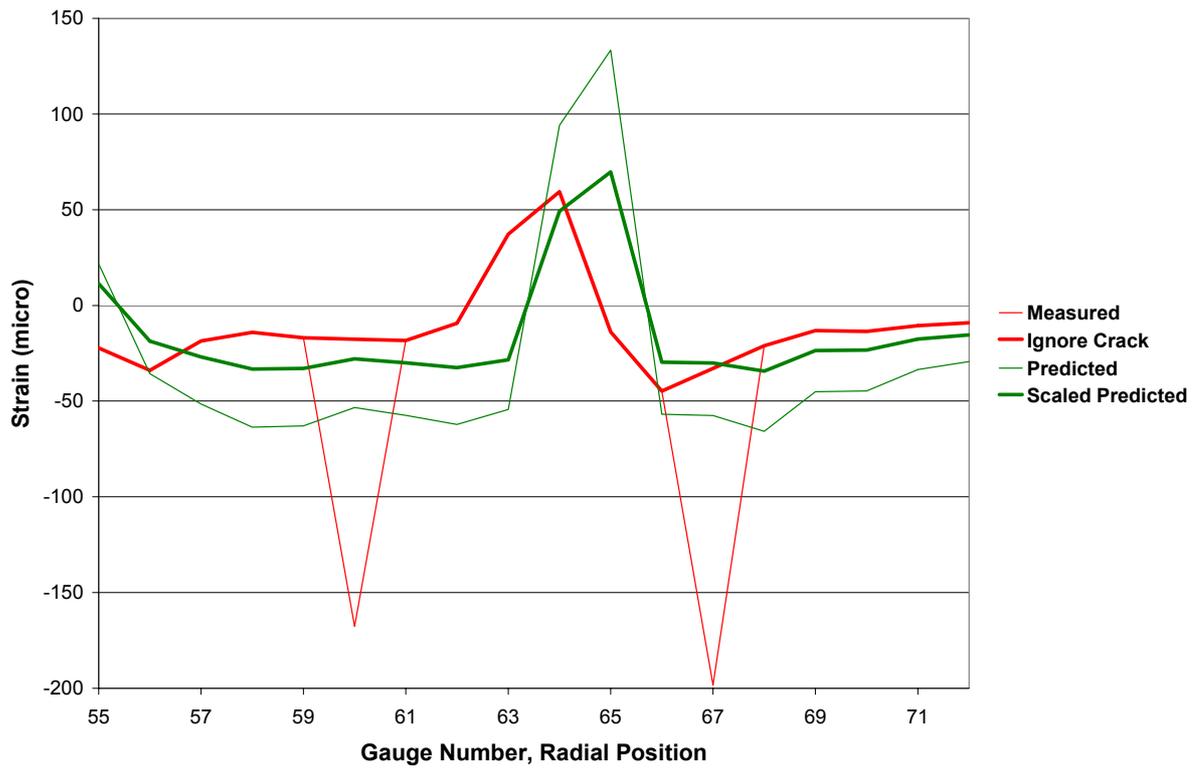
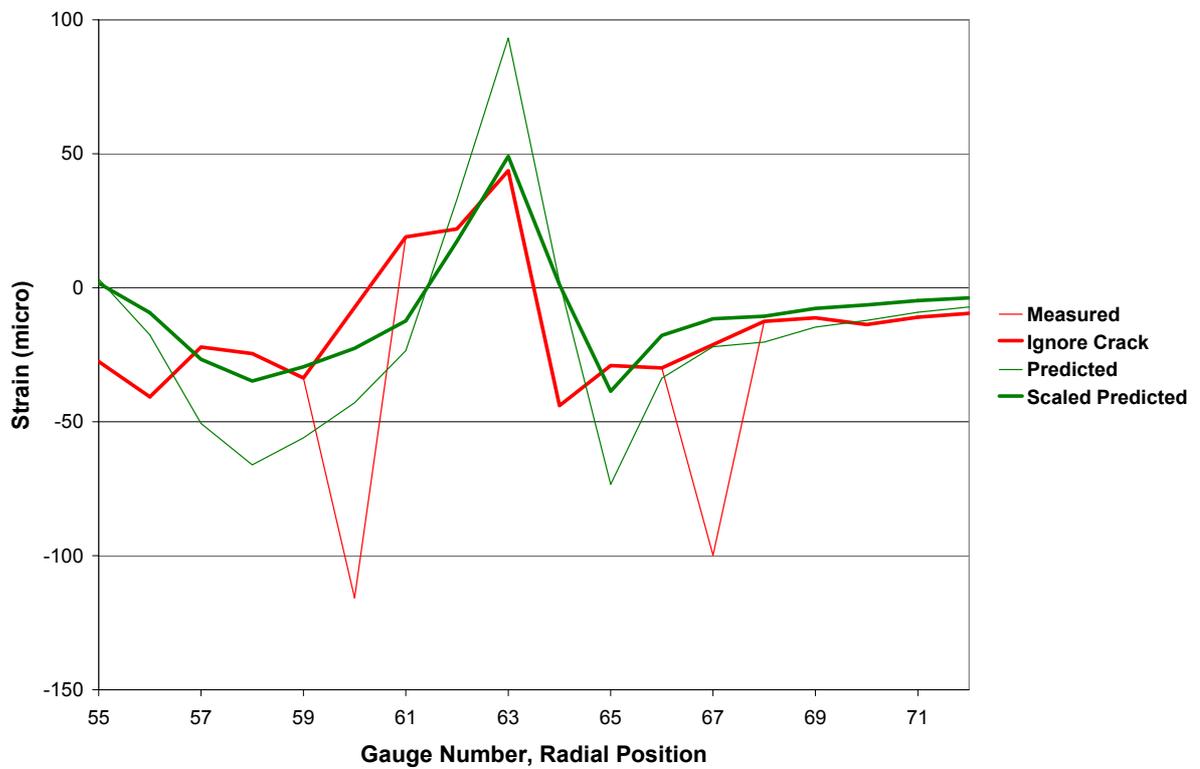
**Figure 7.1 Unstrengthened Test – Predicted versus Test Intrados Macro Strains**

Using the DE model and methodology described in section 6.2, intrados macro strains have been calculated and are compared against measured values in Figure 7.1. Again the representative load cases LC8 and LC9 acting on the south span have been used. The figure shows two graphs each with four curves;

- measured values (reproduced from Figure 6.2), labelled "Measured".
- measured values with the contribution attributed to movement across the significant pre-existing cracks removed, labelled "Ignore Crack".
- numerically predicted values, labelled "Predicted".
- numerical predicted values factored to make some allowance for 3D behaviour, labelled "Scaled Predicted". (As noted in Section 5, the 2D analysis is inherently conservative and, as anticipated, gives upperbound values with regard to strain, etc, since the 3D effects of transverse distribution, bridge skew and contribution of spandrel walls are not accounted for).

Load case LC8 – A pair of 11.4 tonne axles at mid-span of the south span

Load case LC9 - A Pair of 11.5 tonne axles at pier quarter-span of the south span

Once the above adjustments are made, for both cases the measured (curve marked "Ignore Crack") and predicted (curve "Scaled Predicted") results compare very well. Even before any adjustment is made to the predicted results (curve "Predicted"), the distribution of strain compares closely with that measured.

These comparisons show that 2D DE simulations have been used to conservatively predict intrados strains in a defective arch barrel in its existing condition and after Archtec strengthening under working loads (serviceability limit state).

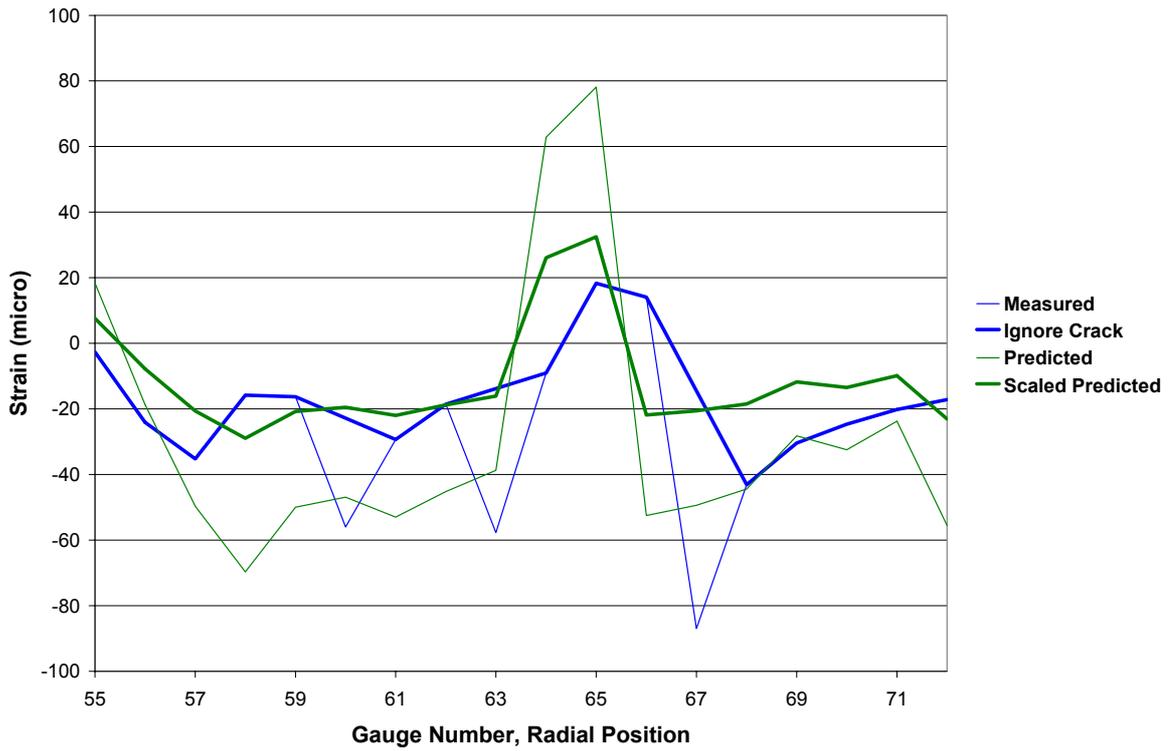
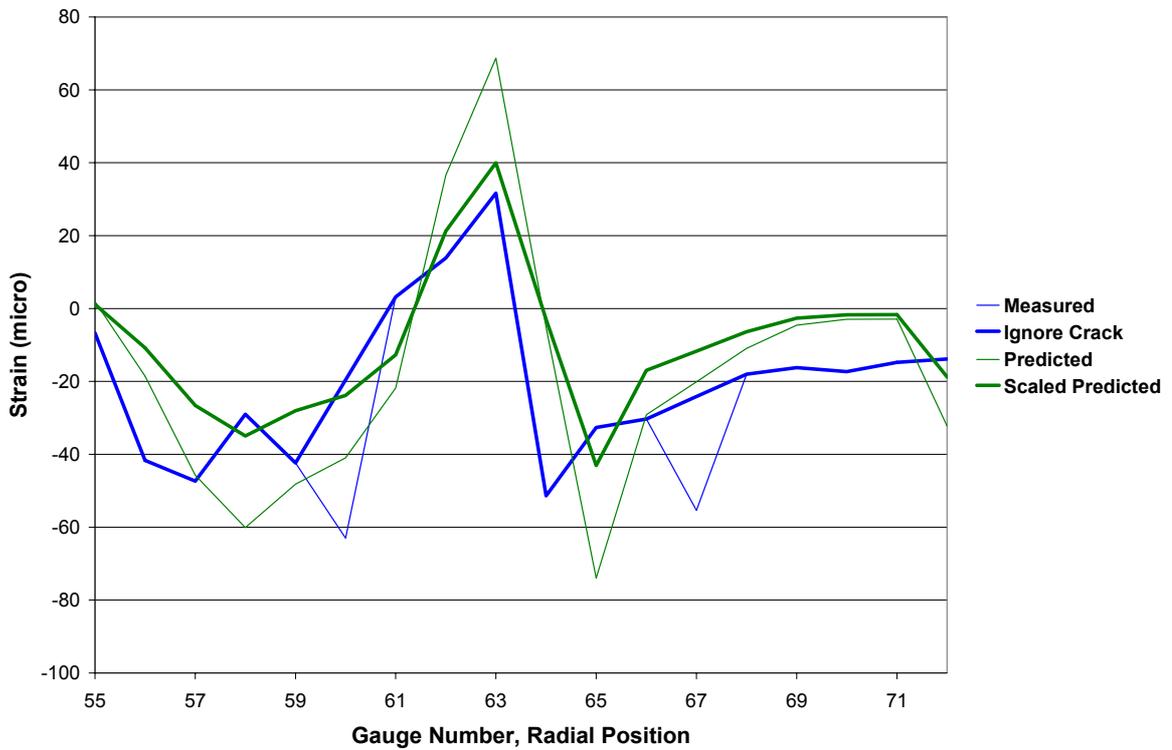
**Figure 7.2 Strengthened Test – Predicted versus Test Intrados Macro Strains**

Figure 7.2 shows similar results for Archtec strengthened test. Again once adjustment are made to the raw data for the effects attributable to initial crack widths and full 3D behaviour measured (curve marked "Ignore Crack") and predicted (curve "Scaled Predicted") results compare very well. As for the unstrengthened case before any adjustment is made (curve "Predicted") to the predicted results the distribution of strain compares closely with that measured.

*Load case LC8 – A pair of 11.4 tonne axles at mid-span of the south span*

*Load case LC9 - A Pair of 11.5 tonne axles at pier quarter-span of the south span*

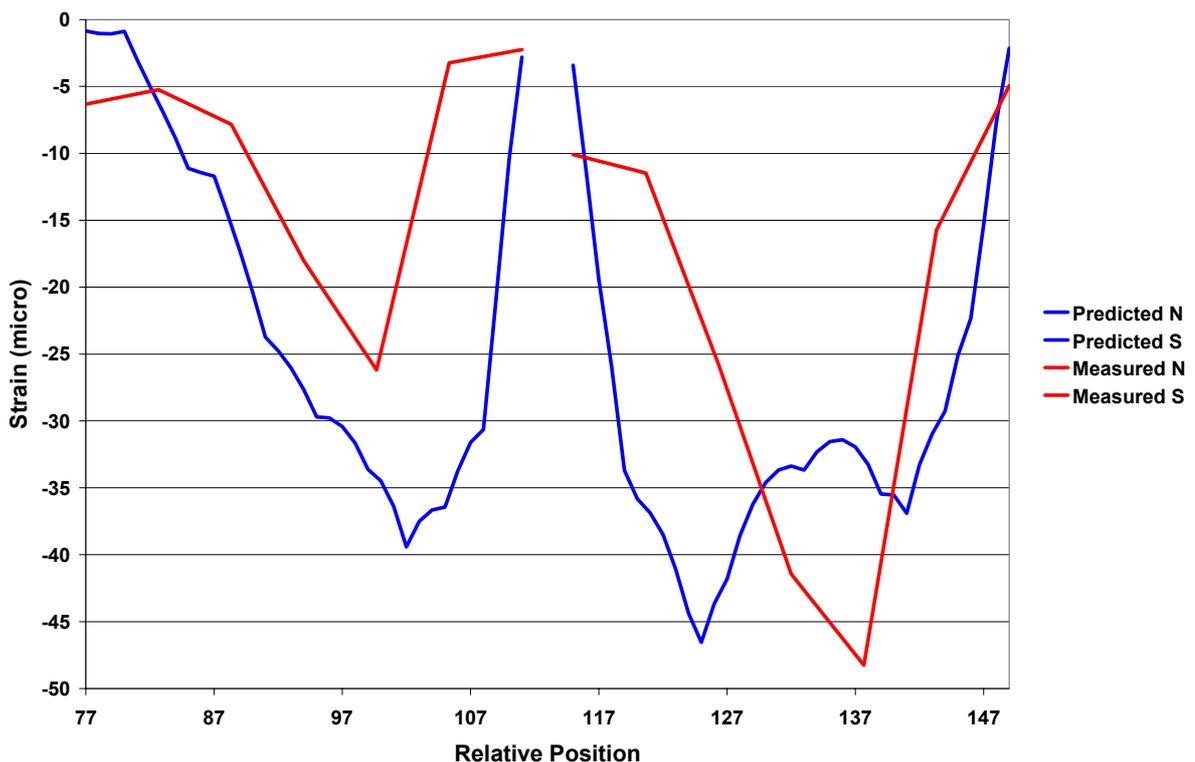
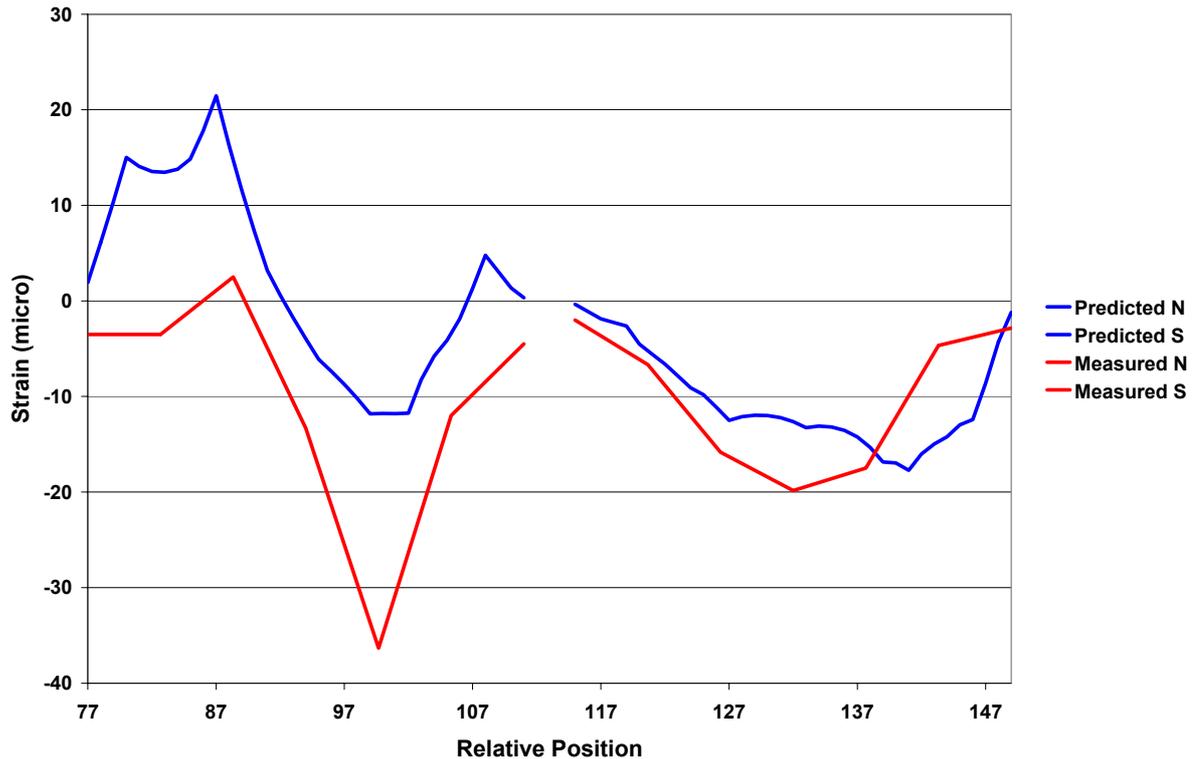
**Figure 7.3 Predicted and Test Anchor Strains**

Using the DE model including Archtec strengthening and the methodology described in section 6.2 anchor strains have been calculated and are compared against the measured values in Figure 7.3. Again the representative load cases LC8 and LC9 acting on the south span have been used. The figure shows two graphs each comparing the predicted and measured strains along the relative length of each anchor; measured values (reproduced from Figure 6.3) and numerically predicted values. Positive strains indicate tension with  $50 \mu\epsilon$  indicated a bar stress of  $10 \text{ N/mm}^2$ .

Load case LC8 – A pair of 11.4 tonne axles at mid-span of the south span

*Load case LC9 - A Pair of 11.5 tonne axles at pier quarter-span of the south span*

Bearing in mind the relatively small strains that are being compared both the distribution and magnitude of the results compare well. Some adjustment might be warranted to cater for finite crack widths and 3D behaviour but the approach to use is less clear than for intrados strain results. A pattern is discernable which suggests that measured strains do exhibit additional compression in the proximity of the cracks (close to 97 and 127 on the abscissa) compared with predicted values which do not allow for pre-existing open cracks.

These comparisons show that 2D DE simulations have been used to predict anchor strains in a defective arch barrel that has been strengthening using Archtec under working loads (serviceability limit state). Consequently simulations can be used to assess the level of stress in the bars.

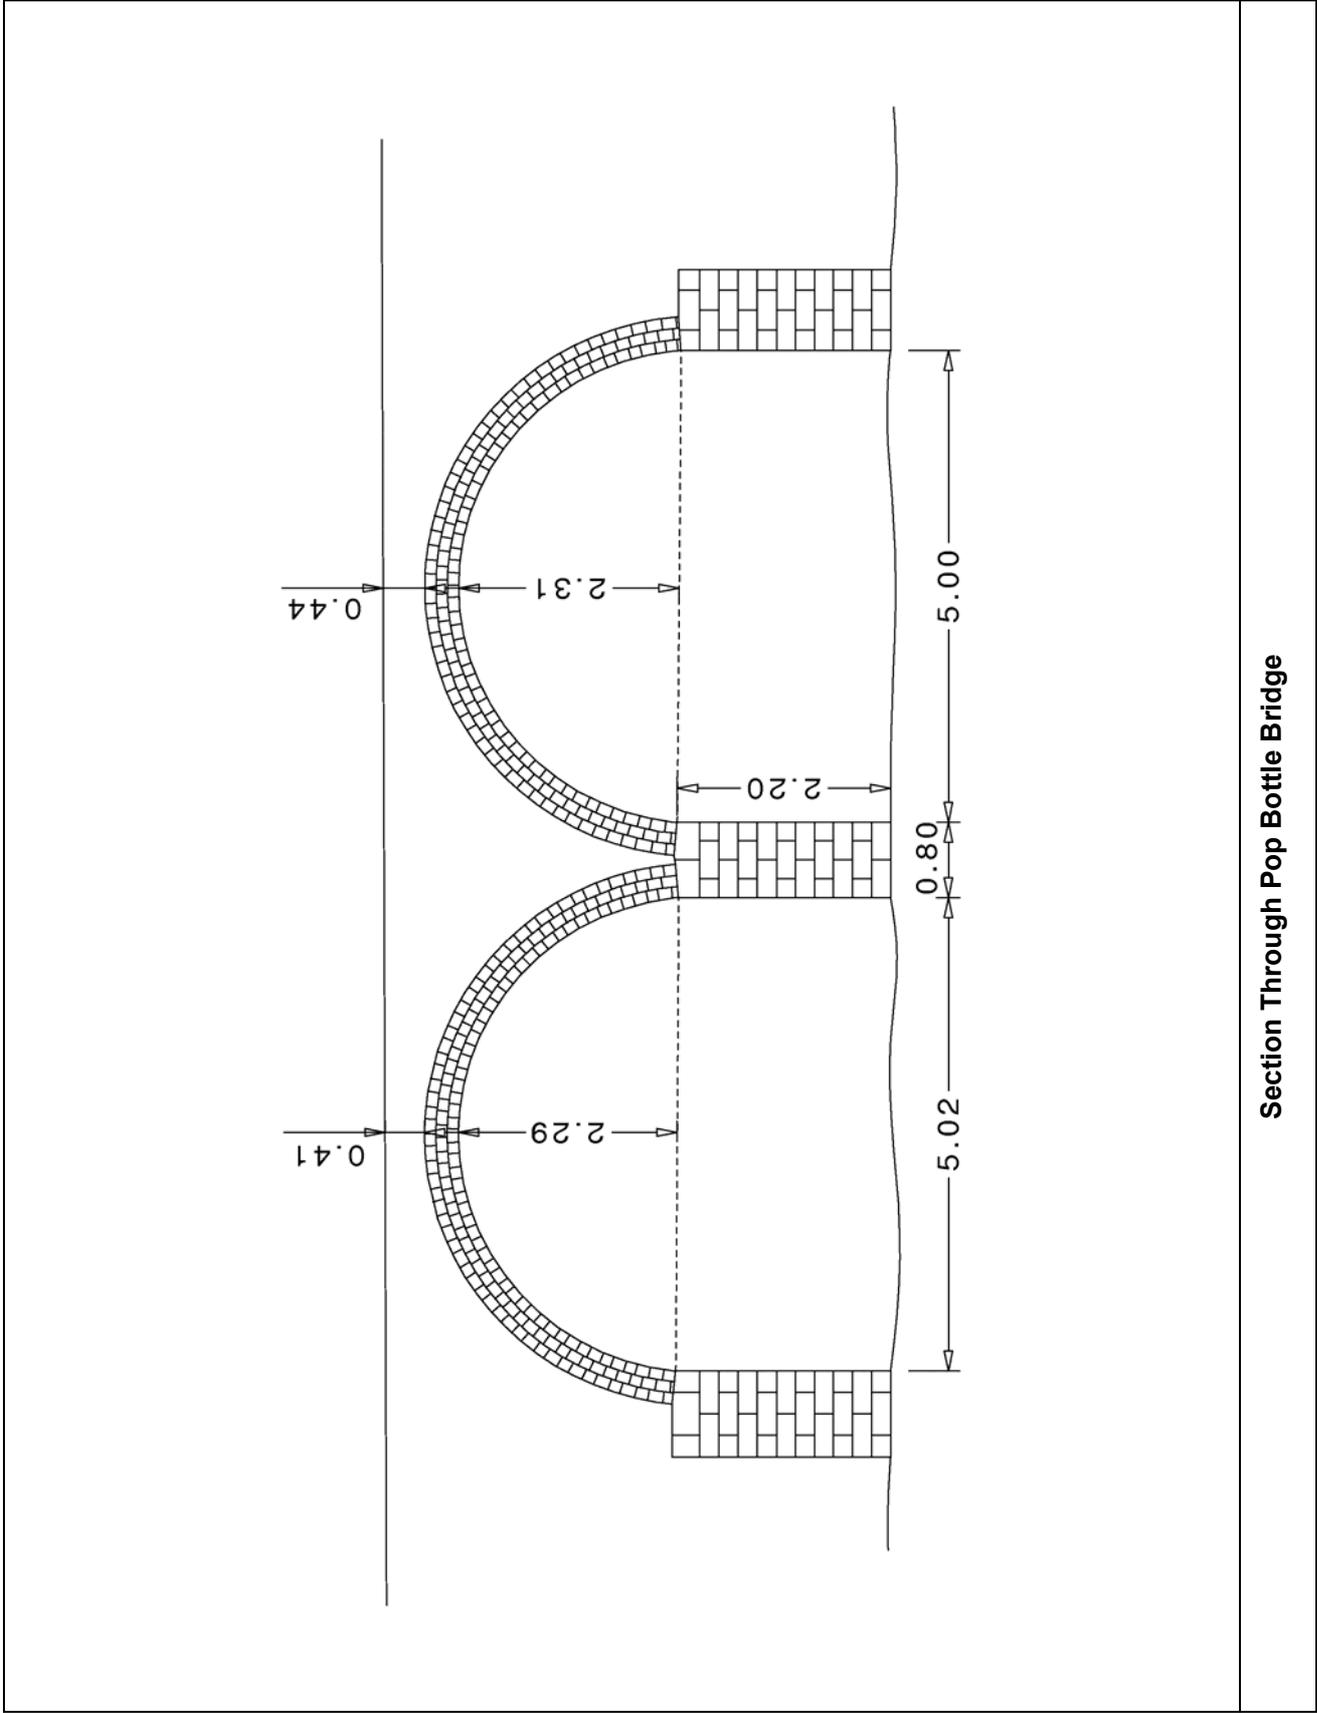
### **General Arrangement of Pop Bottle Bridge**

Section Through Pop Bottle Bridge

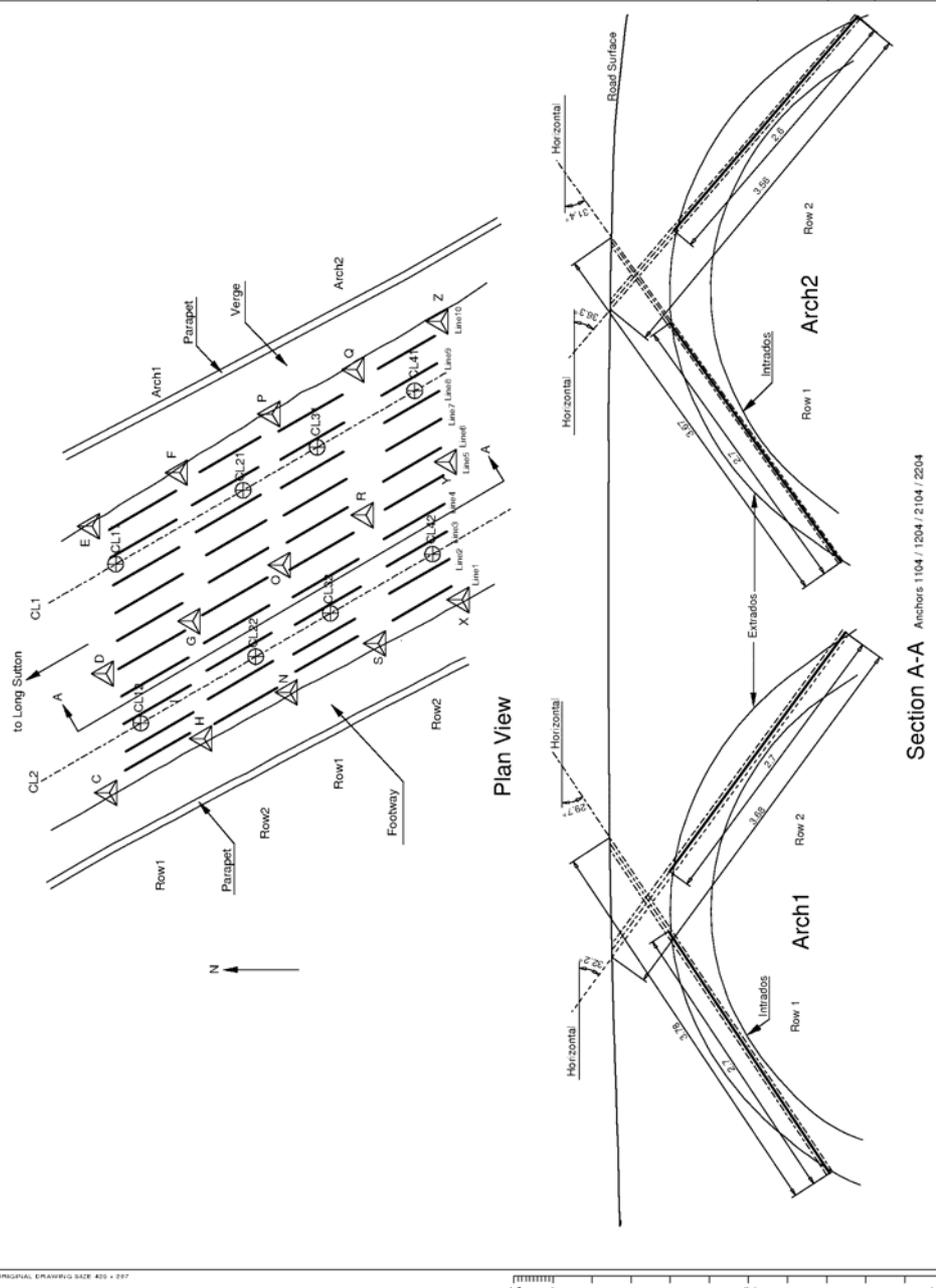
**GENERAL ARRANGEMENT**

- i) Drawing shows Concre anchor, hole, burial and bridge including parapets, spondaels and abutments are not shown.
- ii) All anchors to be S25 - stainless steel type 2 ribbed reinforcement and to be high yield steel. The anchors shall be made of stainless steel bars for use in concrete. Stainless steel anchors to be Grip Bar G327 type 304.
- iii) All anchors are installed in 85mm diameter holes and grouted using Concre Prestec grout in a ratio of 1 part grout to 3 parts aggregate with DIN standards 1045, 10200, 19156 and 19555.
- iv) No more than three holes per span may be left ungrouted at any one time.
- v) This drawing is to be read in conjunction with drawing number B1660A214DR002 and B1660A214DR003.

An Archtec design, including a full geometric survey had already been prepared to strengthen Pop Bottle Bridge to a live load rating of 40/44 tonnes. Details of the Archtec strengthening are contained in Appendix B.
