Fullers Brewery, London, UK

Cintec Anchors were put to the test in two ways at the Fullers Brewery in London. First anchors were used in major structural repairs to the Brewery. However, the unique qualities of those anchors were clearly demonstrated in the second test – when the Brewery was destroyed by fire.

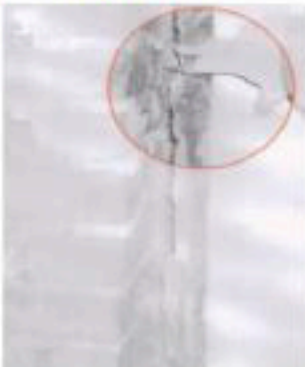
<-Remedial anchors installed prior to the fire. The anchors are still functioning. The grout cover protected the main steel body of the anchor.

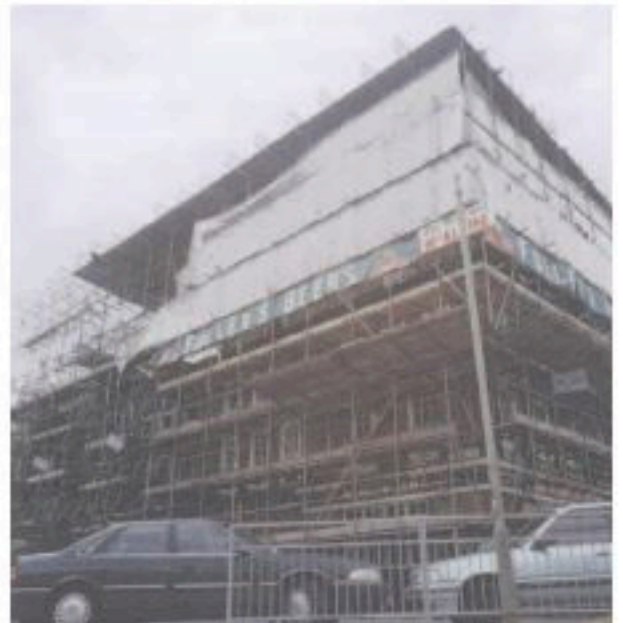
Even though the brickwork had been subjected to extreme temperatures, the anchors survived well; pull out tests revealed that they still performed to their original design specification.

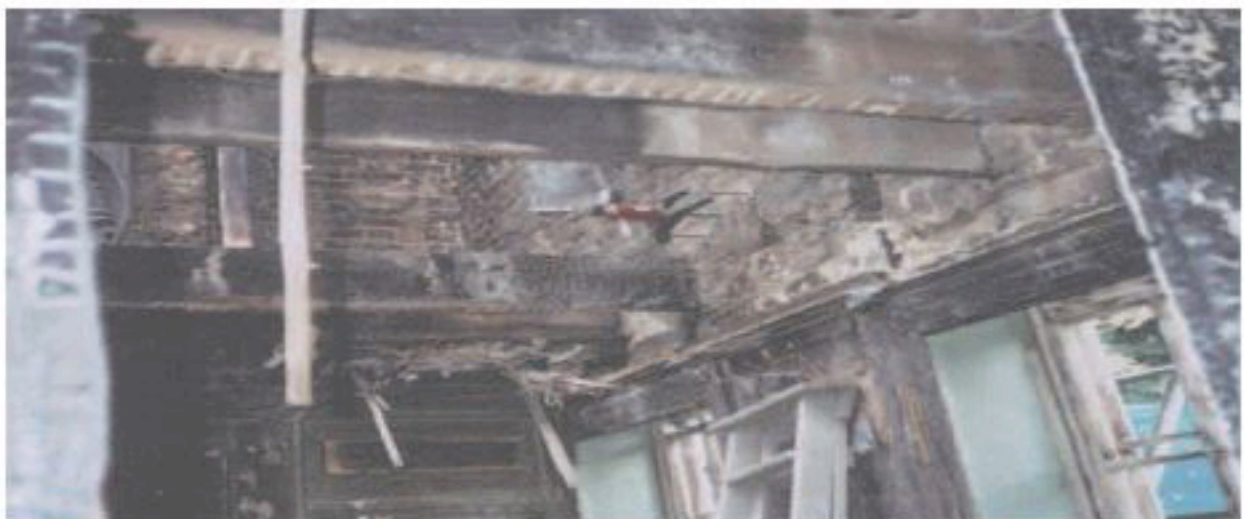
After the fire proposal was consolidated all delaminated brickwork (fig 1) using Cintec RAC anchors, allowing repairs of the internal delaminated skin to be undertaken without risk of further failure to the masonry. At the same time the major cracks were stabilized using Cintec SHS anchors (fig 2). The final remedial work included stabilizing the brick arches and providing new seating for floors. However, it is the “real” fire test which will be of great interest to engineers and organizations using Cintec anchors. It has proven that the anchors have outstanding resistance to the effects of fire.
