CINTEC

Engineered Micro Cement & Lime Grout Anchor Systems for Earth Retaining & Ground Anchors

Combi-Tec Ground Anchoring

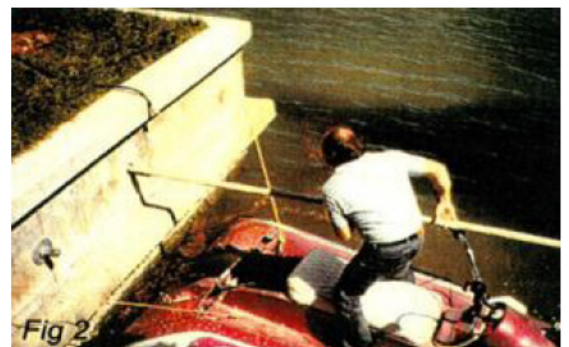
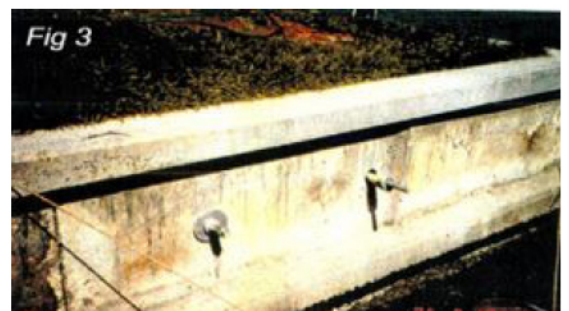
As can be seen in the images (right) the individual boreholes were produced by diamond core drilling, in this case with a core diameter of 65mm (2 ½") and to the length of the anchor : 3.2 meters (15ft) – Fig 1. The anchors were then installed with a plastic half pipe to facilitate their insertion – Fig 2. Finally the anchors were injected with 'presstec' cementitious grout expanding them from their far end to the front. Although not essential, a flange – plate was also screwed to the exposed anchor end for additional securement – Fig 3.

In the case of Marco Island, an additional wide section of expandable sleeve, or sock as it is often called, was attached to the far end of the anchor. When the grout was injected, the additional section expanded to a diameter greater than the rest of the anchor. This created a bulb deep within the soil and ensured a truly secure point of anchorage.

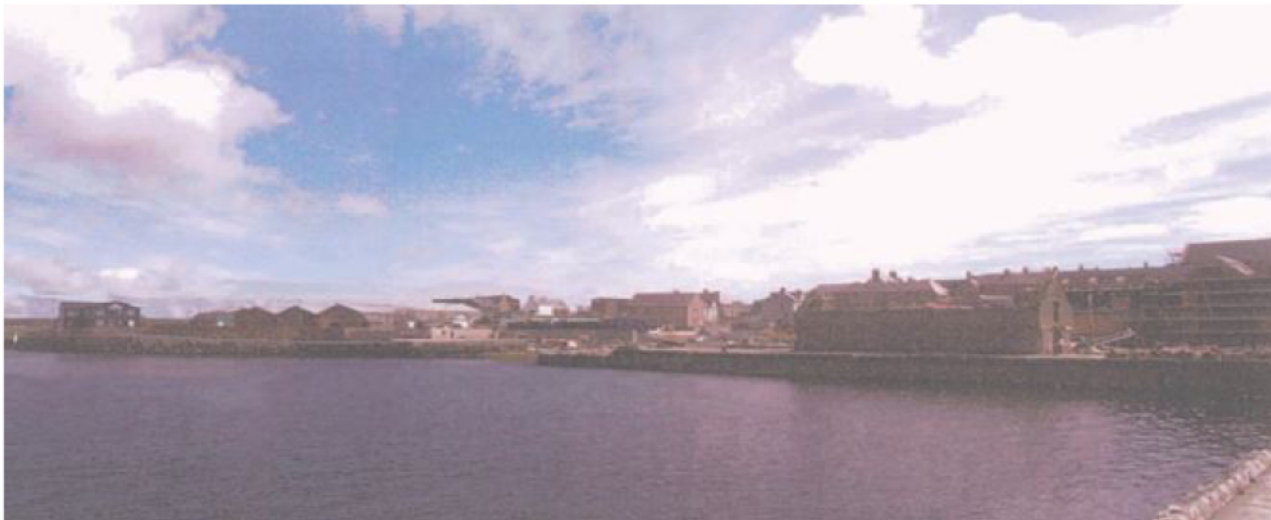
Panorama of Hay's Dock with the Heritage Centre under construction in the background (right), the restoration of the old sail house on the quay (centre right) and Cintec stabilisation work (end of the quay left of sail house).

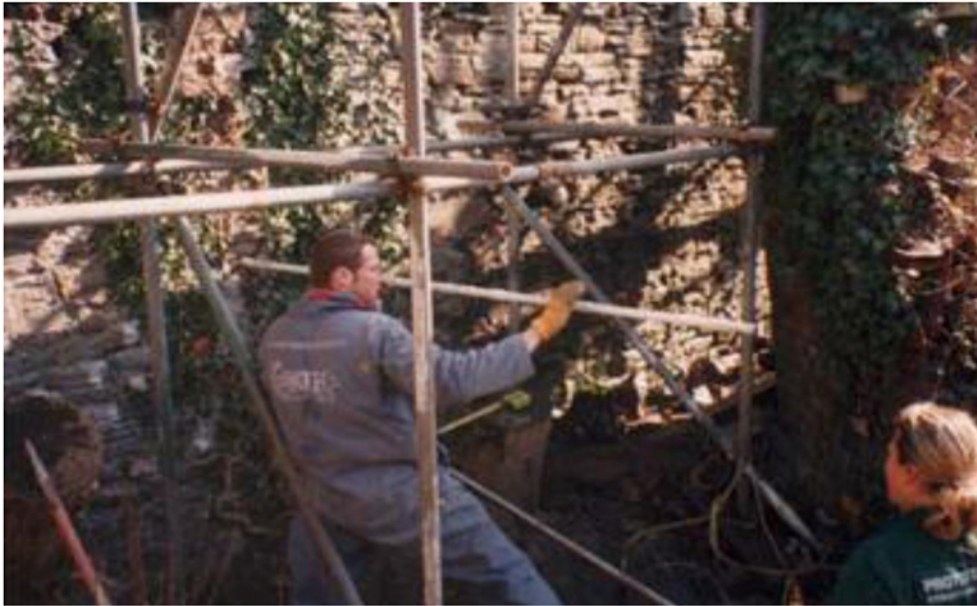
Insertion of 3m Cintec Anchor (left). Its inflation using cementitious grout, (above).

Cintec ground anchors were installed horizontally through the bed joints and into the ground infill retained behind it. This infill comprised mainly of broken brick, stone, clay, pottery shards and other assorted material. The core drilling technique employed to create the holes also revealed many voids within it, a significant feature of the Cintec anchor is its ability to bridge such gaps by retaining the flow of grout with its polyester sleeve. The 3 meter long Cintec anchors were installed at 1 meter horizontal intervals and tested to a working load of 15kN each.

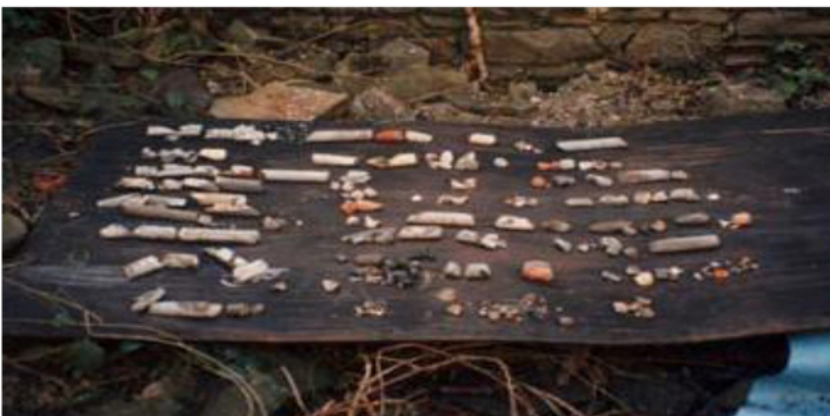
The process of diamond drilling (below). With the subsequent core samples produced, (left).

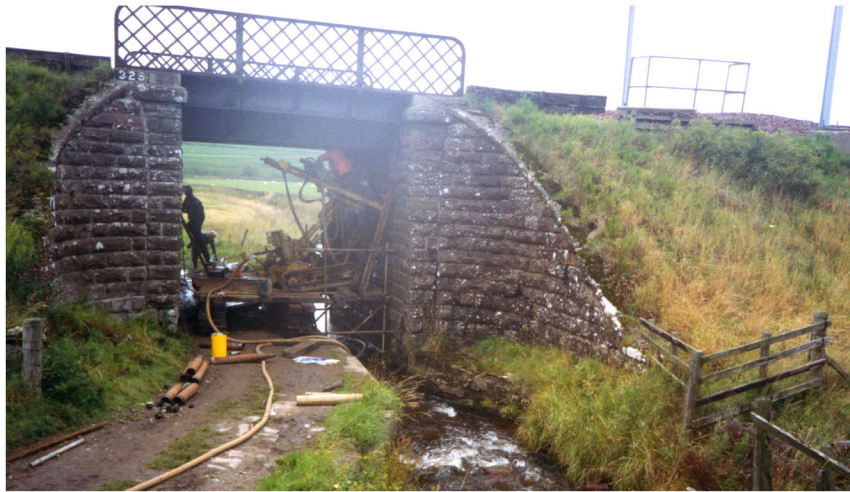
Installation of Ground Anchors Through Railway Bridge Abutment

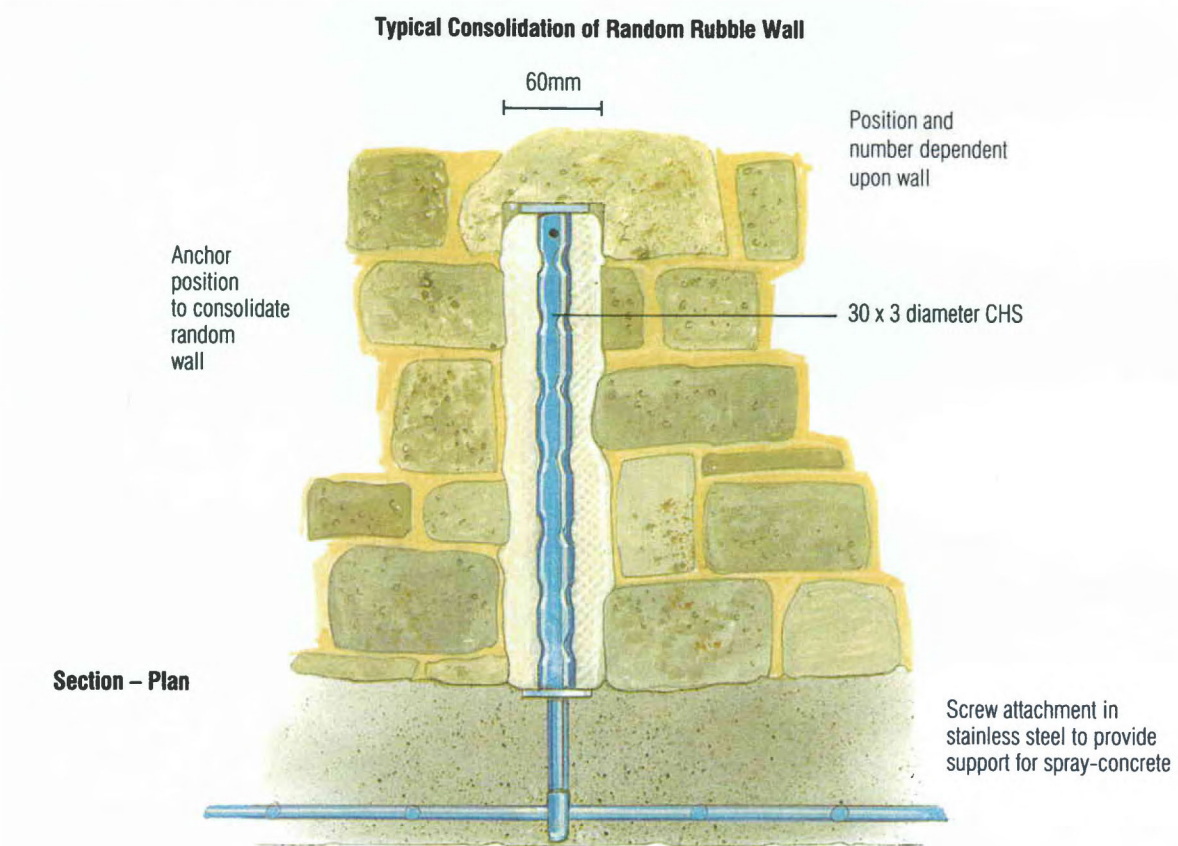
Typical detail of random wall consolidation using circular hollow section to overcome difficulties that arise when the wall is badly deformed and avoid the need to have differing anchor lengths

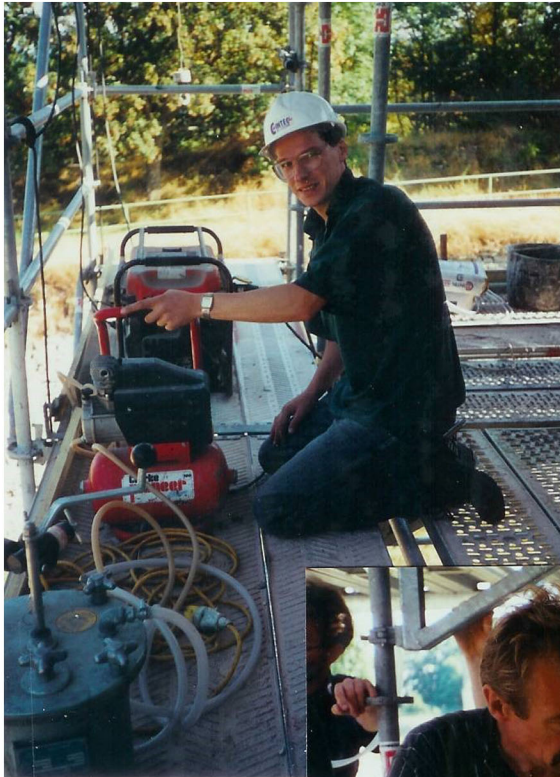
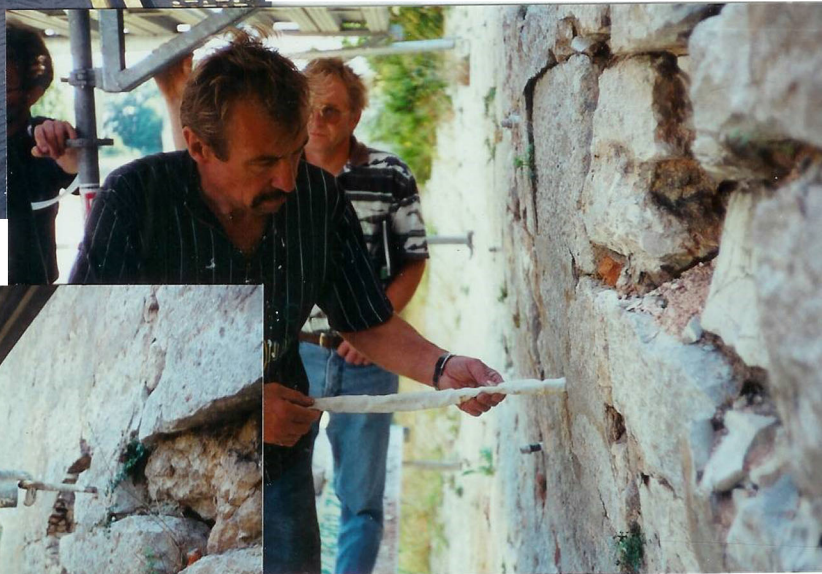
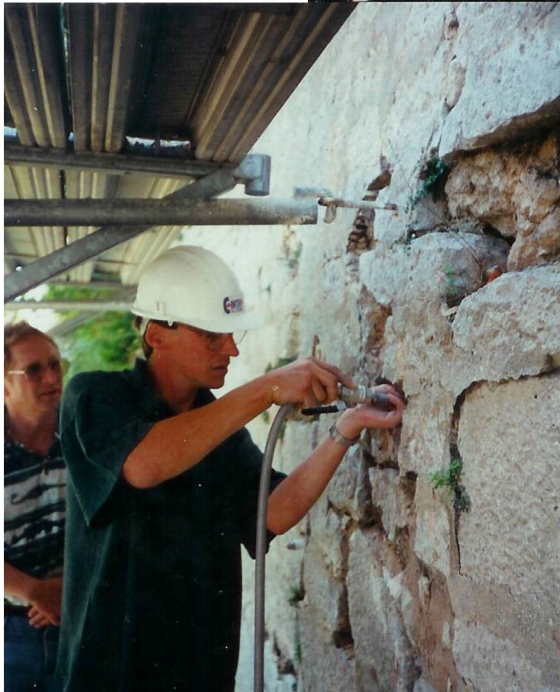
Corner, drilling for small stitching anchors,
Grout mix

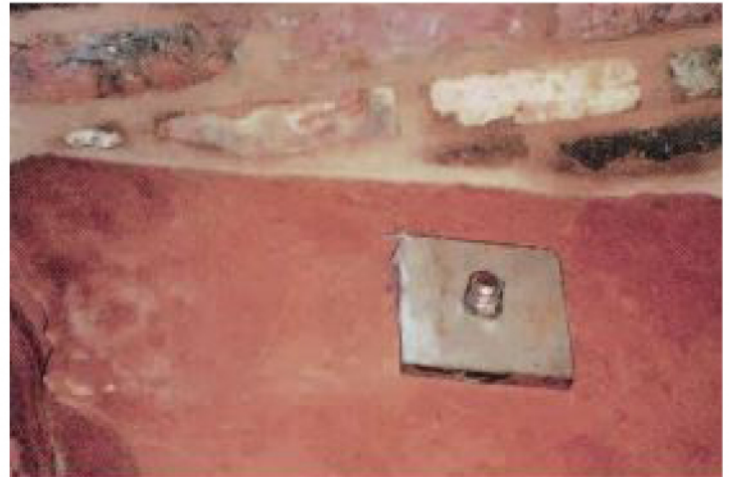
Roof bolt support to ballroom ceiling.

The drilling and grouting of the rock anchors was carried out by A.P.B. Group Limited of Stoke-on-Trent in August 1997. The Specification was for 5 Cintec rock anchors 3-4m long, and 20mm diameter, 316 grade stainless steel rebar. The anchors were grouted into 40mm – 50mm diameter holes drilled with air flush rotary rock drills. In addition to the main rock bolts, several more ceiling bolts were installed under the Engineer's direction using 16mm diameter anchors of varying lengths.

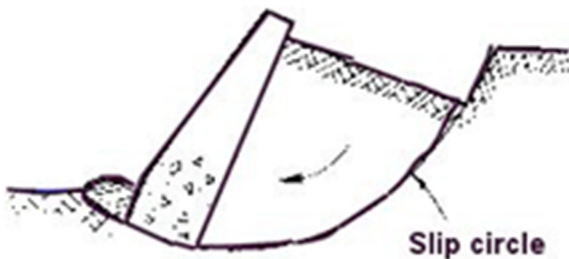
Deep seated failure

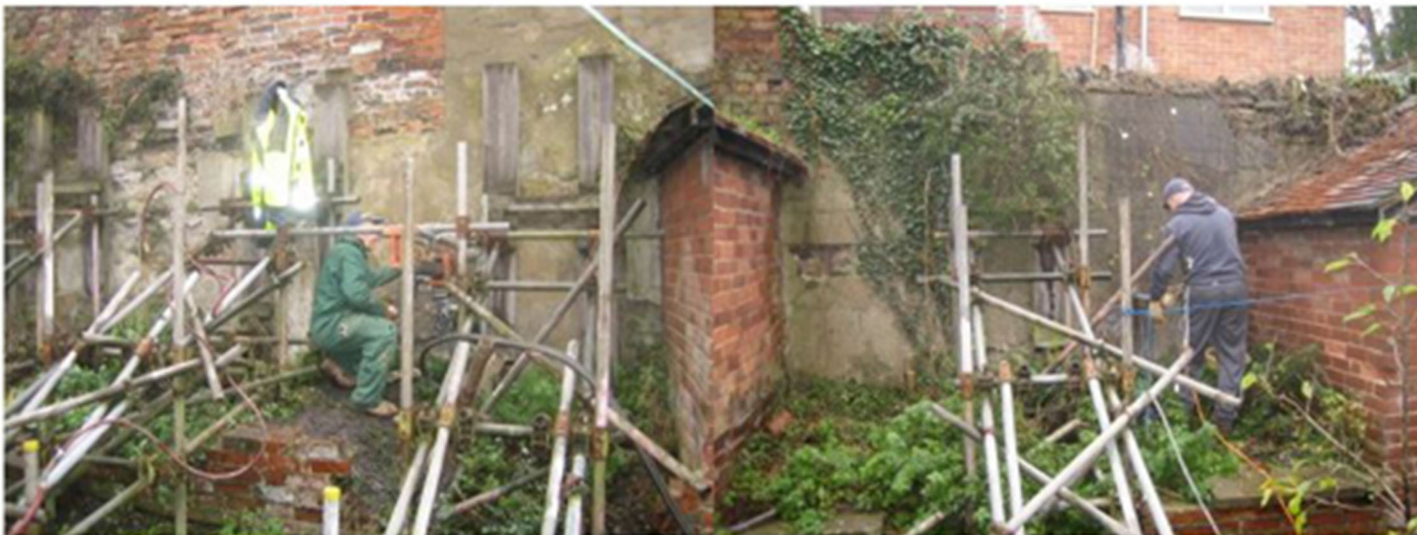
Investigative cores are taken to determine the wall thickness, type of material within the wall and the consistency of the retained material. This will enable a design to be established regarding the location of the Cintec ground anchors.

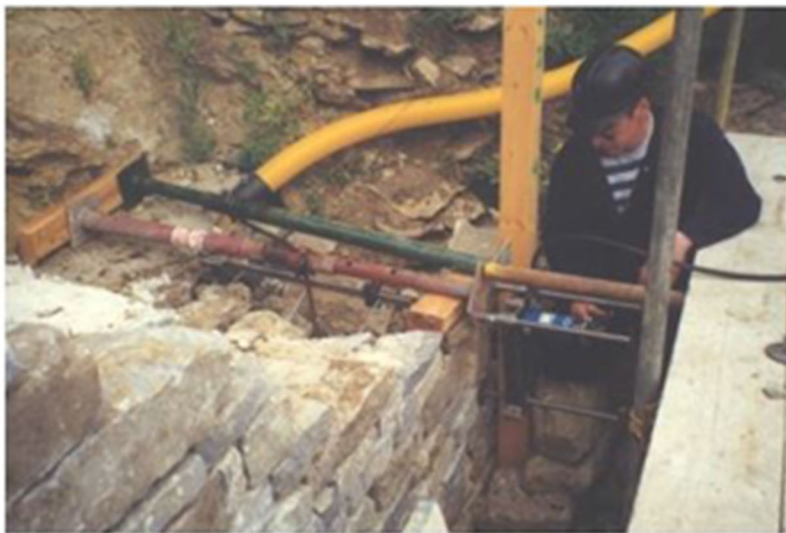
IN-SITU LOAD TESTING THE CINTEC GROUND ANCHOR

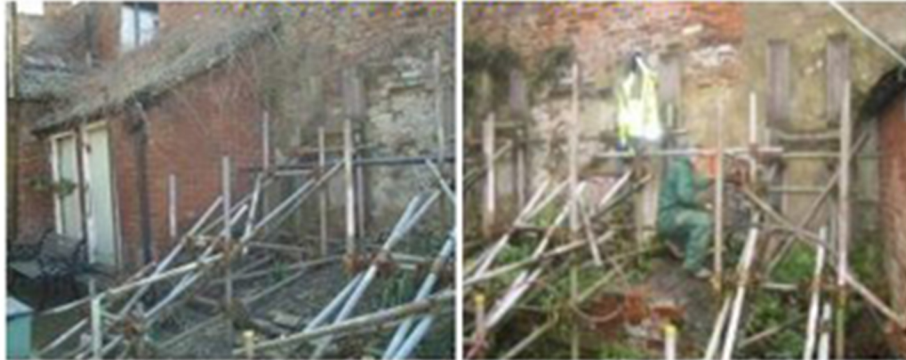
As found shored upDrilling and installing Cintec ground anchors

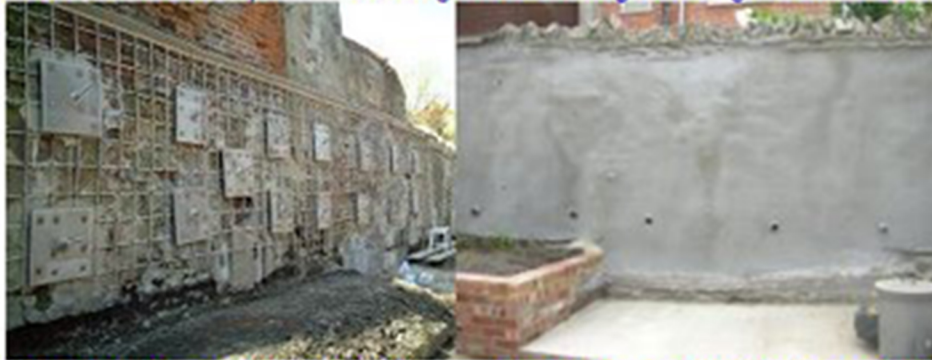
Mesh and face plates secured.....Final lime rendered finish applied

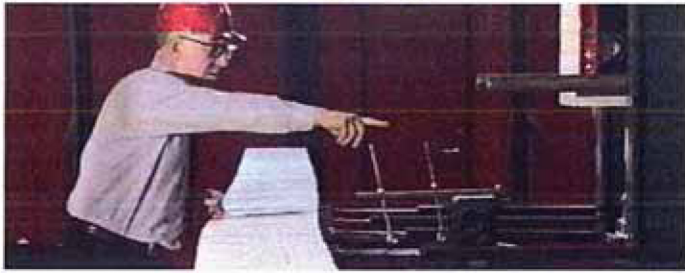
Dynamic full-scale parapet wall tests were undertaken in the heavy structures laboratory at Tyne-Tees University. The tests clearly demonstrate the robustness of parapet walls reinforced with Cintec masonry anchors. The walls were impact loaded using a falling weight test rig designed to generate the force/time history of an actual vehicle impact test that had previously been recorded and analysed at MIRA.

In this test, the Cintec reinforcement used was a 19.5 metre high yield MS multibar anchor comprising six individual stainless steel bars of 8mm in diameter. This was installed 370mm below the top of the wall.

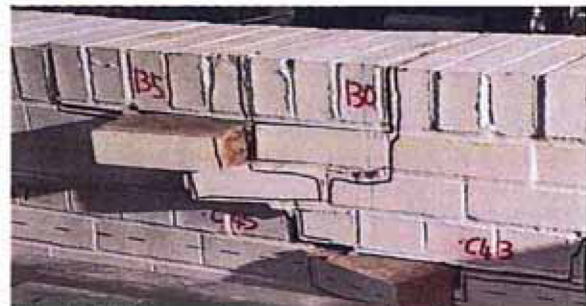
Although the bridge was shunted by the force of the impact, it remained intact with no significant spalling. The picture above shows the wall face opposite to the point of impact after two consecutive tests.

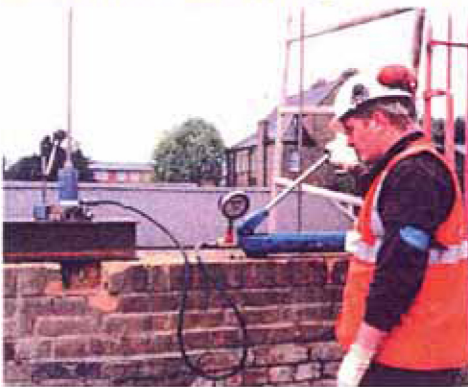
Post-tensioning Cintec anchor in test panel.

An insitu load test was carried out in order to demonstrate the applicability of Cintec anchors for both stabilising these structures and for strengthening them against dynamic air pressure loading. The test was also used to confirm that the performance of the strengthened wall had been correctly calculated and thus provide assurance of the methodology.

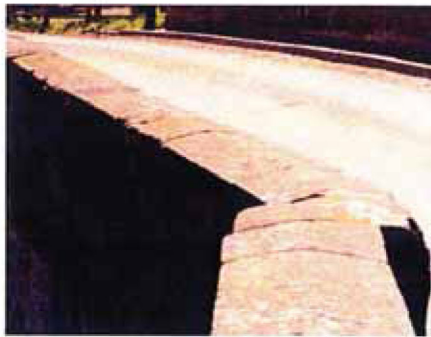
With the use of non-percussive diamond core drilling, thirty-six prestressed Cintec anchors of between 1.4m and 2.8m in length were installed vertically through the parapet walls and into the arch barrel. Core drilled sections of the monolithic coping stones were then replaced and grouted into the entrance of the anchor holes to provide an almost invisible finish.
