‘Stitching up’ the past – The strengthening of three heritage marine structures in Jersey with needling technology

WWII sea wall in St Aubin's Bay, Jersey: infrastructure improvements to alleviate flooding

Parapet Strengthening
to Containment Standard

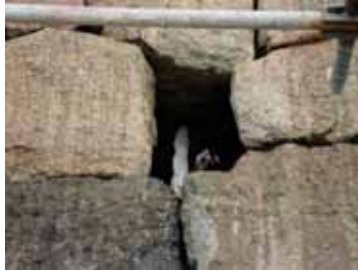
Figure 16 - Pre-injection with masking tape

furthermore mitigated pollution control concerns by the 'sock' principle of the anchor system where the grout is contained within a small radius of the sock diameter. Only a small surface area of grout oozes through the sock material to bond to the adjacent substrates and when cured, forms a concrete skin over the 'sock' material (Figure 16 before grouting injection/Figure 17 after grouting injection).

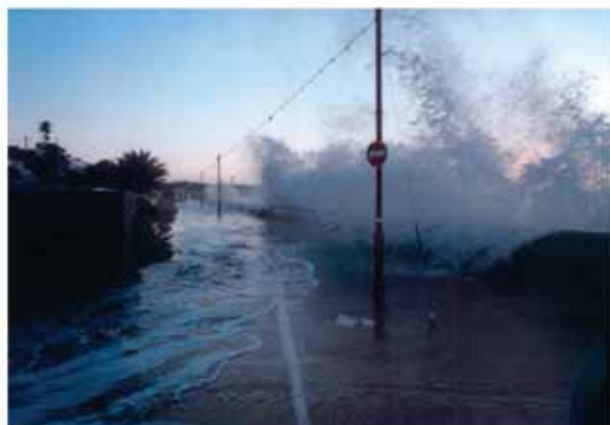
Figure 2. Inland flooding – overtopping and flooding at St Aubin's sea wall near the Gunsite slipway

On many occasions in recent years, particularly at times of exceptional high tide and storms, overtopping at this relatively short section of sea wall in St Aubin's Bay on the south coast of the Channel Island of Jersey (see Figure 1) has resulted in significant flooding of residences and businesses at the main roundabout and highway immediately inland. As this roundabout is the main access leading from St Helier and St Aubin on the south coast up to the airport, the States of Jersey engineers for the Department for Infrastructure (DI) decided that these significant flooding events needed to be addressed.

The States of Jersey engineers commissioned the consultants, Arup Rothwell, to investigate the flooding problems (see Figure 2) and put forward engineering concepts for a solution to alleviate the flooding which included the option of raising the height of this World War II (WWII) concrete wall. Other options considered at this location, such as rock armour and groynes, were not thought viable because this part of the St Aubin's Bay beach is a popular tourist spot, and the solutions impinging on the beach amenity use, coupled with the cost of such methods, precluded their use at this location.

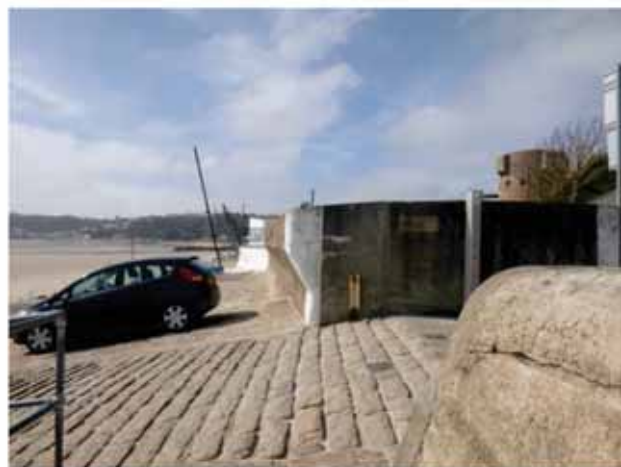
Figure 9. Gunsite angular recurve at the slipway

new angular recurve profile. The Gunsite Café and St Ouens WWII sea wall PMZ3 antitank top wall have an angled, outward-leaning sections and then a vertical beam section, and the contractor's design shutter proposal utilised a metal shutter bolted to the wall which conformed to the new recurve profile design (Figure 10).

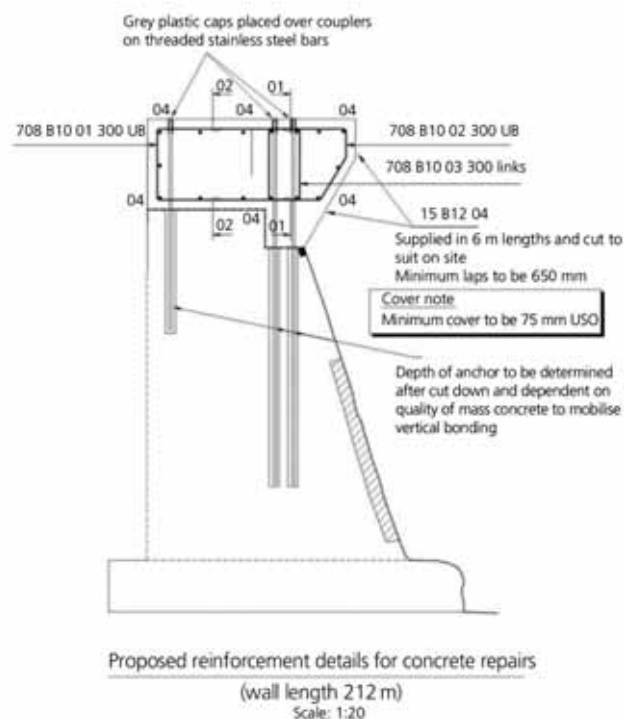
Figure 10. Angular modified recurve design

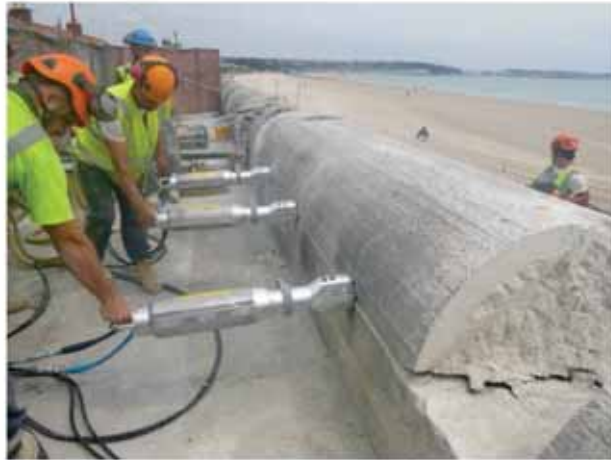
Figure 11. Concrete splitters removing the top of rounded wall

The contractor also received credit in the tender assessment process for his use of modern techniques for concrete splitting using a hydraulic device which greatly reduced site noise and made removing the top of the wall concrete much easier as well as being more efficient when handling the waste concrete pieces for disposal (see Figure 11).

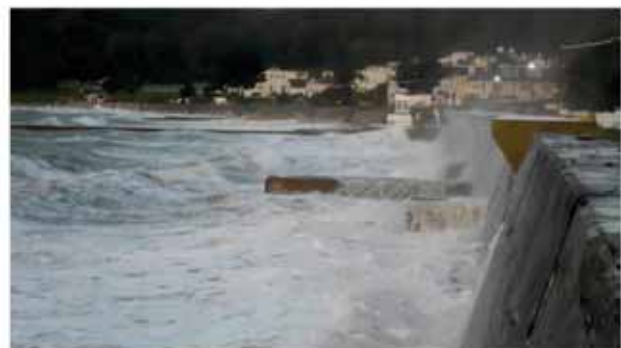
Figure 13. Performance of the wall reflecting waves

Since the construction and completion of the top of the wall to Gunsite Café slipway, two major storms coinciding with high tide have demonstrated the ability of the new geometry of the wall and its recurve to reduced overtopping. Storm Brian tested the ability of the new geometry of the wall, and studying the changed wave action and responses have produced excellent results.

It is interesting to compare the wave action of the original WWII lower height wall with the performance of the raised new recurved profile wall because the new wave behaviour illustrates the reflected wave impact on incoming waves reducing the wave energy at the wall (Figure 13). The arrangement has yet to be tested against the maximum of storm surge, high tide and heavy rainfall, but it is anticipated that with the secondary defences at
