RESTORATION OF HISTORIC EGYPT

A Selection of Case Studies

NORTH OR RED PYRAMID AT DAHSHAR, CAIRO, EGYPT

Project:
Stabilising
Architrave
Stones

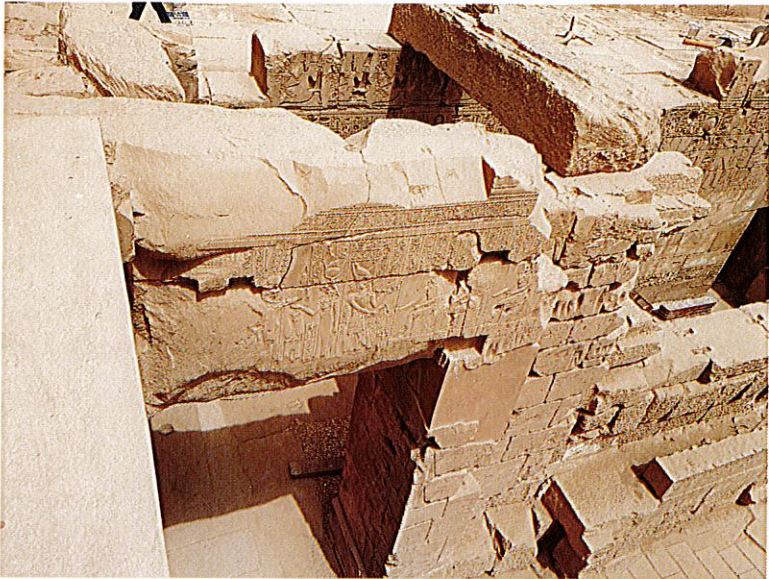
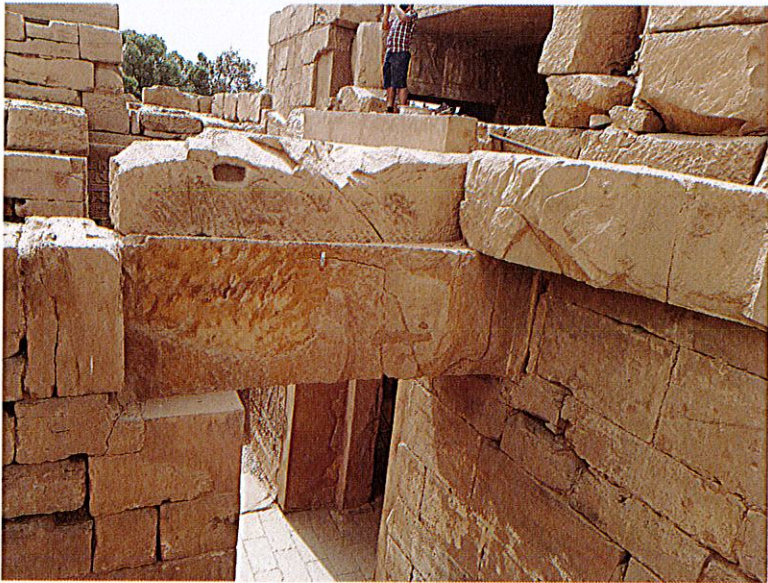
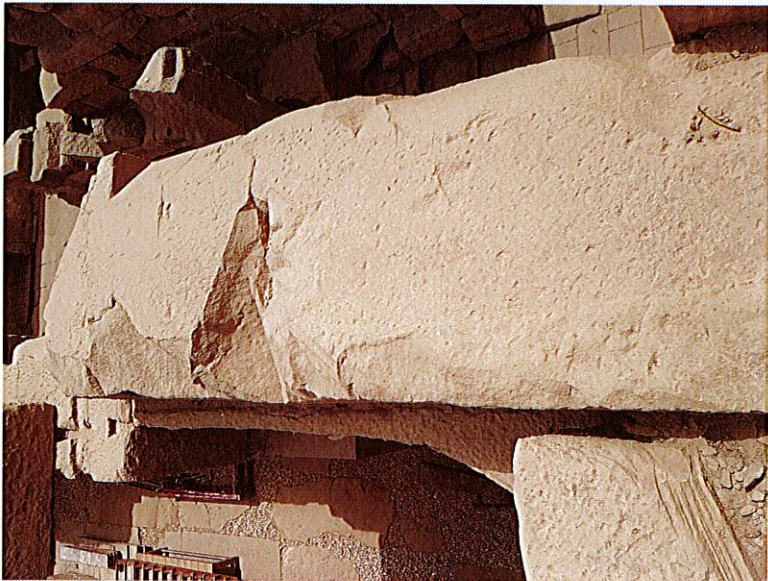
Dry diamond drilling with dust extraction.

Holes were drilled up to 5mts to bridge the cracks in the architrave.

M20 Stainless Steel Socked anchors were then installed

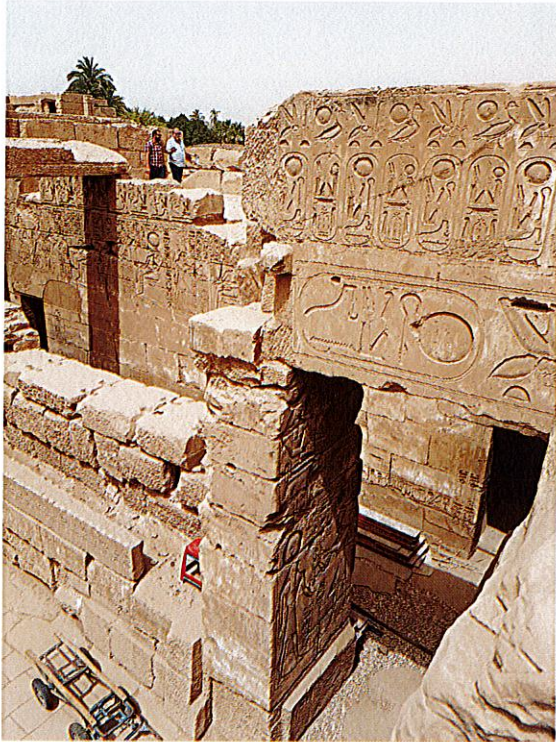
The North architrave from the side and underneath

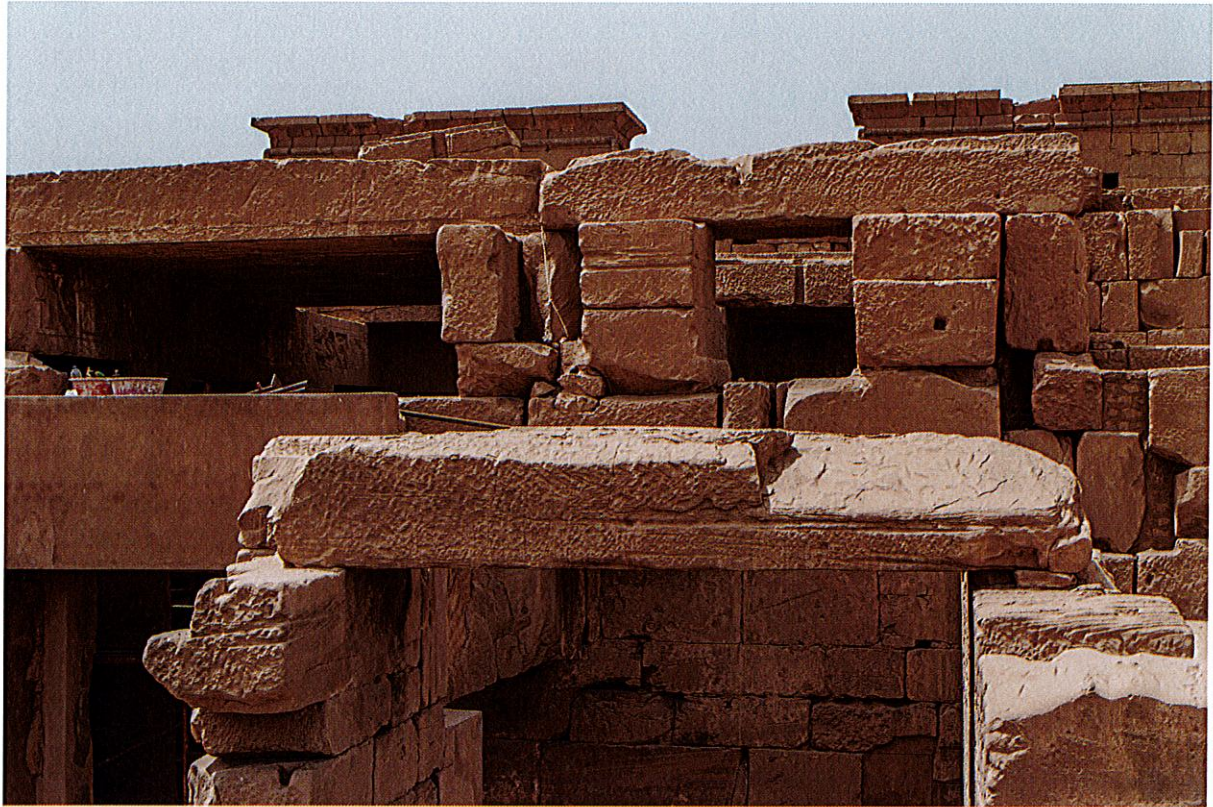
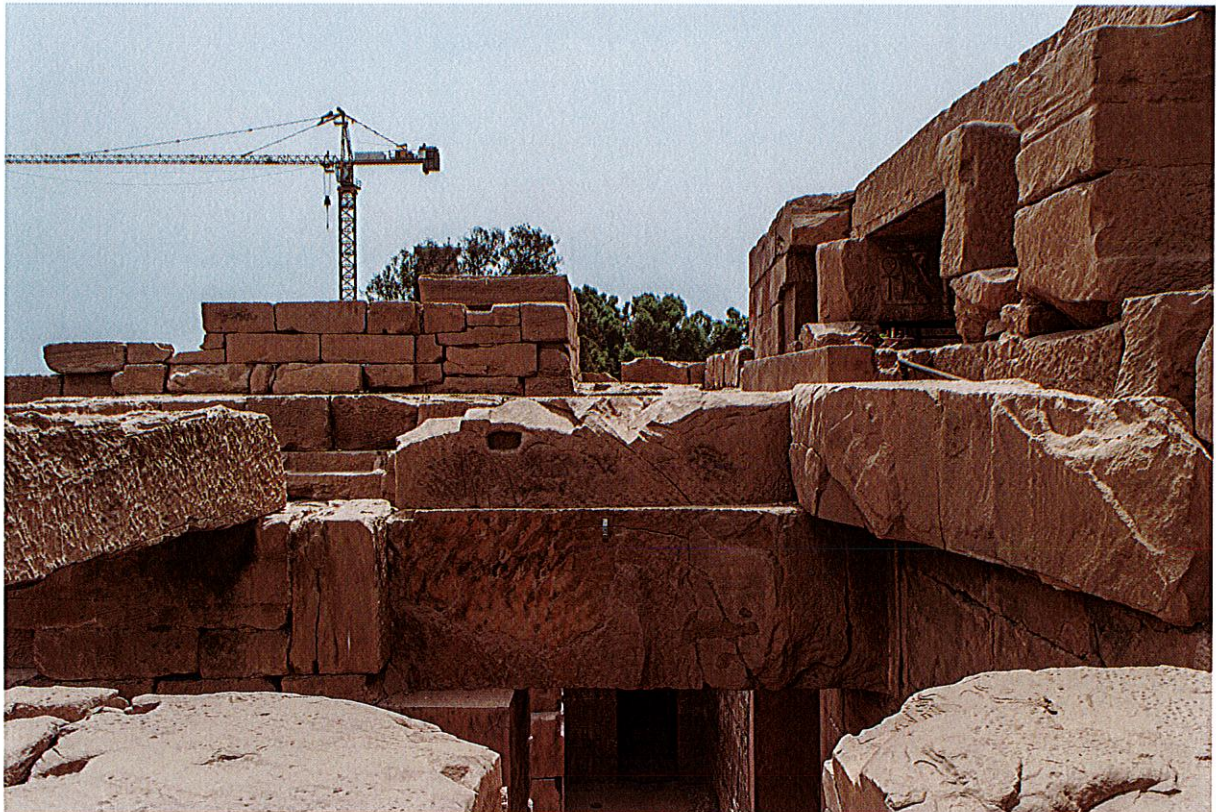
South Architrave, the one face had almost completely delaminated.

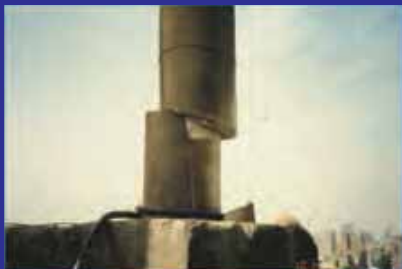
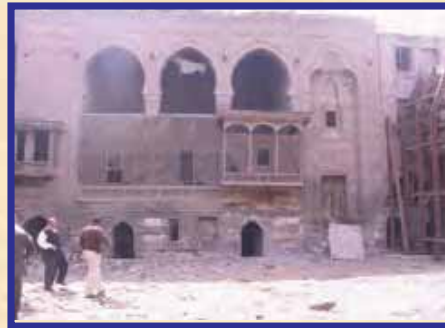
Typical damaged facade

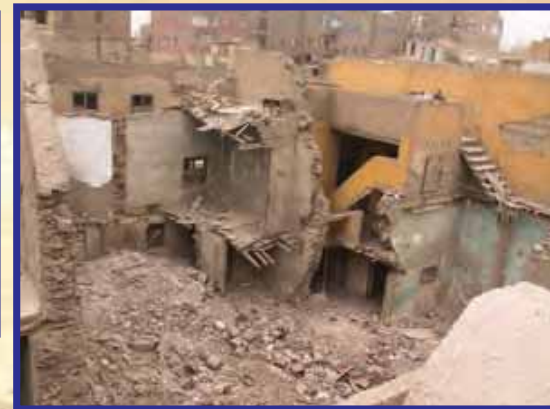
Behind the facade

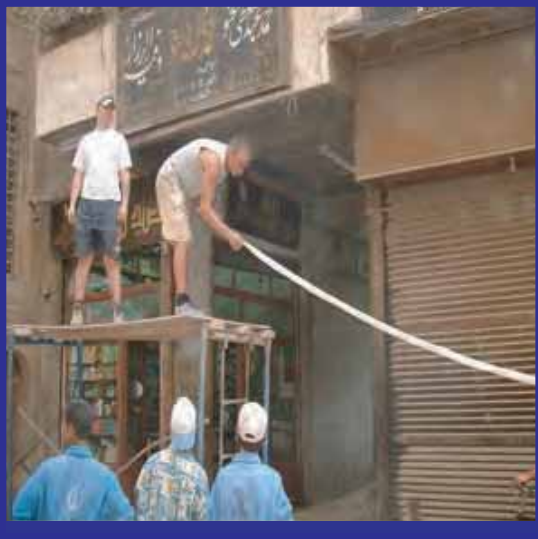
Positioning anchors in confined areas

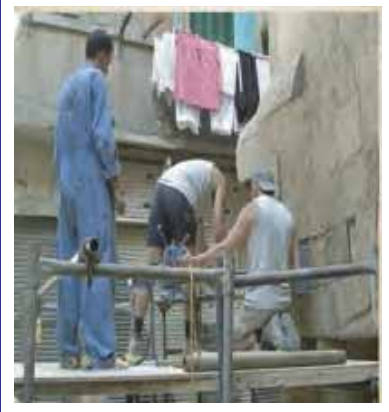
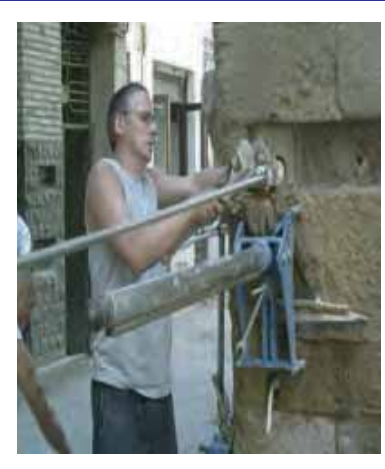
Installation of the Cintec system

Over 15,000 metres of the unique Cintec sock system was installed both to internal and external walls of the buildings. These comprised in the main of M20 stainless steel anchor bodies, M16 anchor bodies and M12 anchor bodies all in 65mm drilled holes. Smaller consolidation anchors comprising of a 10mm circular hollow section in a 32mm drilled hole. The main grout was a special Presstec White lime grout to match the existing parent material.

Each anchor assembly is filled with grout under pressure from the rear to the front so that the entire anchor body is inflated like a balloon.

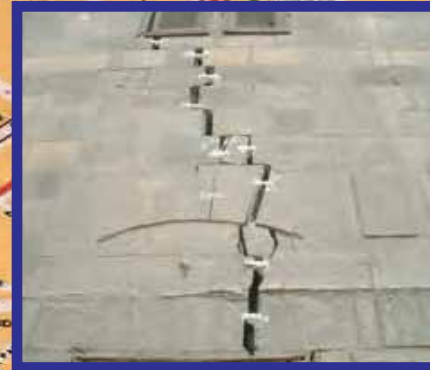
Typical damage caused to exterior walls

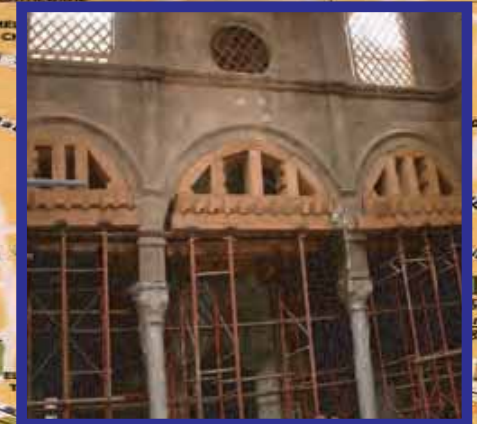
Buckling and movement of columns

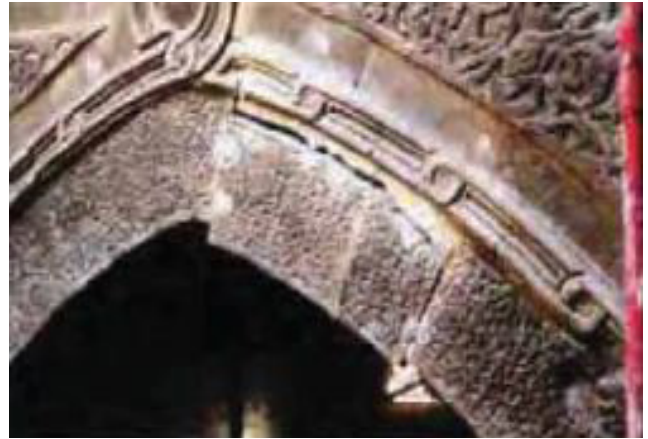
Seismic damage to decorative arches

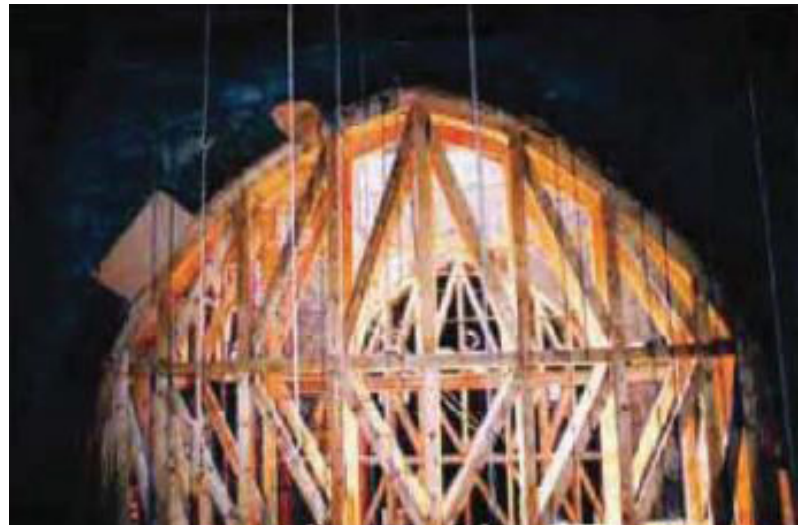
Temporary support of the Dikka arches

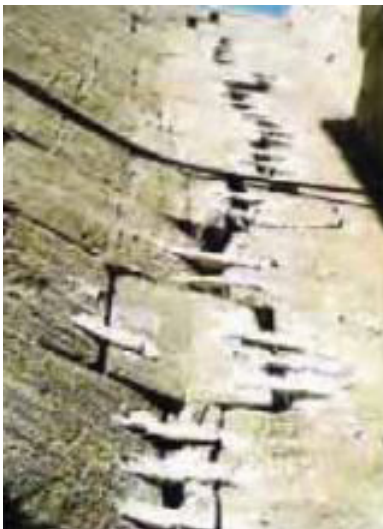
Vertical shear crack

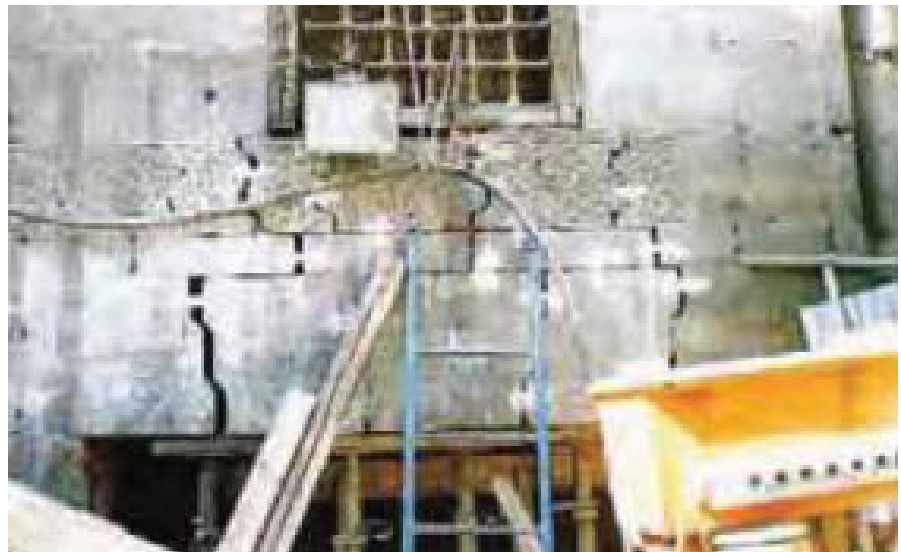
Lintel Stones

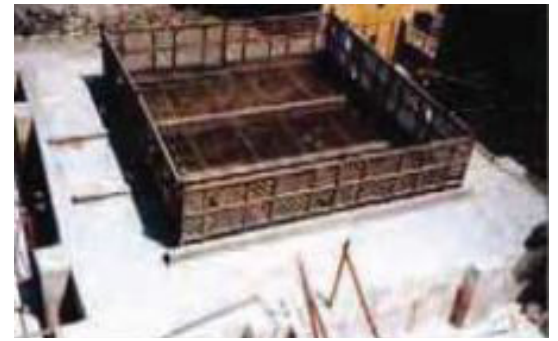
Roof section above central courtyard

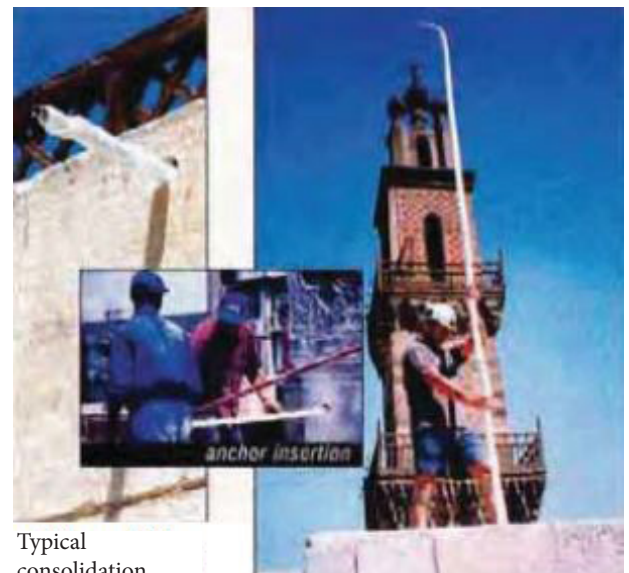
Typical consolidation anchor prior to grout injection
