CINTEC

Introduction to the Cintec Anchoring & Reinforcement System
Non Destructive Test Procedure.
Client Reports from International Testing Establishments
with relevent standards.

TEST DATA FOR CINTEC ANCHORS

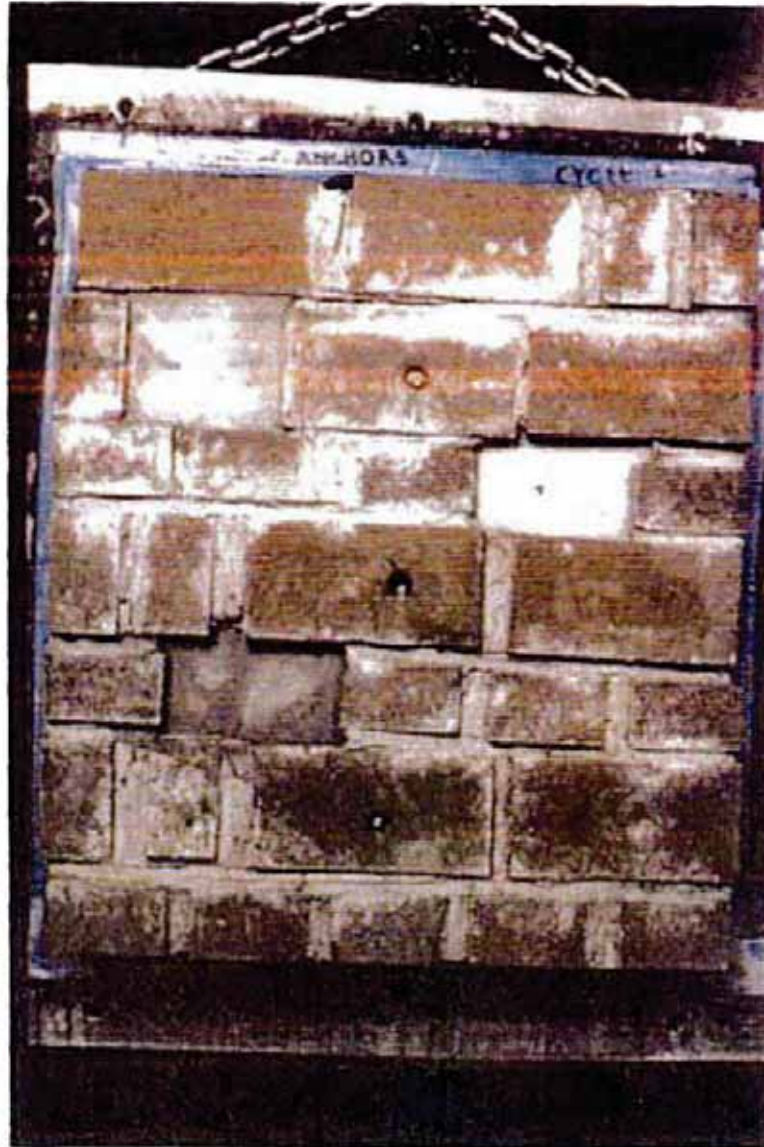
Figure 3 Wallette A before testing

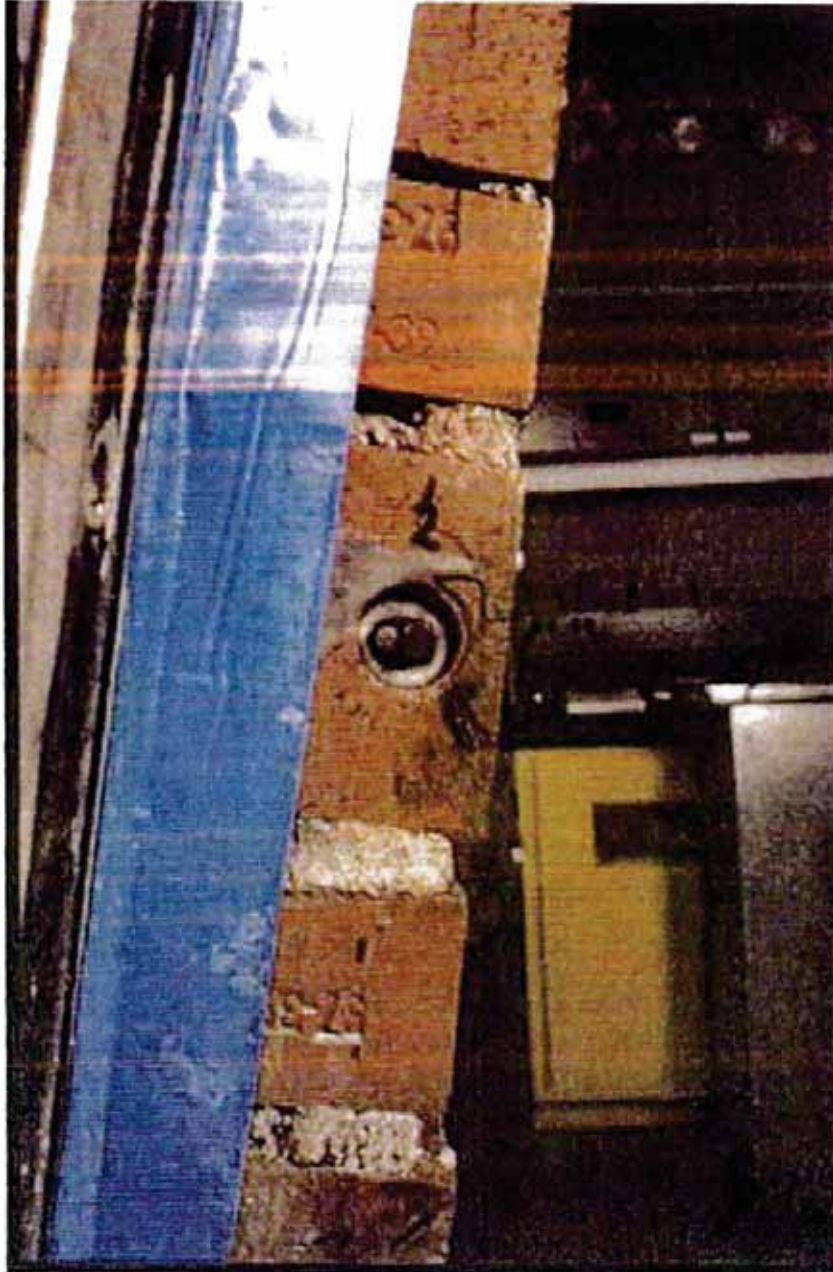
Figure 7 Side-mounted anchor after 100 freeze-thaw cycles

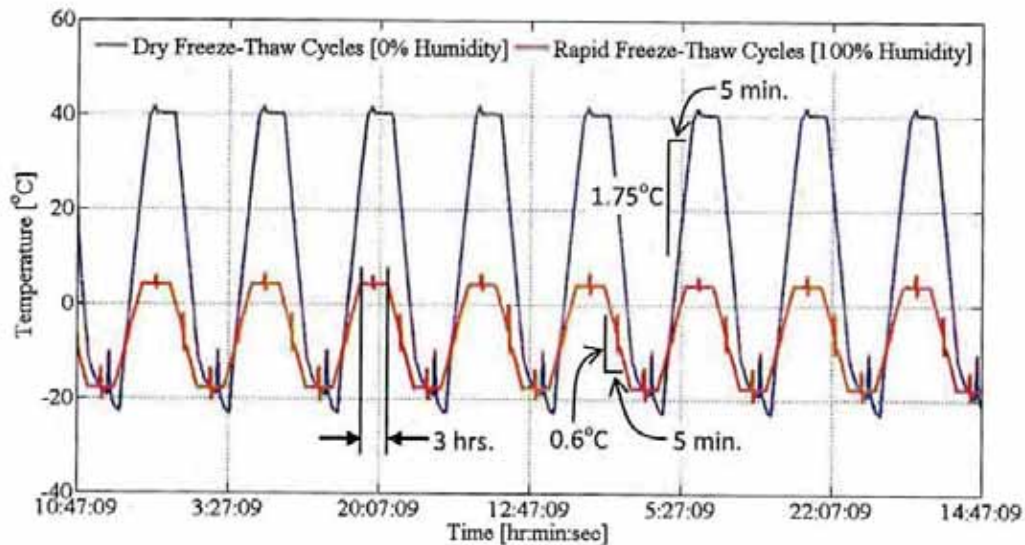
Figure 5 – Temperature Fluctuation during Conditioning: Chamber Records

during conditioning. The extremes of temperature were maintained for 3 hours with a ramping of 1.75°C every 5 minutes. The temperature variation for these dry freeze-thaw cycles is illustrated in Figure 5 over the course of approximately 4 days.

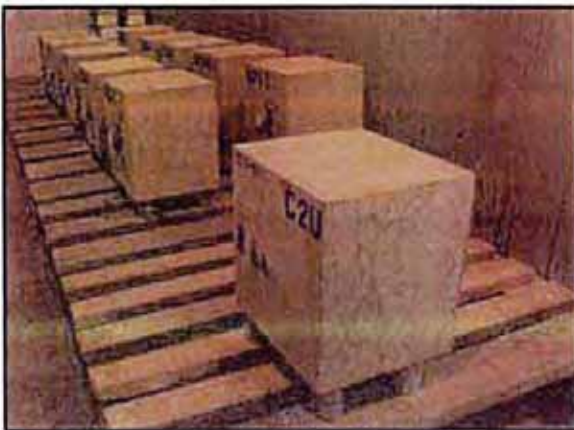
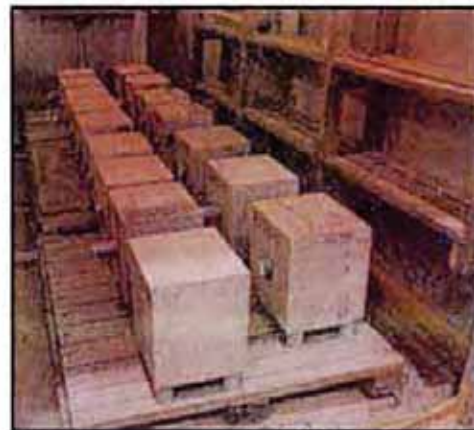
Figure 7 – Sample Layout in the Environmental Chambers

It should be noted at this stage that the dry freeze-thaw cycles and the rapid freeze-thaw cycles were performed simultaneously using two chambers during a total of $2\frac{1}{2}$ months (75 days). The sample layout is shown in Figure 7(a) for the dry freeze-thaw cycles and Figure 7(b) for the rapid freeze-thaw cycles. Several pertinent observations can be made from these figures. The first concerns the absence of the stainless steel rods extruding from the masonry blocks. The absence resulted from a request that rod tails be sectioned flush with the stonework and protected with insulation to prevent infiltration of cold temperature and moisture during conditioning.

(a) Dry Freeze-Thaw Cycle Chamber

(b) Rapid Freeze-Thaw Cycle Chamber

The second observation that can be made from the layout shown in Figure 7 is the fact that all samples were placed sideways on wooden pallets to provide a 3° inclination with respect to the chamber floor. This inclination was provided in accordance with the fact that samples were shipped with anchors installed at a right angle from the surface of the stone. Original drawings provided by PWGSC suggest that anchors should have been installed at 3° with respect to the horizontal to prevent moisture ingress when using the repair technique in the field. A diagram of the shop drawings provided in the Request for Proposal document submitted by PWGSC can be found in Figure 9.

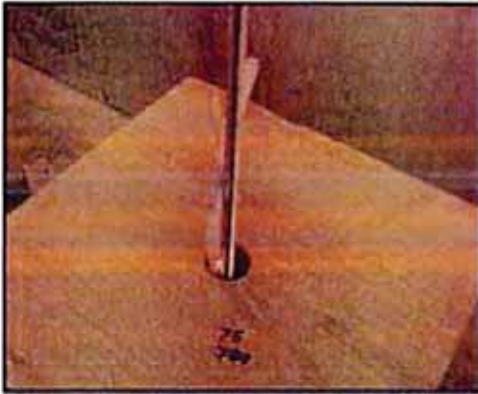
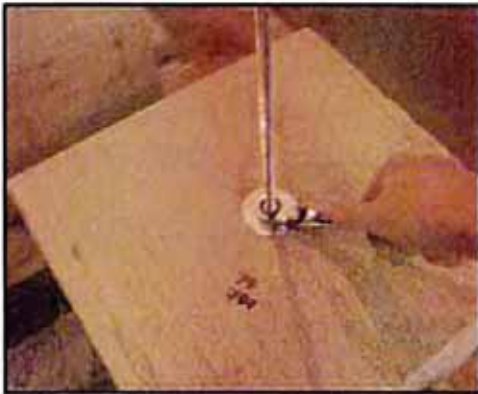
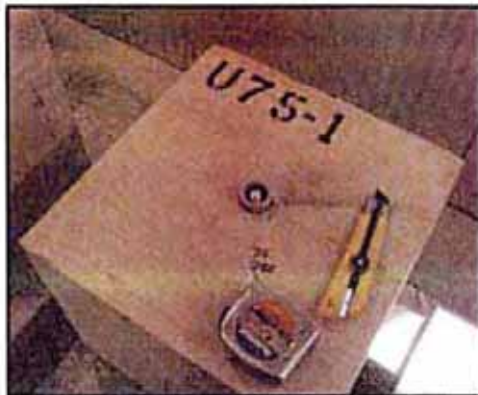
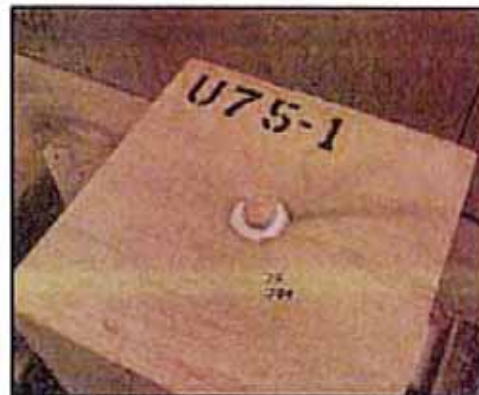
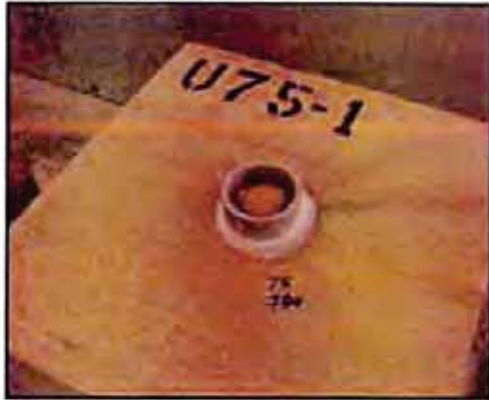
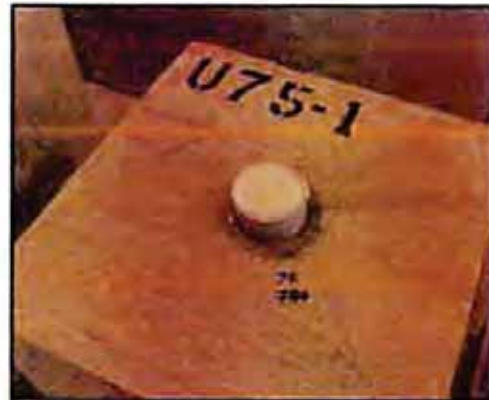
Figure 8 – Sectioning Procedure

The sectioning procedure is outlined in Figure 8 and consists of four steps. The first step involves removal of the rod using a reciprocating saw equipped with a BI-Metal blade (Figure 8(a) to (d)). The rod was secured from excess vibration with a wooden jig that was fabricated from three 2in by 4in studs. A 2in outside diameter, 3/8in inside diameter washer, hand tightened with a nut, was also provided to offer additional stability during each of the sectioning procedures.

(a) Original Stone (75mm Sock Length)

(c) Rod Stabilization (2"OD -3/8"ID Washer & Nut)

(e) External PVC Confinement within Hole

(f) Insertion of Insulation around the Rod
(Silicon added to Seal the Hole)

(g) External PVC Confinement on the Stone Surface
(Silicon added to Seal the Hole)

(h) Insulating Foam against Moisture Ingress
(Expansive Insulating Foam Used)

Once the rod was sectioned, a segment of 1in diameter PVC conduit was inserted in the stonework hole and filled with R-20 FIBERGLASS PINK® insulation (Figure 8(e) to (f)). The use of a washer and nut to stabilize the anchor during the sectioning process provided a threaded rod stub of approximately 9.5mm (3/8in) that extruded from the stone. As a result, an external 2in PVC confinement was placed on the surface of the stone and expansive insulating foam was inserted to protect the top of the rod from temperature and moisture ingress (Figure 8(g) to (h)).

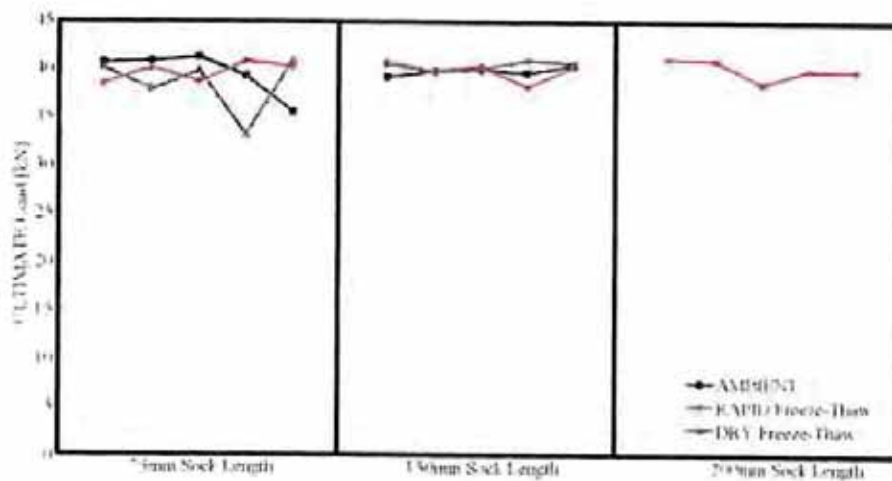
Figure 11 – Anchorage System Capacity in Ohio Sandstone (All Samples)

Results from all tests performed in this project are shown in Table 3 in terms of the ultimate load and type of failure. The failure loads are consistent among all specimens and weathering conditions considered. The table also shows that two main failure types were observed. These include steel failure in the threaded rod within the grouted portion of the anchor followed by slippage but also failure of the steel in the rod between the stonework and the anchorage plates. The ultimate loads recorded during the tests are shown in Figure 11 with respect to sock length as well as in terms of weathering conditions.

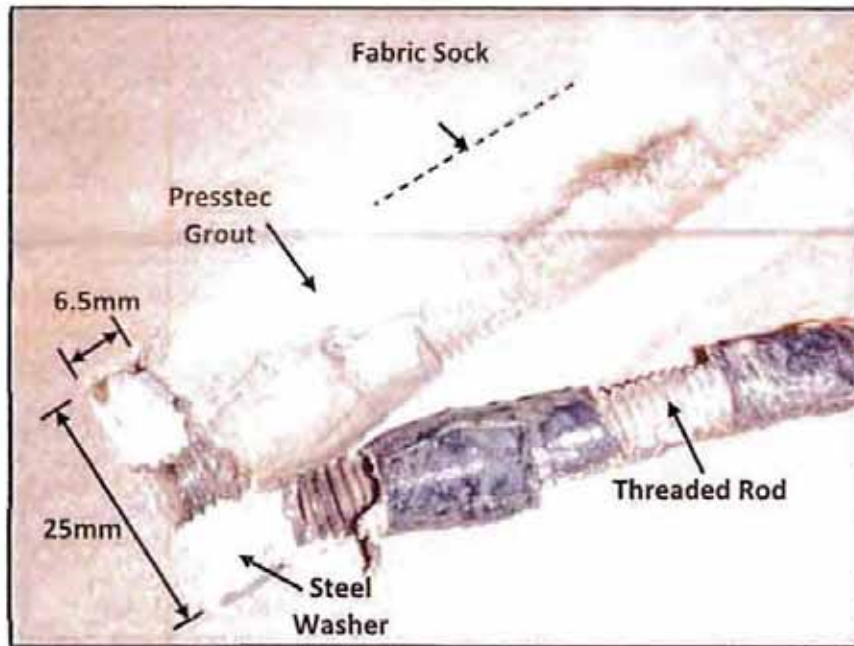
Figure 15 – Cintec Anchor Assembly with Bottom Threaded Washer

failure in the rod at the bottom of the grouted hole, immediately above the washer. This additional strength will increase the ultimate loads listed in Table 5 for bond failure to that which is equivalent to steel failure and thereby confirms the consistency obtained for pullout loads listed in Table 3 despite having used varying embedment (sock) lengths for the anchors.

A complete illustrative documentation of the failure planes similar to the one shown in Figure 15 after testing is provided in Appendix B of this report. The illustrations do not show evidence of damage in the grouted portion of the anchor for any of the failure modes, which indicates that the Cintec rehabilitation technique is resilient despite the consideration of thermal weathering. It should be noted that the failure planes in these illustrations were exposed by sectioning the samples down the center of the grouted hole. Sectioning was performed by DITECH International Inc. and took place at the University of Manitoba. Several pictures of the sectioning procedure are shown in Figure 16.

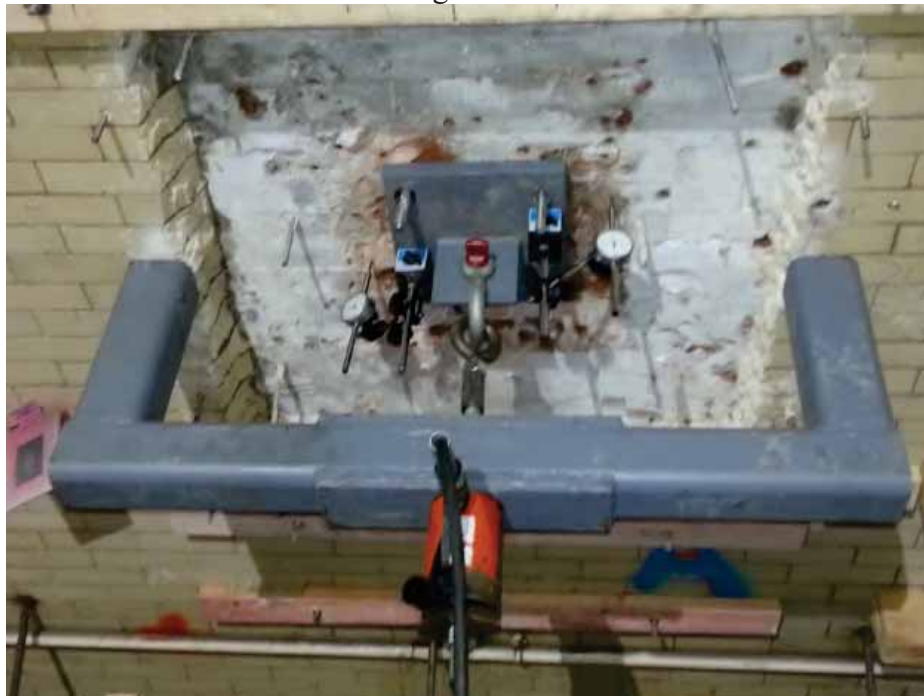
To validate the required proof load tension and shear values, NYC Transit under contract A36193 hired Future Testing Corporation to conduct on site field testing at [to the equivalent of ASTM E488-9696] at both subway stations. All specifications for testing were designed by Weidlinger Associates, Inc. A total of 22 anchors at 168th and 22 anchors at 181st subway stops. Photo below is the A anchor being tension tested.

Type A Anchors test results

- 5/8" threaded rod, 12" embed, installed in 1.5" hole and 1.5" sock
- Proof load 4800 tension max displacement .125 inches
- Grouping of 4 = 19,200 combined tension load
- Subway station 181 Anchor A1, A2, A3, A4
- Tested to 19,200
- Result 19,200 Passed in Tension max movement .018

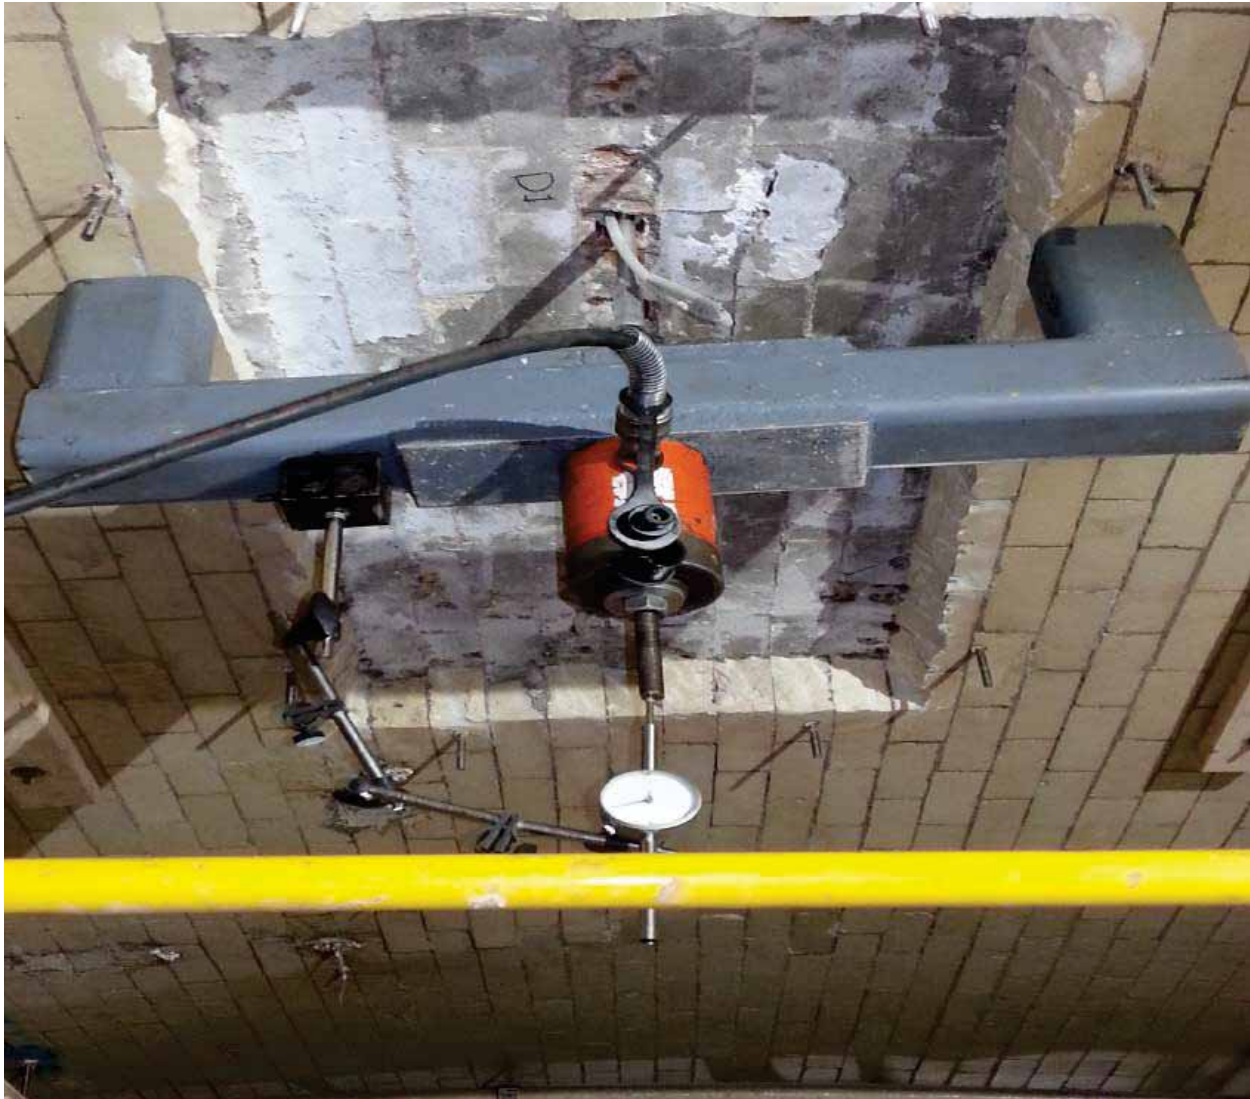
Type A Anchors

Type A Overhead Anchor

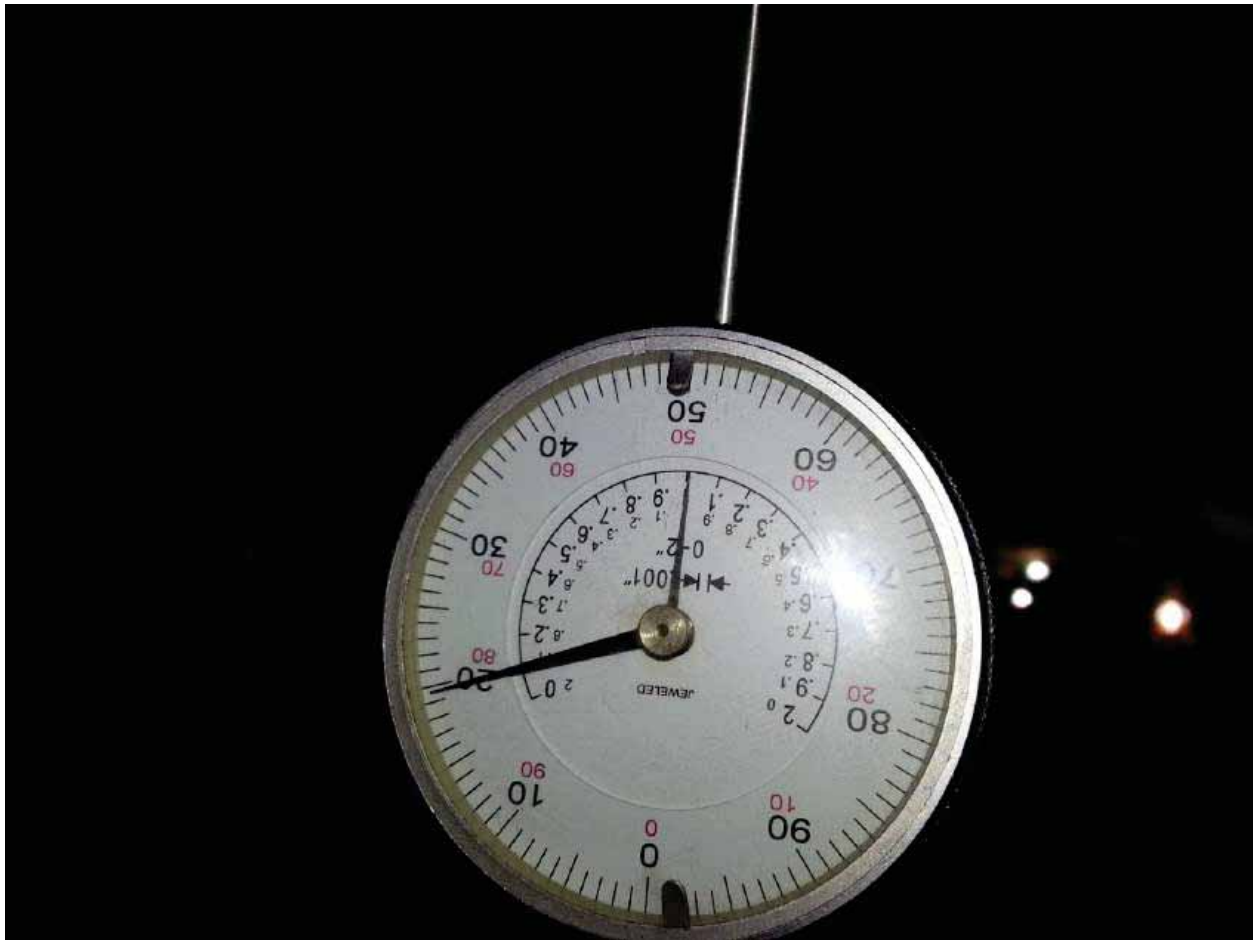
- **Overhead application**
- 5/8" threaded rod, 12" embed, installed in 1.5" hole and 1.5" sock
- Proof load 5,600 tension max displacement .125 inches
- Subway station 181 Anchor D1
- Tested to 5,600
- Result 5,600 Passed in Tension max movement .019

Dial Gauge actual reading after 10 minutes at rest. .019

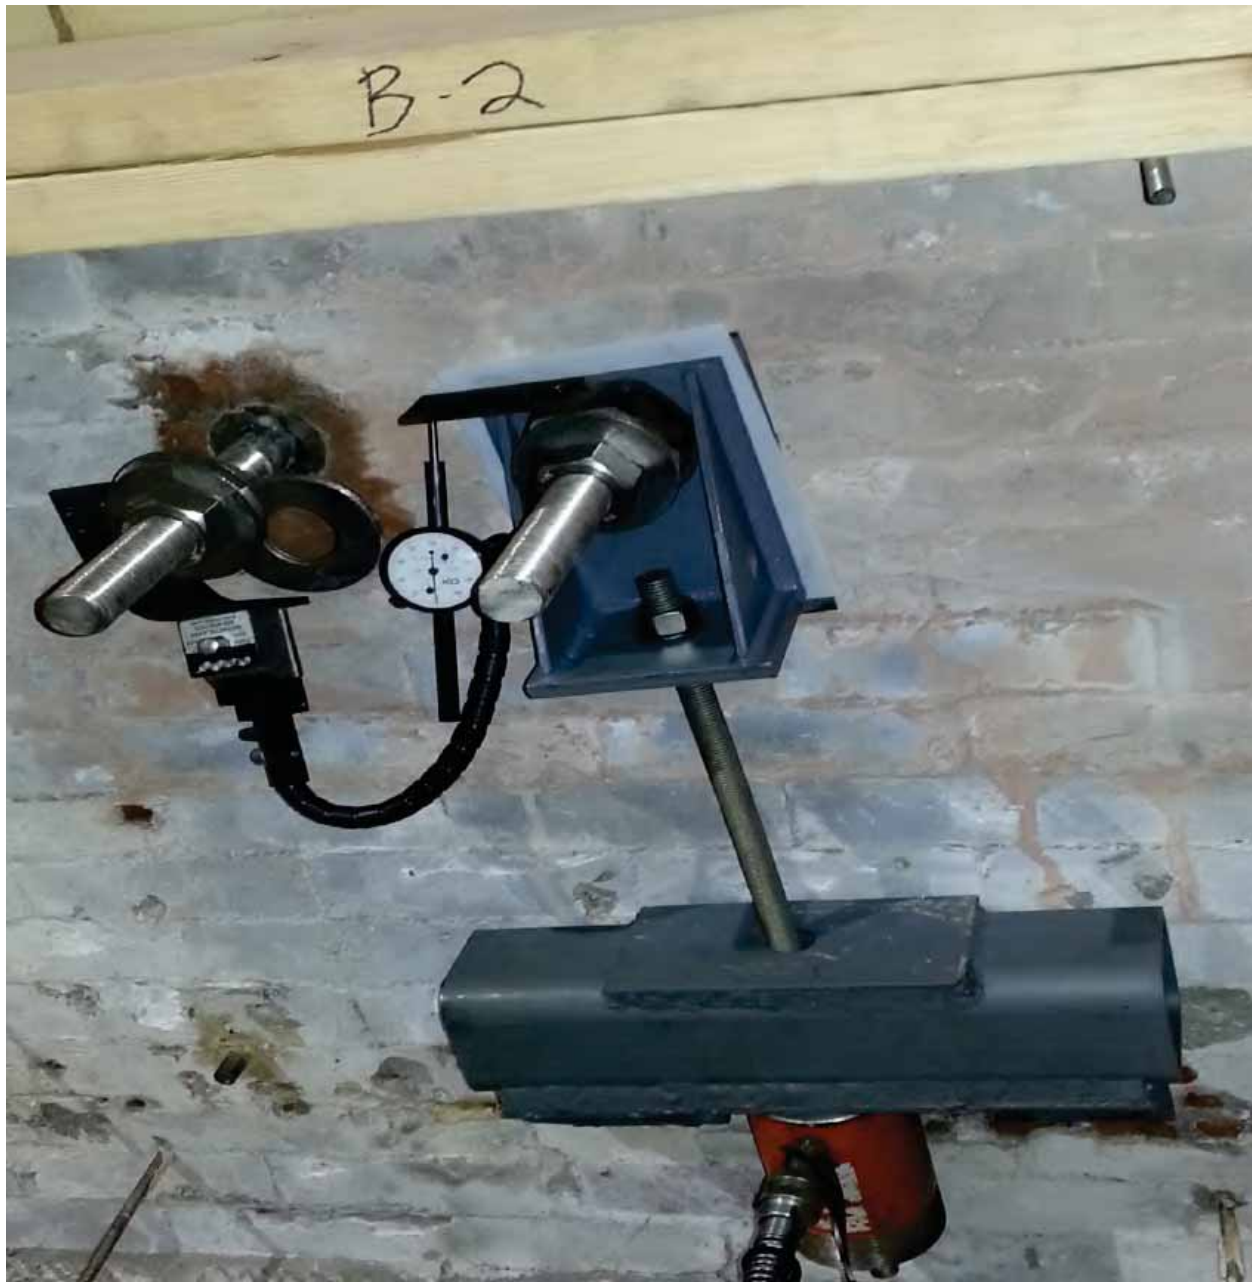
Type B Anchors side wall brick retention:

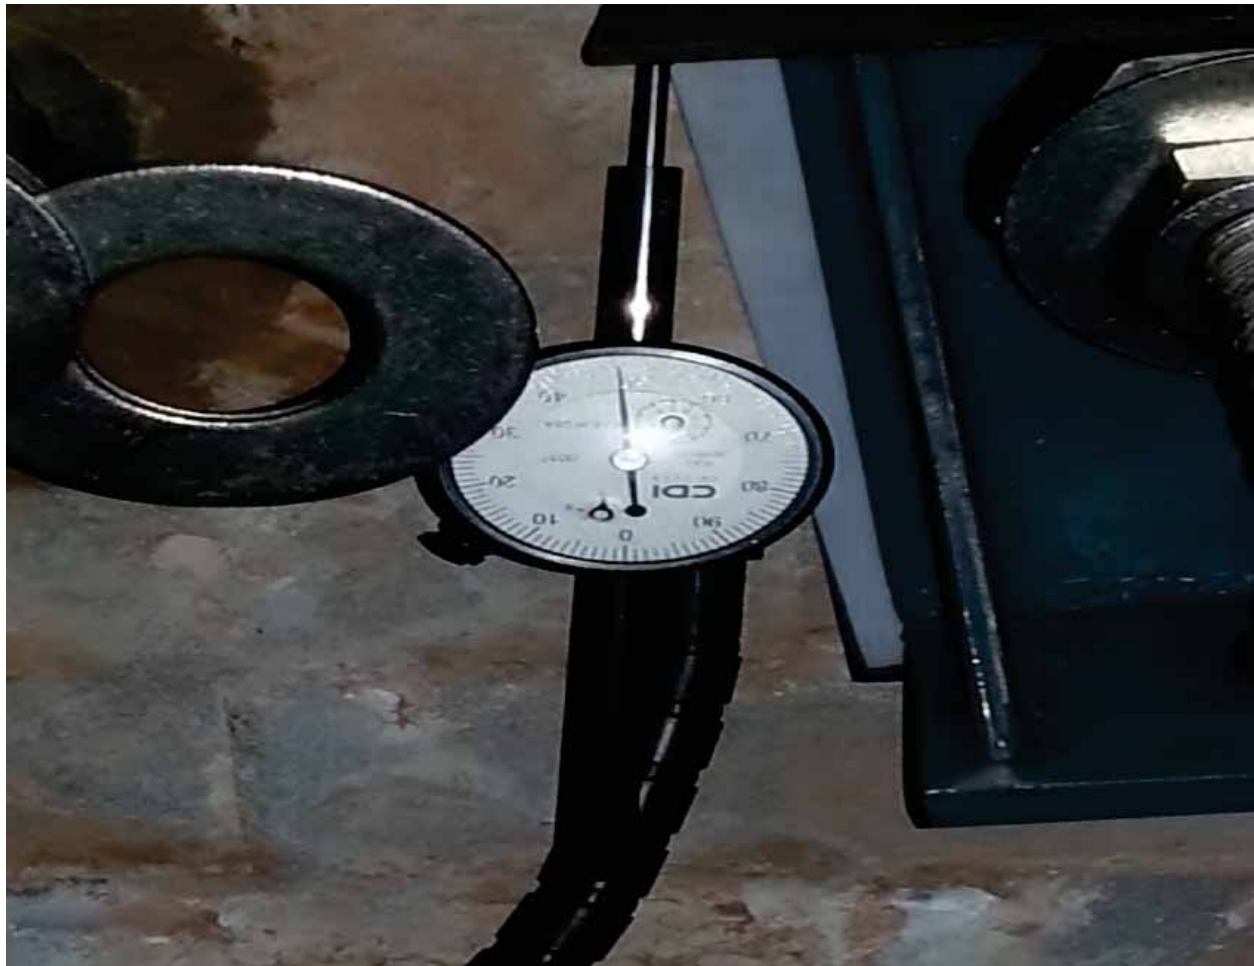
- 1 ¼" threaded rod, 22" embed, installed in 2.5" hole and 2.5" sock
- Proof load 6,400 shear max displacement .125 inches
- Subway station 181 Anchor B2
- Tested to 6,400
- Result 6,400 Passed in Shear max movement .018

Dial Gauge actual reading after 10 minutes at rest. .049

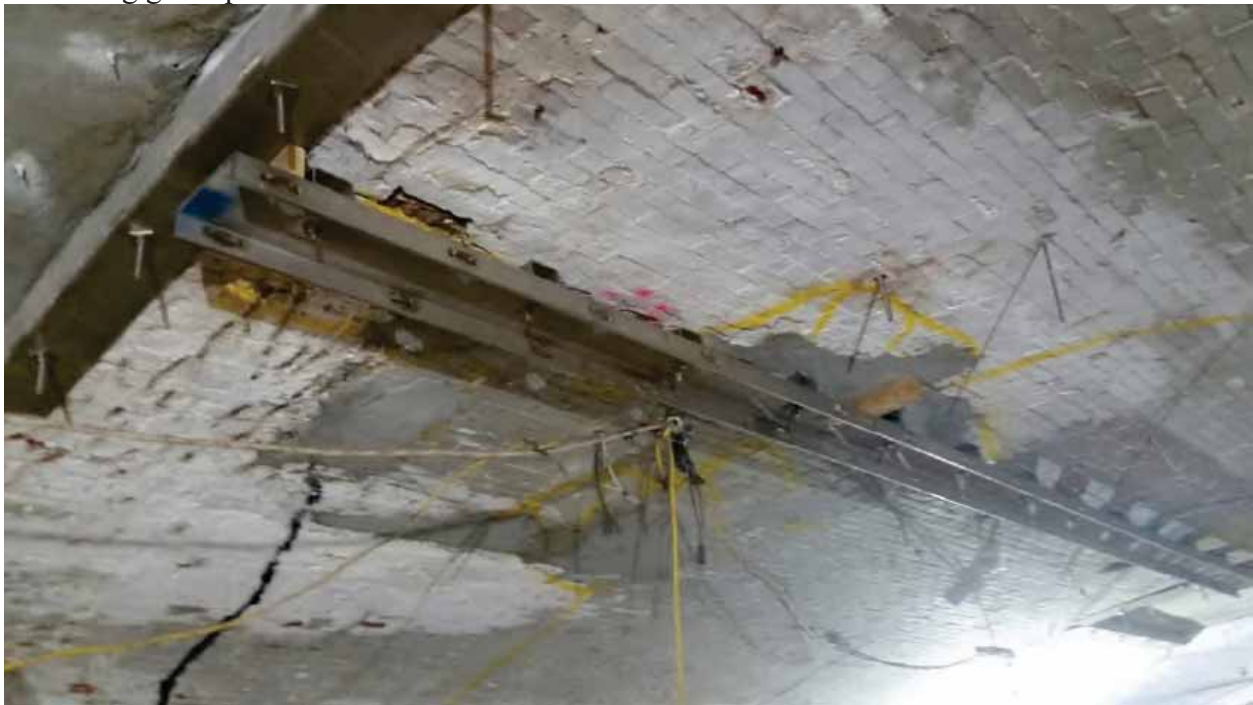
The panel were lifted to the ceiling on a custom designed lifting rig which allowed the finished panel to be aligned with the guide panel installed in the ceiling and side wall. This pictures show the ceiling guide panels.

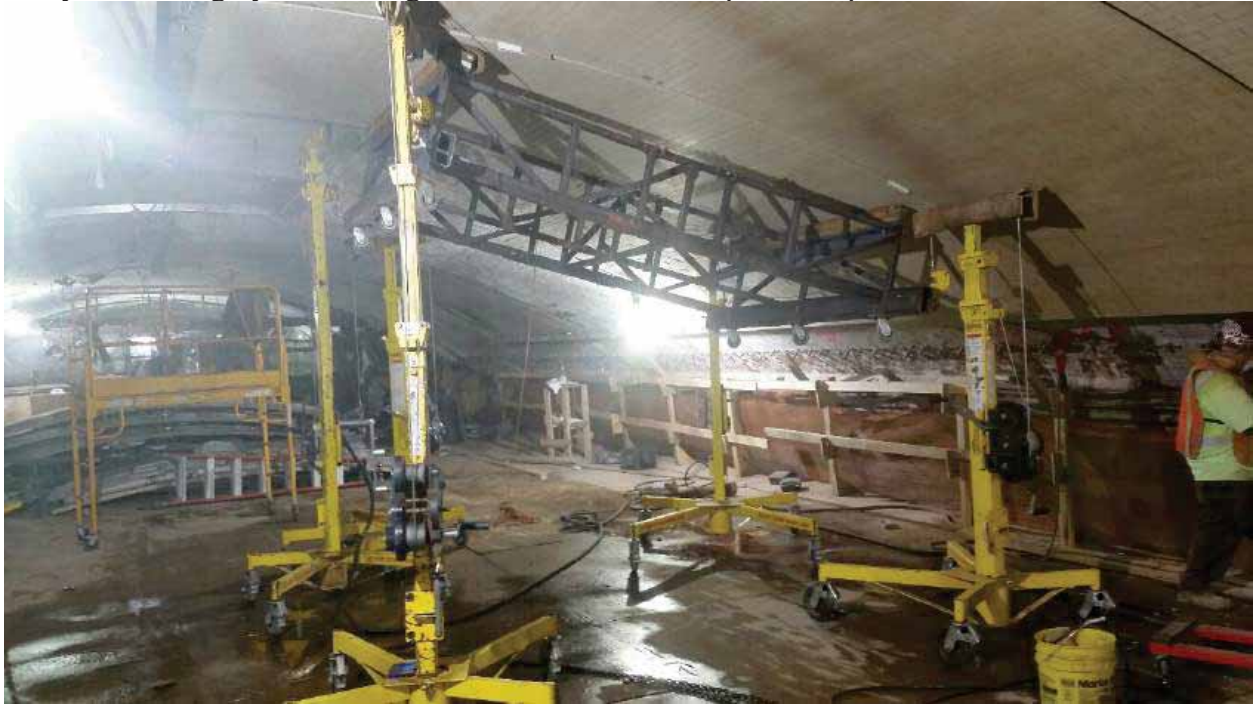
The yellow and gray lift in foreground is used to lift the panels in place.

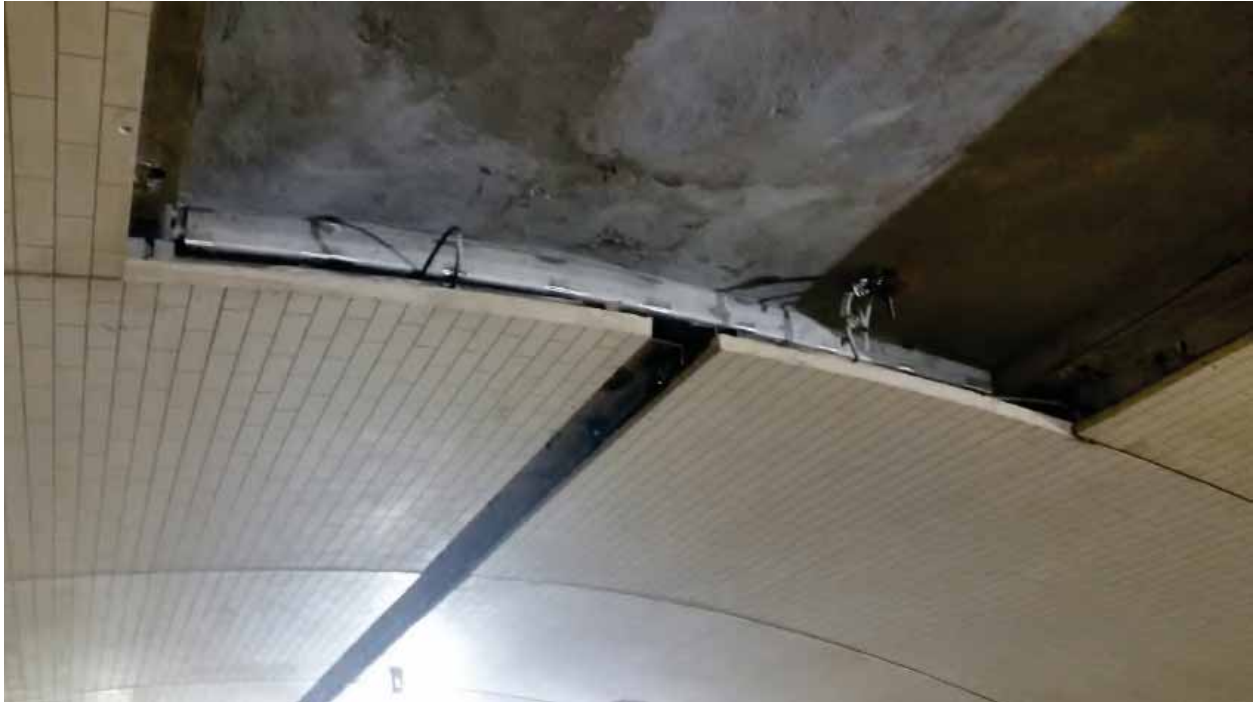
The panels are attached to the center guide panel and to a safety anchor which can be seen in the far right of the picture with a cable strap. The opening in the picture is for original terra cotta medallion reinstallation location.

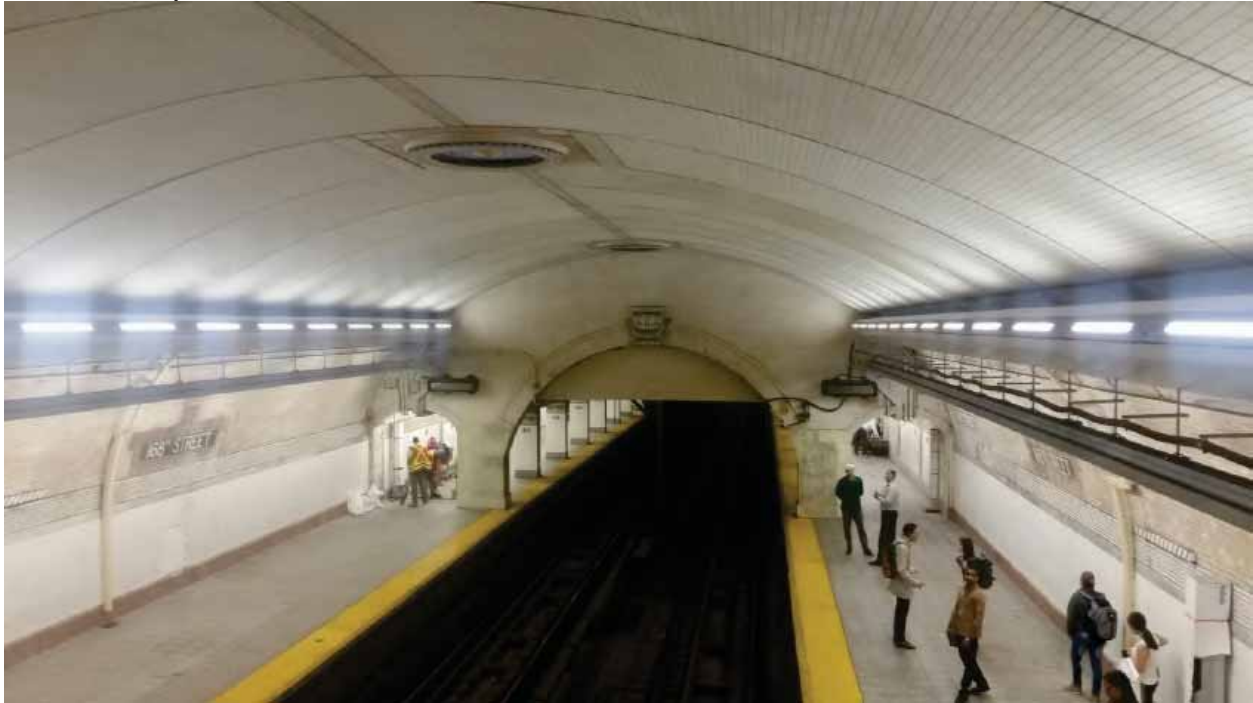
The finished panels over 168th.

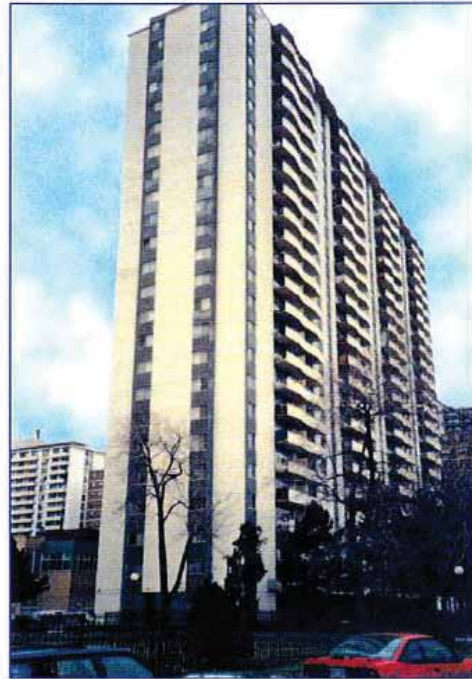
1. Bowing of walls.
2. Crushing of over stressed units.
3. Shear failure of the header courses.
4. Rotation of shelf angles

Corrosion deterioration has also occurred in the shelf angles and connecting bolts. Due to occupation of the dwellings, complete replacement of the walls was impractical. Thus Halsall Associates in conjunction with Cintec Canada participated in the development of a stabilization strategy.

- a. Use of the Cintec corbel anchor to transfer vertical loads from the exterior walls to the back-up walls.
 - b. Broken header ties to be restored using Cintec stitching anchors.
- These concepts were proven with full laboratory load tests. Results available upon request.

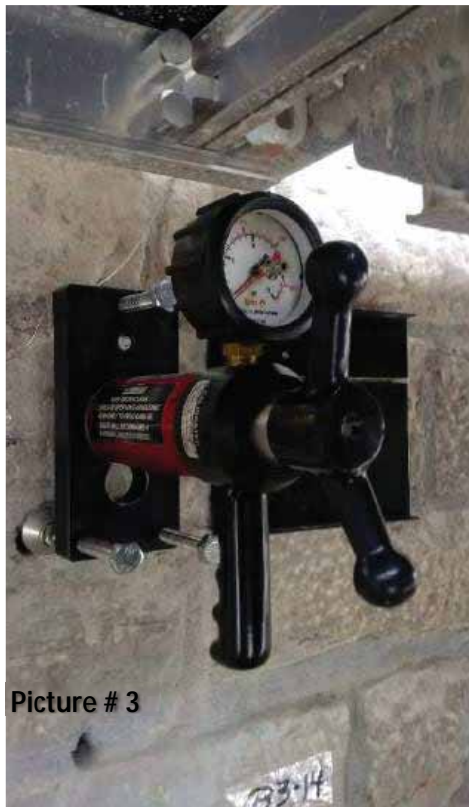
The Hydrajaws test apparatus is a purpose made system for testing anchors and consists of a mechanical screw-jack arrangement fitted through a hydraulic load cell. The tester was suspended from above by means of a wire attached to a Tapcon concrete screw. The Cintec anchor was attached to the test equipment using an M12 threaded rod and nut adapter. The leg lengths of the test equipment were adjusted so that all 3 legs were in contact with the base material and the line of action of the test meter was axial with the anchor under test. See picture # 3, 5 and 6
