Case Study

**Conserving a Terra-Cotta
Cornice and Puerto Rican
Patrimony:****Dome of the
Capitol Building****Restoration Project**

San Juan, Puerto Rico

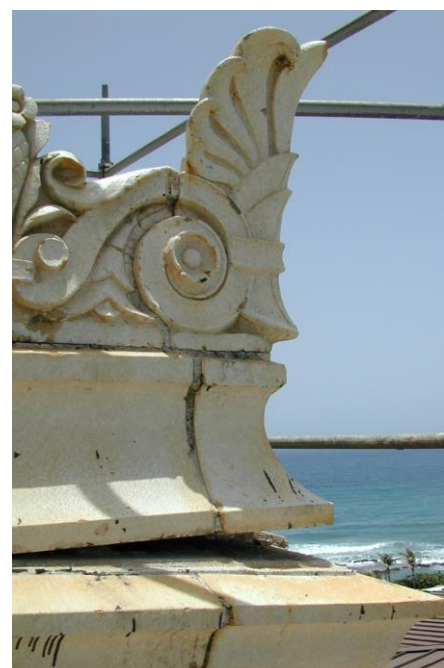
The HistoryConstruction of El Capitolio (the Capitol Building of Puerto Rico)
began in 1925 in the neighborhood now known as "Old San Juan".The building contains two chambers, with the Senate on one side,
the House of Representatives on the other, and an array of
galleries, friezes and mosaics in between. A vast marble staircase
faces Ponce de Leon Avenue and gives access to the building to
the south.**The building also boasts an impressive rotunda** in which Puerto
Rico's 1952 constitution is exhibited. The Rotonda extends
upwards to the three floors of the building. **The cornice adorns
the base of the dome**, which rises at the center of the building on
an octagonal drum.**The Findings**In 1998, an investigation
revealed **several major
problems** which were related to
the ingress of large quantities
of salt-laden moisture.The **corrosion had been so
severe** that it was no longer
possible to establish the exact

dimensions of any of the
former steel elements. Some
had disappeared totally,
leaving only rusty stains in the
terra-cotta work.**Severe cracking and
movement** of the corners were
also evidence of a **structural
failure and deterioration**.

It was recommended that all heavily damaged and collapsing areas of the cornice be dismantled and rebuilt using high quality matching new units from a well-established terra cotta manufacturer. To retain as much original material as possible, it was also recommended that the undamaged but unstable areas of terra cotta be stabilized in-situ using the Cintec anchoring system.
