## Case Study

**Conserving a Terra-Cotta  
Cornice and Puerto Rican  
Patrimony:****Dome of the  
Capitol Building****Restoration Project**

San Juan, Puerto Rico

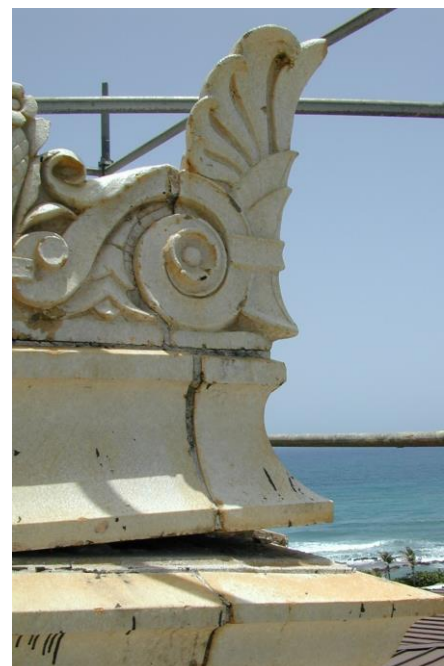
**The History**Construction of El Capitolio (the Capitol Building of Puerto Rico)  
**began in 1925** in the neighborhood now known as "Old San Juan".The building contains two chambers, with the Senate on one side,  
the House of Representatives on the other, and an array of  
galleries, friezes and mosaics in between. A vast marble staircase  
faces Ponce de Leon Avenue and gives access to the building to  
the south.**The building also boasts an impressive rotunda** in which Puerto  
Rico's 1952 constitution is exhibited. The Rotonda extends  
upwards to the three floors of the building. **The cornice adorns  
the base of the dome**, which rises at the center of the building on  
an octagonal drum.**The Findings**In 1998, an investigation  
revealed **several major  
problems** which were related to  
the ingress of large quantities  
of salt-laden moisture.The **corrosion had been so  
severe** that it was no longer

possible to establish the exact  
dimensions of any of the  
former steel elements. Some  
had disappeared totally,  
leaving only rusty stains in the  
terra-cotta work.**Severe cracking and  
movement** of the corners were  
also evidence of a **structural  
failure and deterioration**.
