Rehabilitating an icon of Freedom:**The Statue of Liberty****Restoration Project**

New York, US

Repairing the Statue of Liberty's star shaped pedestal – Fort Wood.

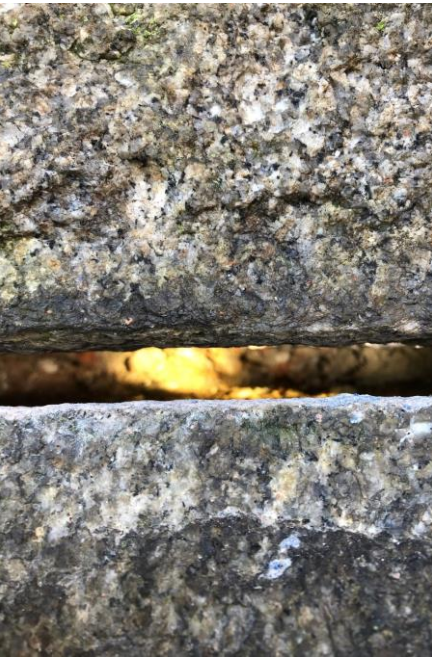
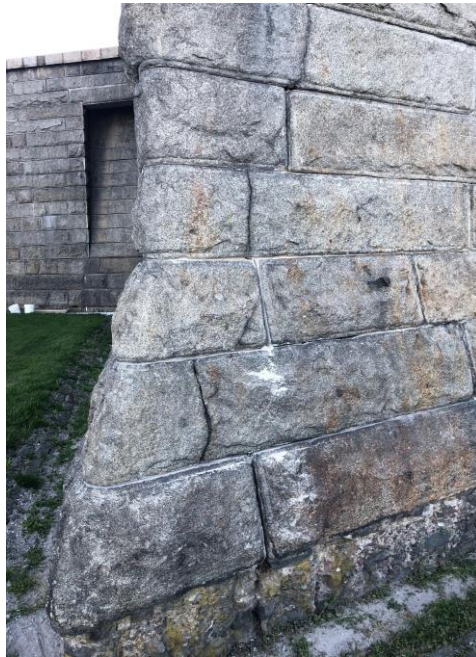
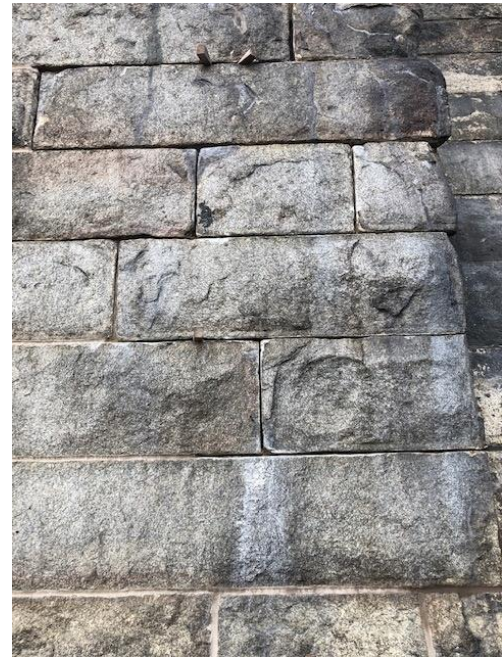
In 2020, and after 200+ years of exposure to storms and seawater, **the exterior stone walls at Fort Wood needed to be rehabilitated.** As part of the masonry restoration, some mortar joints were extremely deteriorated to the point that grout repairs were required to infill the bedding joints. For repointing repairs of 0" – 12", typical repointing was specified.

Injection repairs included the infill of bedding joints for depths greater than a feasible repointing depth (>12"). This repair was provided by Cintec, and it was necessary to **replace the deteriorated – or nonexistent – mortar joints and fill up the voids** at the back of the wall.

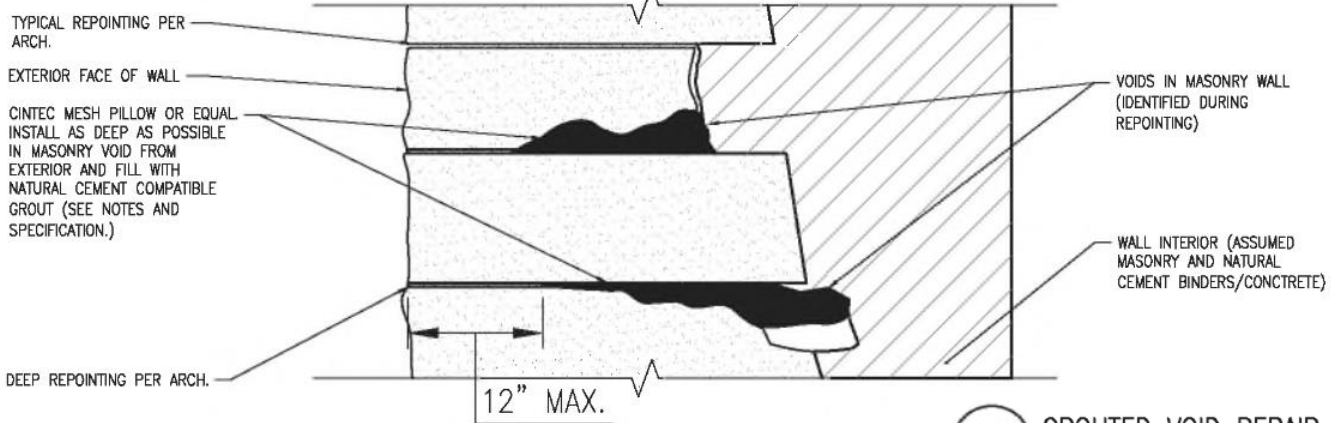
2
S4.01
GROUTED VOID REPAIR
N.T.S.

SECTION VIEW

The Cintec Grout Pillows (9" by 24" and 12" by 12"), were designed to be installed as deep as possible into the bed joint and filled with Presstec® Grout.

As the grout was injected, **the Cintec Grout Pillow expanded to fill the voids and molded to the contours of the substrate, establishing both a mechanical and adhesive attachment, and resulting in a robust bond and support.**

The Cintec Grout Pillow allowed to **constrain the grout to the bed joints** without infilling large voids within the rubble wall, also **preventing leakage of grout and damage to the surface**.

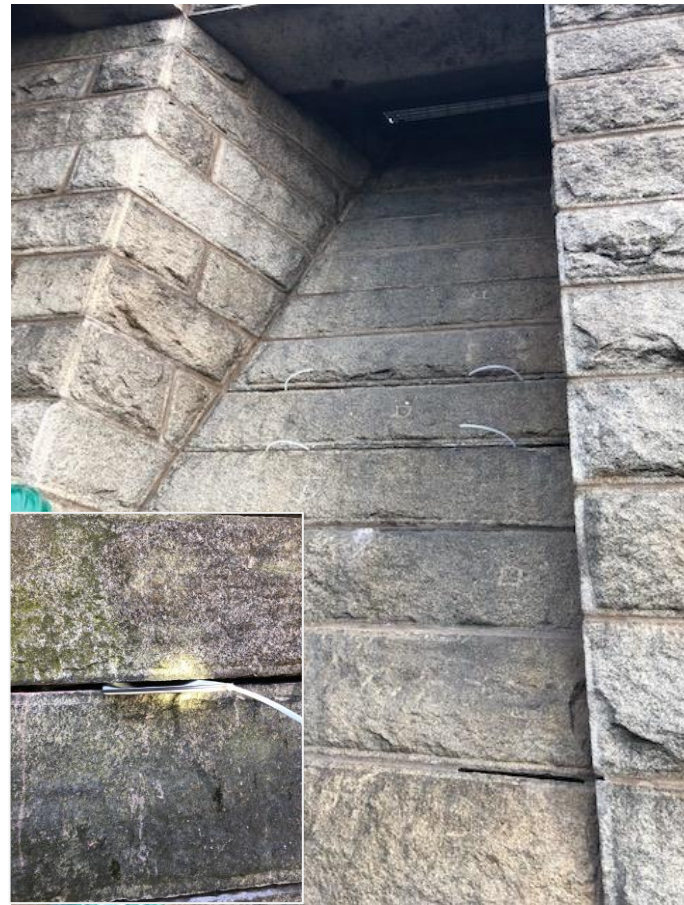
Over 100 Cintec Grout Pillows were installed as part of the exterior stone wall rehabilitation. Additional anchors were installed to reinforce Stair C on a preliminary phase.

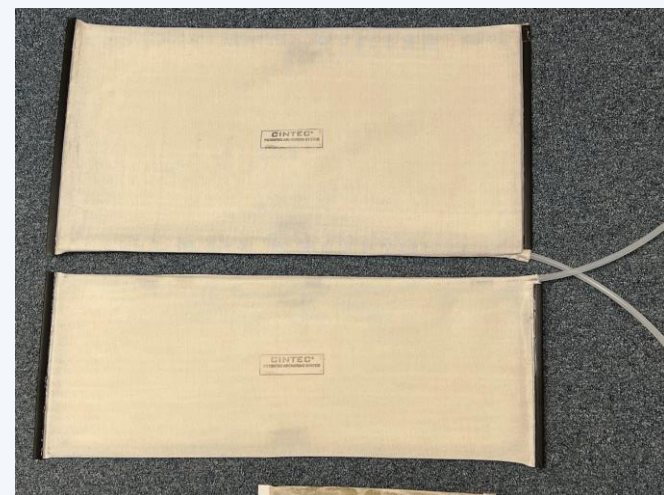
Cintec Grout Pillows, custom-designed to meet the needs of the project.
