CASE HISTORY

DON'T TEAR IT DOWN... ANCHOR IT DOWN!

THE MADRASA & KANQAH OF SULTAN AL GHURI
CAIRO, EGYPT

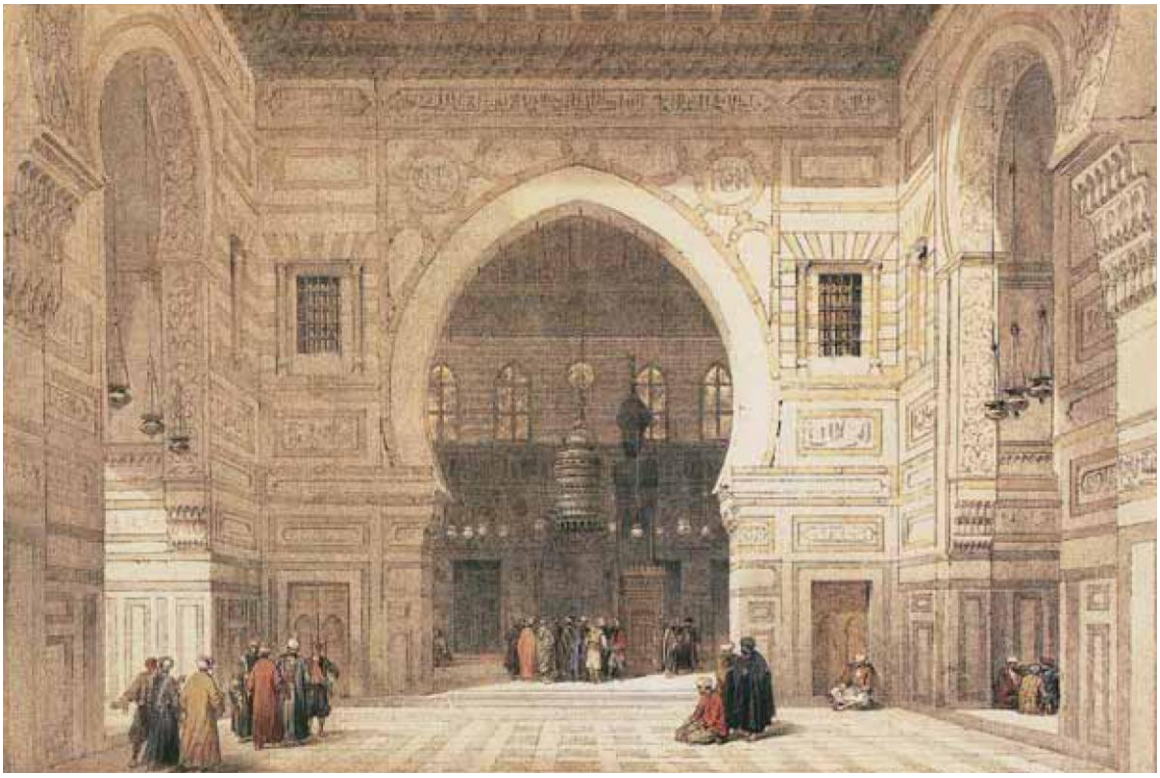
19th Century illustration of Mosque

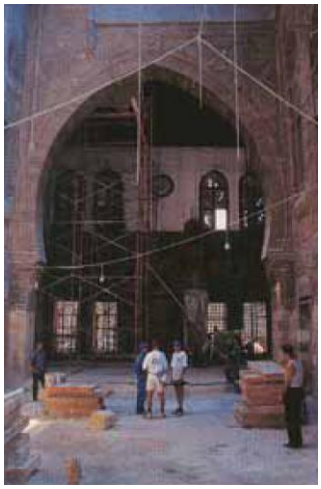
Dikka arch in the main courtyard
