COMPOSITE ANCHORING, GROUTING AND STABILIZATION OF THE BRISTOL MARITIME ARMORY

BY JOHN M. WATHNE

Bristol Maritime Armory Stabilization Bristol, Rhode Island

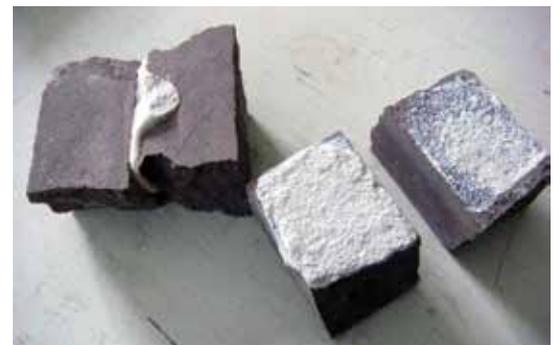
Fig. 6: Bond test specimens

High Adhesive Strength: It is important that the grout be adhesive enough to bond surfaces together with an adhesive strength that equals or exceeds the cohesive strength of the grout (Fig. 6). This is so that any shrinkage that did occur would result in jagged microcracks within the grout rather than in debonding from the substrate surfaces.
