## A treatment report by Conservation Solutions, Inc., on a terra-cotta cornice adorning the Capitol Building in San Juan, Puerto Rico, shows the potentially catastrophic effects of corrosion in a marine environment, and offers some innovative solutions to the problem.

Conservation Solutions, Inc., was contracted by the government of Puerto Rico to assist Pablo Quinones of OPQ & Associates in the investigation of the main terra-cotta cornice at the base of the dome of San Juan's Capitol Building.

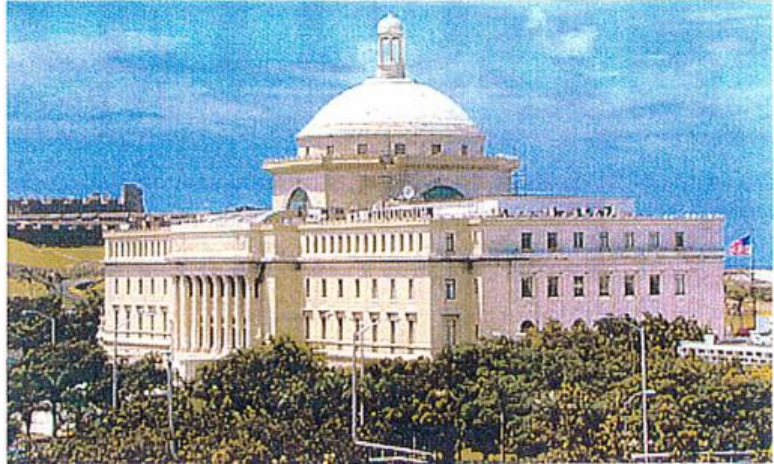
Puerto Rico's Capitol Building or "El Capitolio," in San Juan, was completed and inaugurated in 1929. A major part of San Juan faces the Atlantic Ocean to the north. The marine environment was a major factor in the deterioration of the building's facade.

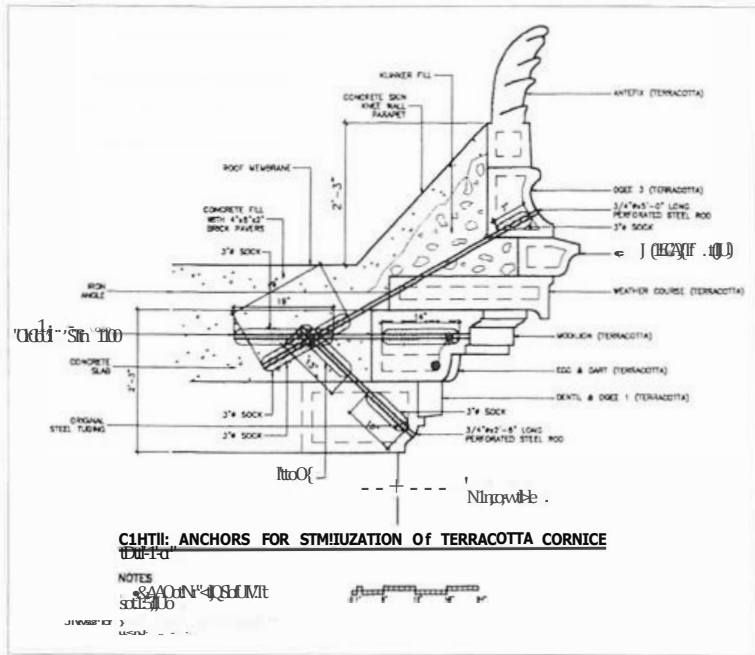
Following observation of severe cracking and movement at the corners of the main terracotta cornice of the octagonal lower drum of the dome, it was jointly decided to erect scaffolding and to carefully make an exploratory opening into the terracotta work.

Water had penetrated down into the cornice, and all its steel structural supports and anchors had been totally destroyed by corrosion. The total failure of the structural-support steel and anchor system had led to the structural failure of the cantilevered, and now unreinforced, terracotta cornice. The only reason that it had not collapsed was a combination of the cohesive and frictional effects of the mortar and brick fragments used as back-up to the hollow terracotta units.

Moisture had entered the open joints and cracks and, to a lesser extent, through leaks in the roof above and behind the cornice. The reason for the extreme corrosion of the steel was a combination of chlorides from sea spray and the sulfuric acid formed when saline moisture saturated and then passed through the contaminated cindercrete. The corrosion had been so severe that it was no longer possible to establish the exact dimensions of any of the former steel elements. Some had disappeared totally, leaving only rusty stains in the terracotta work.

Most importantly, we disassembled approximately 6 feet of the cornice to reveal its construction and its anchoring system. We also exposed a portion of the parapet decking to determine the condition of the underlying concrete substructure. In collaboration with the architect and Martin O'Leary, a new anchoring system was designed. We also worked with the noted terracotta manufacturer, Gladding, McLean, to determine which sections of terracotta would need to be replicated.

The dismantled corners should be rebuilt using AISI Type 316 non-corroding stainless-steel rods in a grout-injection anchor system by CINTEC, specially designed with small injection tubes positioned in the joints between the terracotta units for inflation with grout after assembly.
