**DON'T
TEAR IT
DOWN...
ANCHOR
IT DOWN!**

ST. ANNE CHURCH, OTTAWA, ON, CANADA

SAINTE-ANNE D'OTTAWA CHURCH, BUILT IN 1873

by John G. Cooke, Engineer

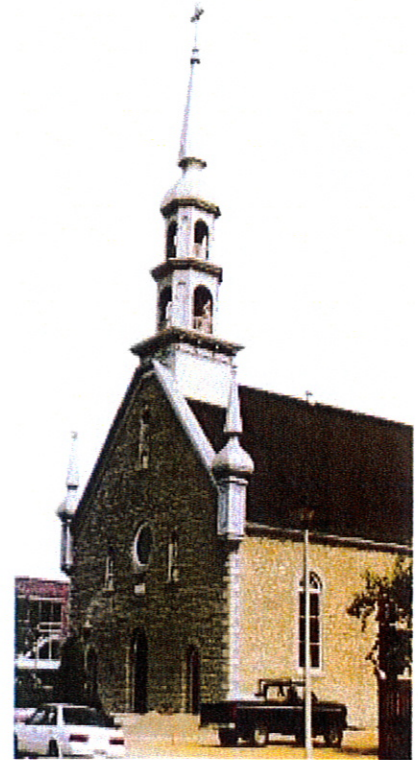
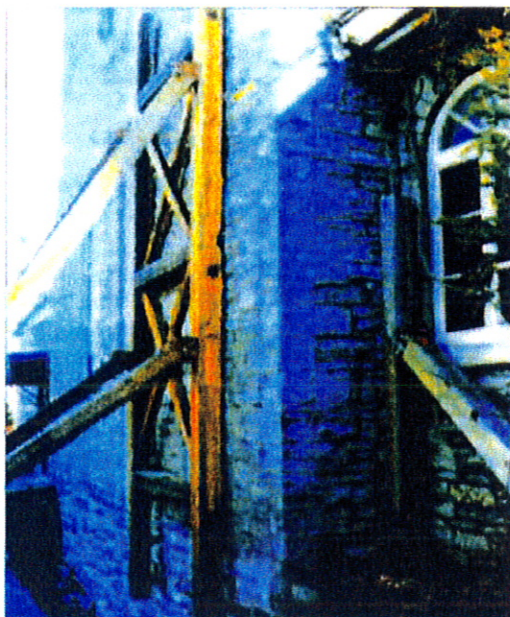
Anrep Associates Ltd, designed and supervised the repair of both transept walls of this Church using CINTEC wall tie anchors and stitching anchors, during the summer of 1991. This Church was built in 1867, and is designated a historic building by the City of Ottawa. This required that the repair work must restore the structure to its original state. Both transept walls consisted of an exterior and interior wythe of limestone masonry of varying thickness, with an interior core of rubble and mortar. The overall wall thickness was 26" (650mm). Over time the mortar in the joints and interior core deteriorated and turned to sand due to weathering, moisture penetration and frost action. When this occurred the rubble and loose sand slowly worked their way down the wall core due to gravity and vibrations. This resulted in a wedge forming in the core, driving the two outer wythes apart. Eventually, the Interior and exterior wythes would no longer act together as a load carrying unit and failure would occur. At one corner a serious bulge had already occurred in the exterior wythe, and vertical cracks on each side of the corner indicated that this portion of wall was separating from the adjacent wall.

The repair required anchoring the two wythes of limestone masonry together using 22" (550mm) long CINTEC wall ties spaced at 3 ft (900mm) on centre horizontal and 1' 6" (450mm) on centre vertical. The inner wall core was then pressure grouted to fill any voids and the existing mortar joints in the exterior wythe were removed to a depth of 2" (50mm) and replaced. In addition at the corner of the transept wall where the bulge occurred, the exterior wythe of masonry was stitched using CINTEC stitching anchors, installed in holes drilled parallel to the exterior wall face in two directions at 12" (300mm) on centre, staggered. These anchors were 10 ft (3M) long in one direction and 4 ft (1.2M) long in the other direction.
