The Restoration and Stabilization of the Blists Hill Furnaces, Telford, England, U.K.

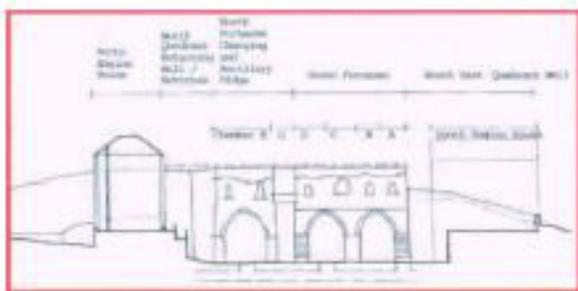
Side Elevation

- Superficial damage of the masonry and stone walls cause by the presence of vegetation and water ingress. This was most evident at the top of the structure, where significant loosening of the brick and stonework had occurred with subsequent loss of the retained material. Water penetration, in conjunction with frost action, was also causing significant deterioration to the fabric of the brickwork and stonework.
- Differential settlement in the south wall of the furnace charging building resulting in westward rotation of part of the wall and consequent vertical and diagonal cracking through the superstructure supported by it.
- Cracking and spreading movements in the superstructure, resulting in outward displacement of walls.
- Distress cracking, loss of material and localized collapse of the stone masonry retaining walls which were up to 13m high.
