COMPOSITE ANCHORING, GROUTING AND STABILIZATION OF THE BRISTOL MARITIME ARMORY

BY JOHN M. WATHNE Structures North Consulting Engineers M.A.

Bristol Maritime Armory Stabilization Bristol, Rhode Island

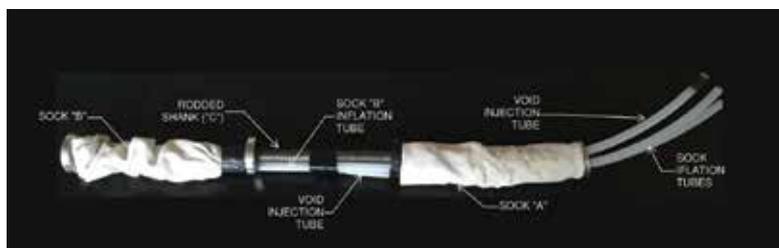
Fig. 4: Void Span Rodded shank anchor

Working with CINTEC an anchor system manufacturer, many different anchor prototypes were analyzed and tested before arriving at some practical, standardized designs (Fig. 4 and 5).

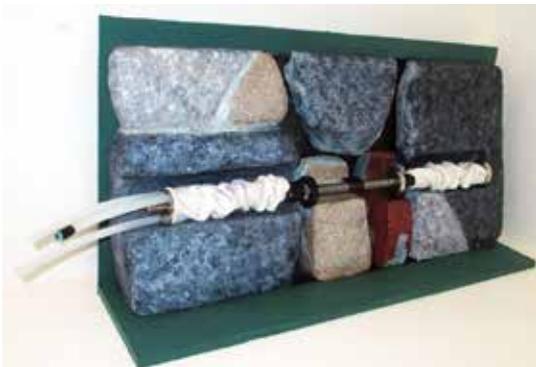
Fig. 7: The composite masonry system (illustrated)

The structural performance of the tie and grouting system (Fig. 7) has several components:

Lateral tying capability: The initial installation of the anchors is intended to provide a lateral tension tie between separated masonry leaves.

Providing a port or pathway into the masonry core for grouting: The port anchor provides the path for grout to be introduced into the masonry mass at the point where the cavity can most easily be cleaned and where the bond is most critical.
