## **Post Earthquake Restoration**

### **Christ Church Cathedral**

#### **Newcastle, Australia**

# Earthquake damage repair and strengthening of Christ Church Cathedral, Newcastle NSW

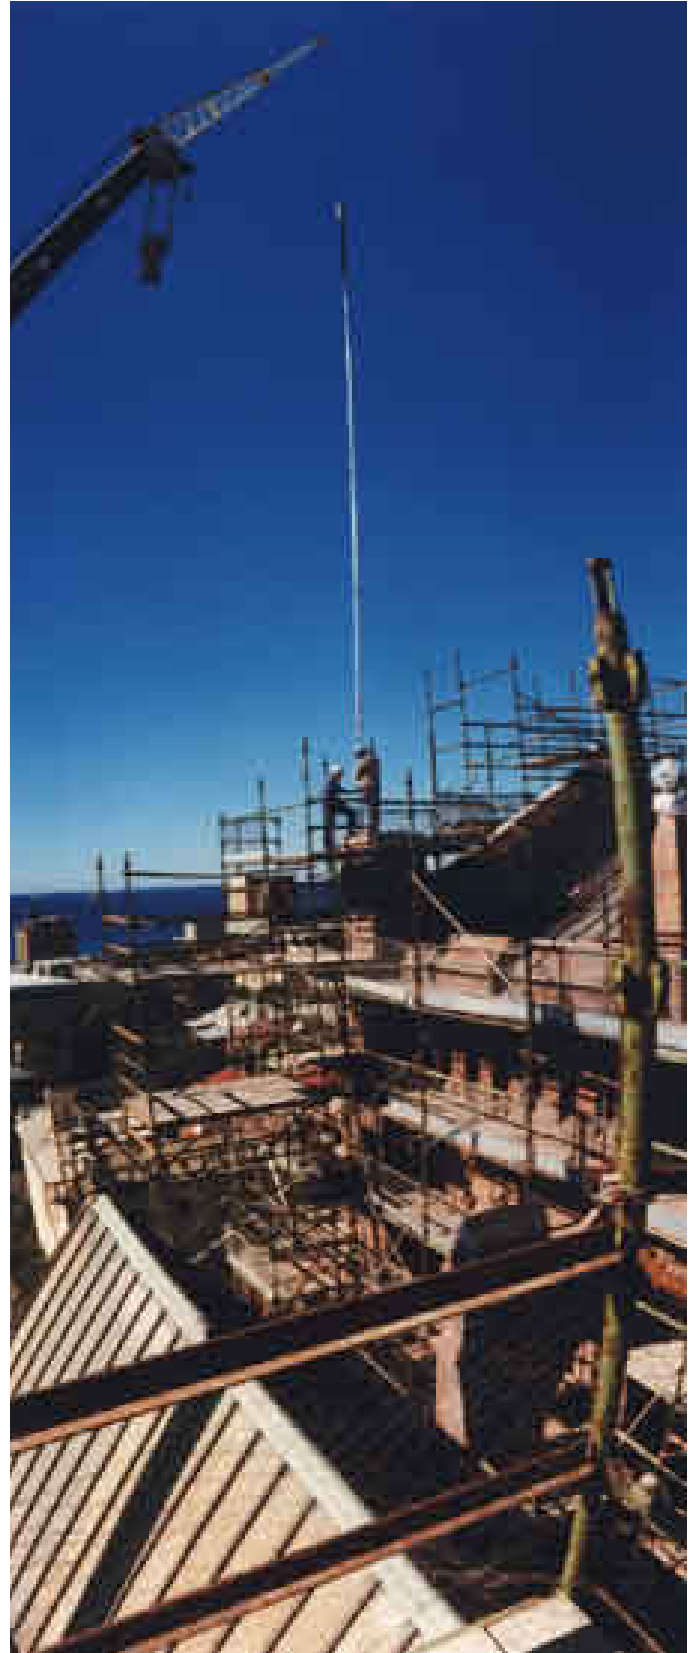
▲ A twenty metre (66ft) vertical anchor being placed by crane. This project saw the installation of horizontal anchors of up to 32 metres (105ft) in length, Cintec's longest to date. Small video cameras and fibre optics were used to verify the integrity of each drill hole along its full length.

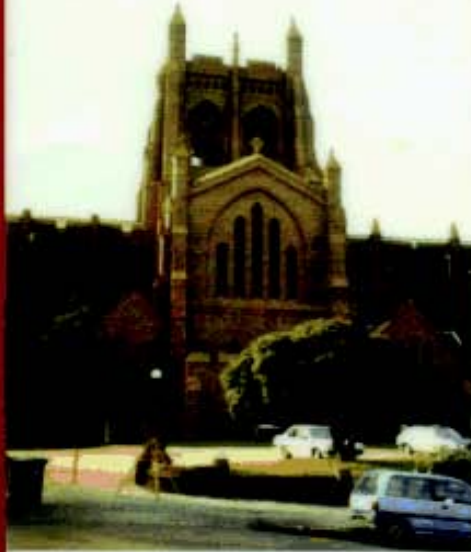
**Cintec Anchors  
Being Craned into Position**

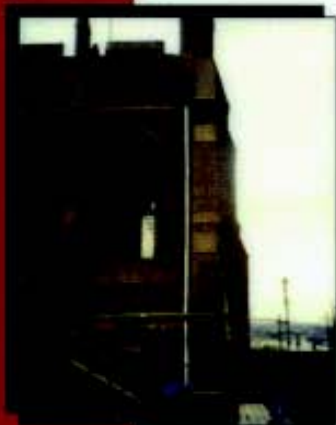
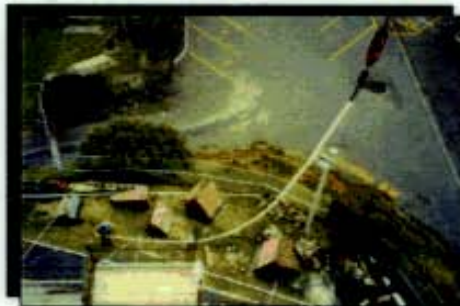
**Cintec Anchors Being Carefully Positioned**

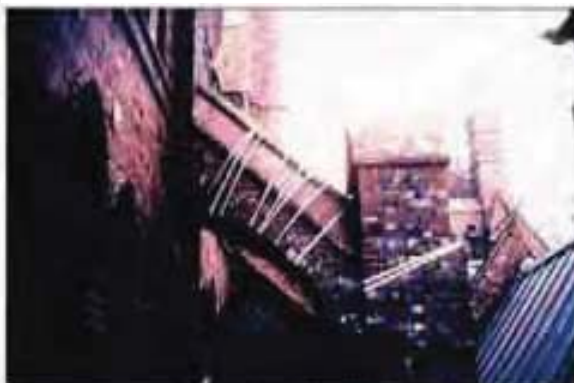
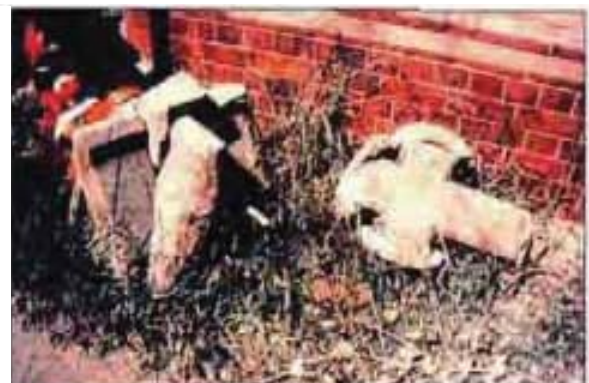
The effect of the earthquake was largely as might be expected: high set stone crosses and other decorations fell to the ground, flying buttresses were dislodged, shear cracking occurred in the north and south walls and out-of-plane movements occurred in the east wall, dislodging windows.

(ICOMOS) principal derived from the world body's Venice Charter. To repair and strengthen the Cathedral, reinforcement of the walls was necessary, with least visual intrusion or damage to the existing fabric. Materials had to be found which were compatible with the masonry of the building and which ensure the long life for which cathedrals are noted.

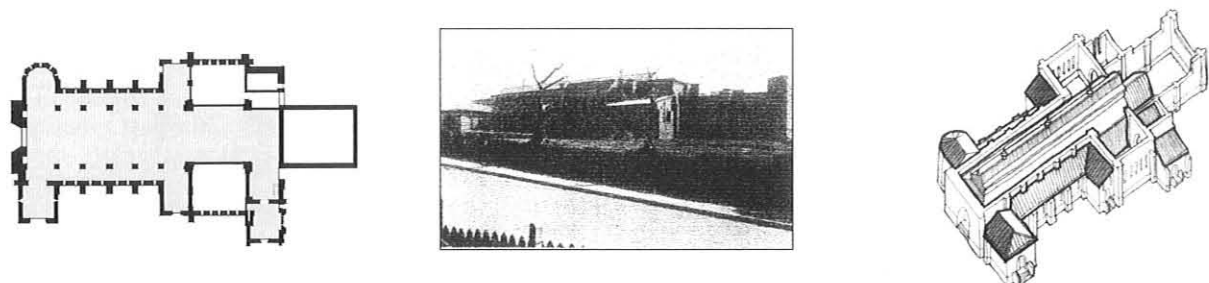
Figure 7: The temporary roof to the nave installed in 1901

facings to the crossing arch supports were introduced. At this time, the deteriorated brickwork was repointed with a hard cement-based mortar to all internal faces. This work was completed and the Cathedral opened for service in 1902. Within five years the Cathedral suffered severe structural damage to its western end with severe mine subsidence which occurred again two years later.

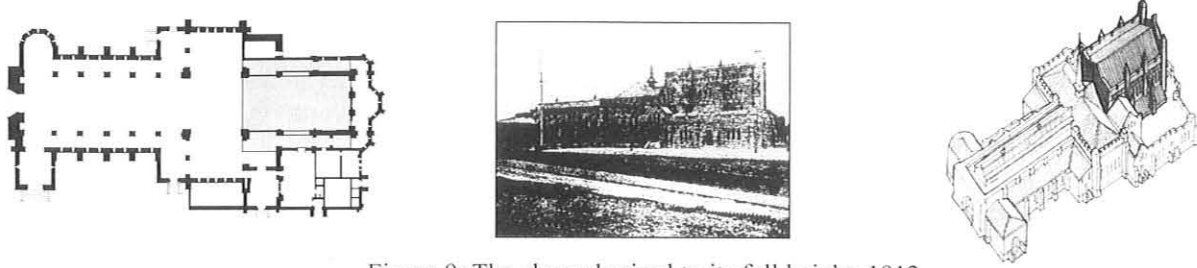
Figure 9: The chancel raised to its full height, 1912

1912 saw the Cathedral begin to be raised to its full height with the construction of the upper walls of the chancel. Significant in this construction was the use of hard refractory bricks as commons, which proved to be one of the many

difficulties encountered in the drilling for the 1996 reinforcing. 1912 also saw the construction of the Great East Window using sandstone and stained glass imported from England.
