CONSERVING A TERRA-COTTA CORNICE

A treatment report by Conservation Solutions, Inc., on a terra-cotta cornice adorning the Capitol Building in San Juan, Puerto Rico, shows the potentially catastrophic effects of corrosion in a marine environment, and offers some innovative solutions to the problem.

by Joseph Sembrat, Head Conservator and President of Conservation Solutions, Inc.

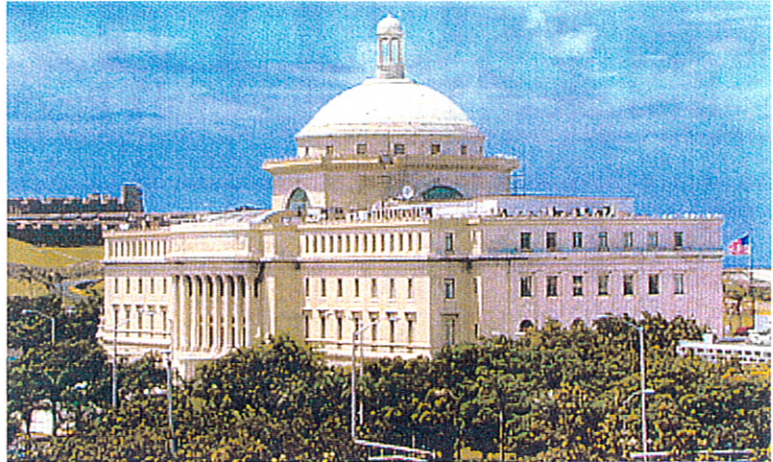
Puerto Rico's Capitol Building, or "El Capitolio," in San Juan, was completed and inaugurated in 1929. A major port city, San Juan faces the Atlantic Ocean to the north. This marine environment was a major factor in the dangerous corrosion of the anchoring system of the building's terra-cotta cornice.

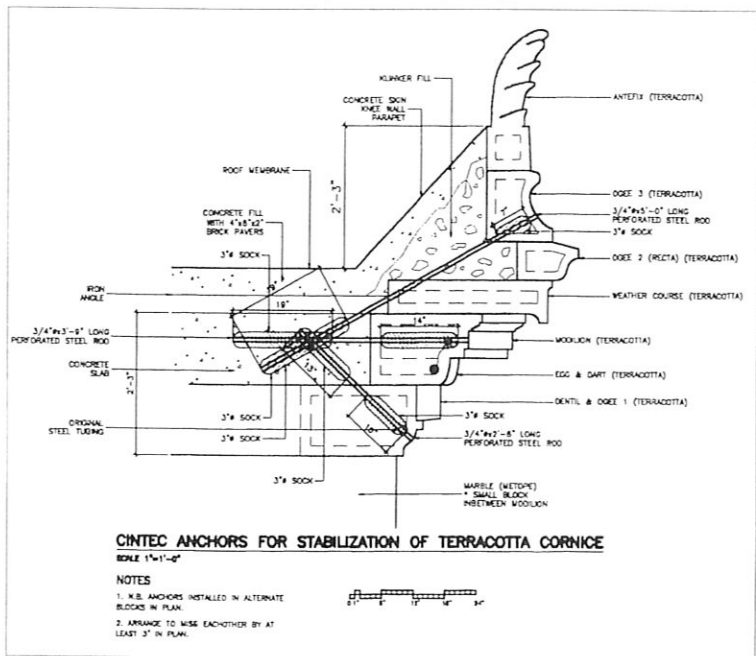
Most importantly, we disassembled approximately 6 feet of the cornice to reveal its construction and its anchoring system. We also exposed a portion of the parapet decking to determine the condition of the underlying concrete substructure. In collaboration with the architect and Martin Weaver, a new anchoring system was designed. We also worked with the noted terra-cotta manufacturer, Gladding, McBean, to determine which sections of terra cotta would need to be replicated.

Water had penetrated down into the cornice, and all its steel structural supports and anchors had been totally destroyed by corrosion. The total failure of the structural-support steel and anchor system had led to the structural failure of the cantilevered, and now unreinforced, terra-cotta cornice. The only reason that it had not collapsed was a combination of the cohesive and frictional effects of the mortar and brick fragments used as back-up to the hollow terra-cotta units.

Moisture had entered via open joints and cracks and, to a lesser extent, through leaks in the roof above and behind the cornice. The reason for the extreme corrosion of the steel was a combination of chlorides from sea spray and the sulfuric acid formed when saline moisture saturated and then passed through the contaminated cindercrete. The corrosion had been so severe that it was no longer possible to establish the exact dimensions of any of the former steel elements. Some had disappeared totally, leaving only rusty stains in the terra-cotta work.

The dismantled corners should be rebuilt using AISI Type 316, non-corroding stainless-steel rods in a grout-injection anchor system by CINTEC, specially designed with small injection tubes positioned in the joints between the terra-cotta units for inflation with grout after assembly.

Undamaged areas of terra cotta may be stabilized in-situ by means of a different type of CINTEC grout-injection anchor system, also using AISI Type 316 stainless-steel rods. It will be necessary to open up a series of areas in the terra-cotta work at random locations to determine if, in fact, the apparently undamaged terra cotta can be safely stabilized in this way.
