‘Stitching up’ the past – The strengthening of three heritage marine structures in Jersey with needling technology

The three structures are the North Pier and South Pier of St. Aubin’s Harbour and the St. Aubin’s Fort Breakwater. Both structures are exposed to waves from the south west and act as breakwaters. Both structures have suffered ongoing failures or unacceptable movements during the past decades, on the inner sheltered side of the breakwaters.

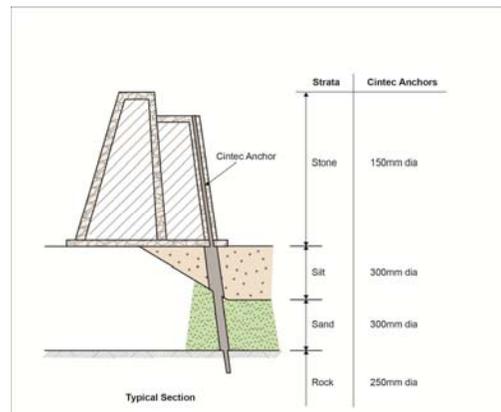
Another design philosophy applied in the design of both structures repair works was that within the

weaker strata such as sand, this grout injected anchor/pile system expands, reducing the potential for buckling and increasing skin friction.

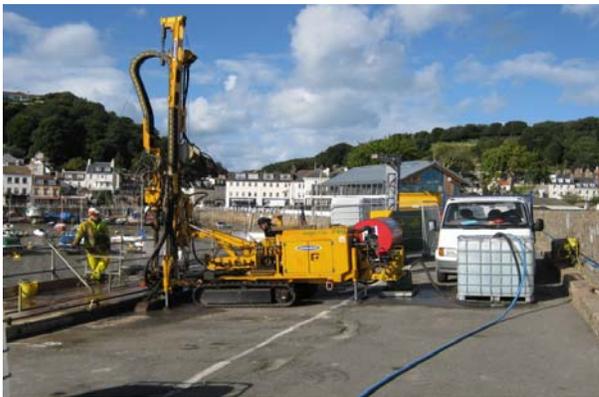
At the North Pier the vertical drilling works for the anchors took place through the inner wall concrete up-stand used for vessel mooring. Plugs in the masonry were reinserted to enable invisible fix (such as that shown in Figure 20) once the anchor had been installed. The supplier utilised standard 2.5m anchor lengths for both structures, coupled together to achieve vertical and horizontal lengths as required (Fig 15).

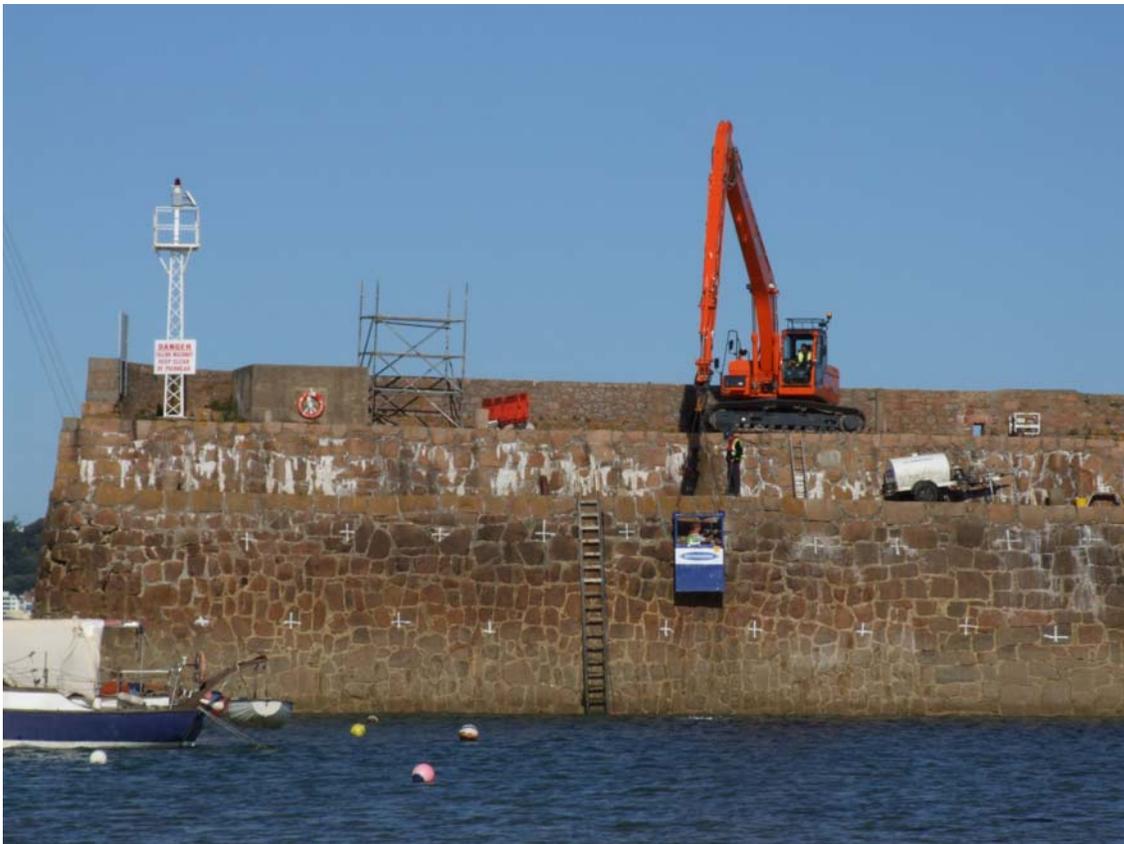
The 'stitching' method used to stabilise and strengthen these two marine heritage structures has proved to be effective on a number of fronts. The 'secret' or 'hidden' fix of the structure means that the heritage planning aspects of the strengthening works are achieved. The predicted wave pressure paths and loadings were analysed in an empirical way to maximise the effectiveness of the solution in areas of local maximum distress. Environmentally, the impact on the endangered mollusc species is now negligible and the risk of grout spillage is low. Economically, the costs budgeted for the original rebuilding of the inner wall of the North Pier on a new foundation, were of a similar magnitude to that for the 'stitching' techniques. There is a certainty with respect to the capacity of each anchor or mini pile as the drilling technique means that every element's bearing capacity is known and recorded. The technique therefore proved itself adaptable to the engineering judgements so necessary in this type of work; effective in terms of providing strengthening and repairs to threatened parts of heritage structures; and cost effective.
