Strengthening of the Charging Ramp Darby Furnace Coalbrookdale, UK

Synopsis

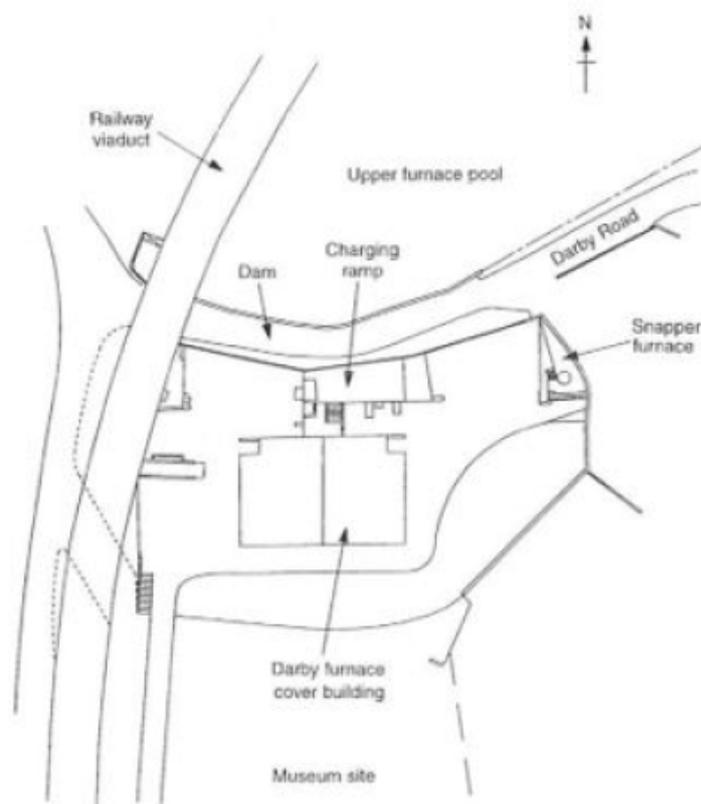
Fig 1. Present-day site plan

By 1827 the general line of the pool dam and the charging ramp area appear very similar to their present-day shape (Fig 1). The raised area to the east of the charging ramp proper is a late addition to the ramp itself which may have been present by the mid 18th century.
