## Windsor Castle - The Brunswick Tower

Report by Richard Swift

# WINDSOR CASTLE

## Structural Conservation and Monumental Disasters

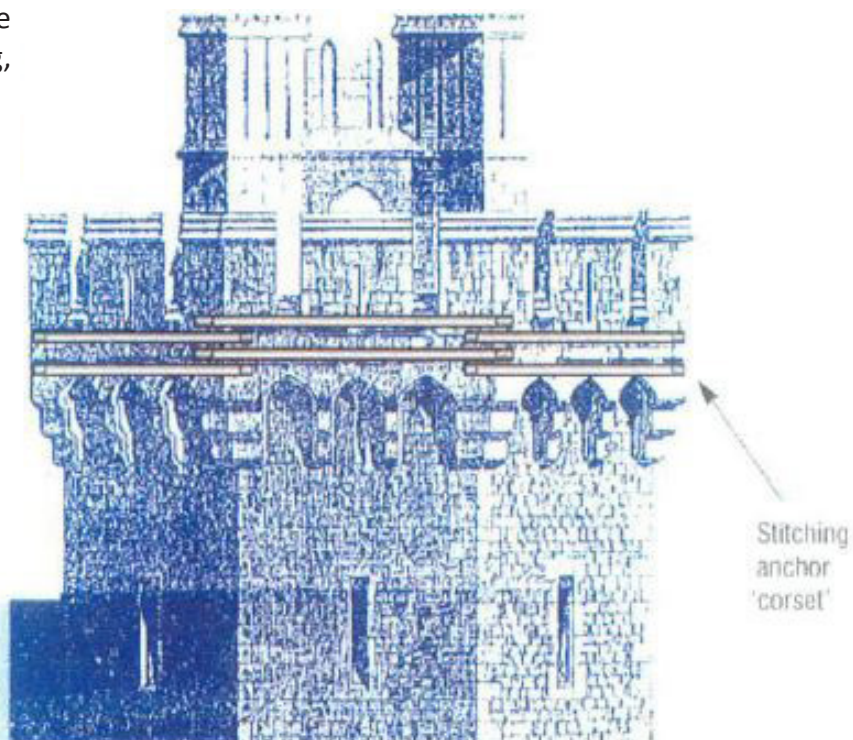
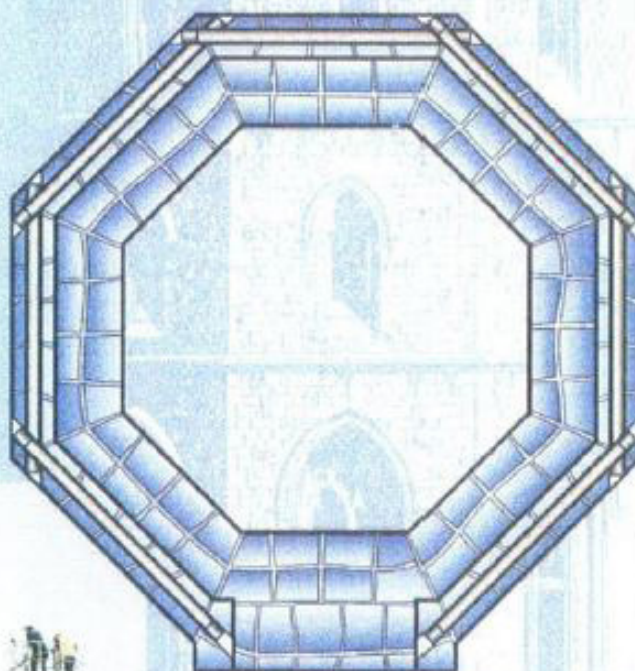
Windsor Castle - The Brunswick Tower The latest Diamond Drilling Techniques were used to create a network of holes within the stonework. The Cintec Anchors and reinforcement system were then installed creating a reinforcing ring, within the fabric of the stonework, maintaining the original appearance of the tower.
