# CONSERVING A TERRA-COTTA CORNICE

A treatment report by Conservation Solutions, Inc., on a terra-cotta cornice adorning the Capitol Building in San Juan, Puerto Rico, shows the potentially catastrophic effects of corrosion in a marine environment, and offers some innovative solutions to the problem.

by Joseph Sembrat, Head Conservator and President of Conservation Solutions, Inc.

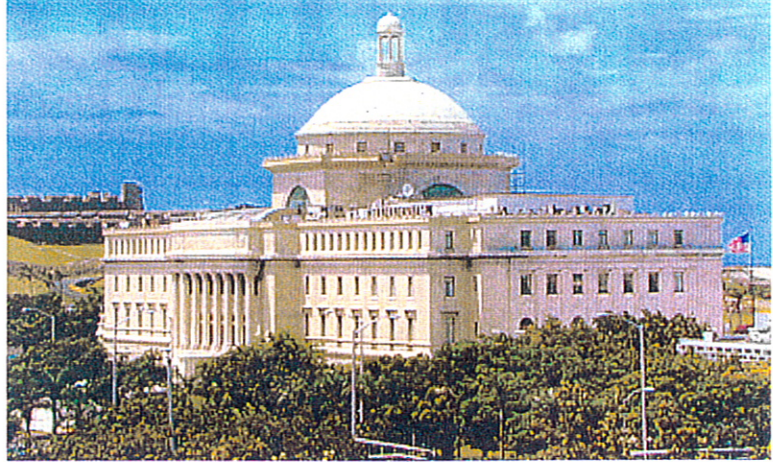
Puerto Rico's Capitol Building, or "El Capitolio," in San Juan, was completed and inaugurated in 1929. A major port city, San Juan faces the Atlantic Ocean to the north. This marine environment was a major factor in the dangerous corrosion of the anchoring system of the building's terra-cotta cornice.

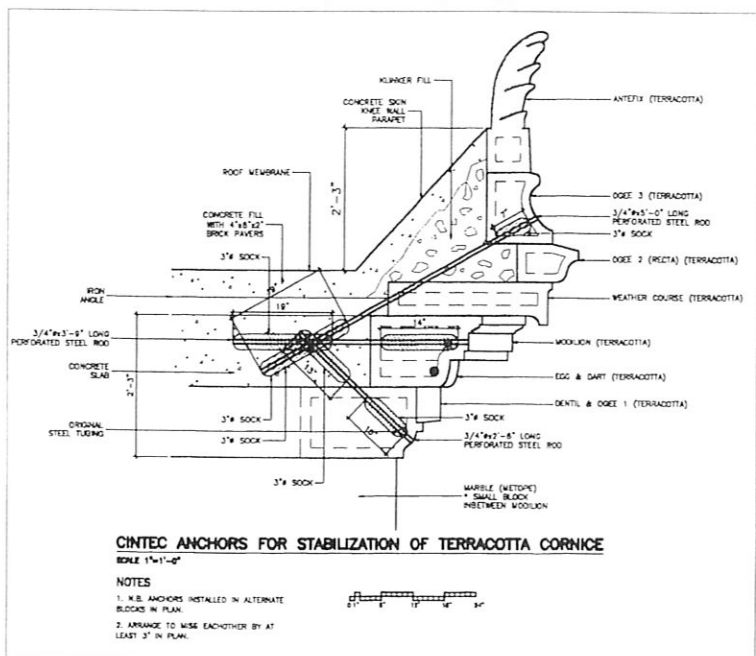
Water had penetrated down into the cornice, and all its steel structural supports and anchors had been totally destroyed by corrosion. The total failure of the structural-support steel and anchor system had led to the structural failure of the cantilevered, and now unreinforced, terra-cotta cornice. The only reason that it had not collapsed was a combination of the cohesive and frictional effects of the mortar and brick fragments used as back-up to the hollow terra-cotta units.

Moisture had entered via open joints and cracks and, to a lesser extent, through leaks in the roof above and behind the cornice. The reason for the extreme corrosion of the steel was a combination of chlorides from sea spray and the sulfuric acid formed when saline moisture saturated and then passed through the contaminated cindercrete. The corrosion had been so severe that it was no longer possible to establish the exact dimensions of any of the former steel elements. Some had disappeared totally, leaving only rusty stains in the terra-cotta work.

It should be noted that any corrosion of embedded steel is associated with massive expansion of the corrosion products. In the case of the Capitol Building, this expansion had resulted, and will continue to result, in the shattering of the immediately adjacent terra cotta. Thus, all stabilization, conservation, and restoration work must involve the removal of all corroding steel and/or the prevention of any further corrosion and associated expansive effects. All new steelwork must be AISI Type 316 stainless steel, which is non-corroding in the chloride-rich maritime environment present here. AISI Type 304 stainless steel is attacked by chlorides and cannot be used here under any circumstances because it will corrode.

The dismantled corners should be rebuilt using AISI Type 316, non-corroding stainless-steel rods in a grout-injection anchor system by CINTEC, specially designed with small injection tubes positioned in the joints between the terra-cotta units for inflation with grout after assembly.

Undamaged areas of terra cotta may be stabilized in-situ by means of a different type of CINTEC grout-injection anchor system, also using AISI Type 316 stainless-steel rods. It will be necessary to open up a series of areas in the terra-cotta work at random locations to determine if, in fact, the apparently undamaged terra cotta can be safely stabilized in this way.
