Cintec, working with North American Architects, Engineers, Preservation Consultants and Contractors to provide specialized fixings for Terra Cotta repairs and re-attachment.

#### A SELECTION OF TYPICAL ANCHORING DETAILS FOR TERRA-COTTA

### Inside Detail on Terra Cotta Repairs and Stabilization

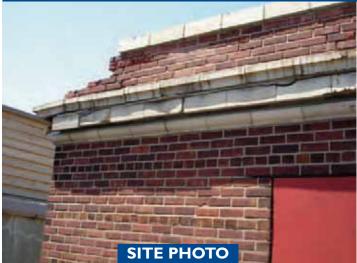
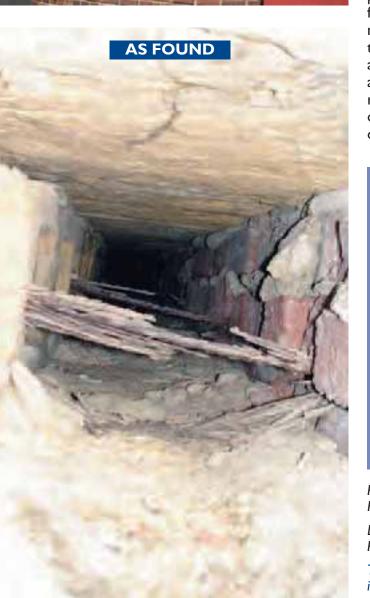
Over time the steel hangers that hold back the terra cotta corrode. When this happens you have the potential for sections, or pieces, of the terra cotta to fall off the structure. The challenge is how to secure the new pieces to the existing facade, or how to stabilize the existing. Cintec has designed a stainless steel anchoring system that is compatible with the terra cotta and the substrate. The system has a 2 hour plus fire rating and can be installed to be invisible. There is no other anchor system, in the world, that offers this level of design flexibility.

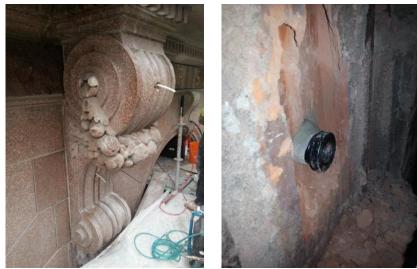
The photo shows the anchor extending through the plate girder and past the attached terra cotta. The inflated anchors is 3.5" in diameter extending out of a 2.5" hole. The picture below shows this wall condition. This attachment approach secures the scrolls directly to the plate girder with a nut and washer which is recessed into

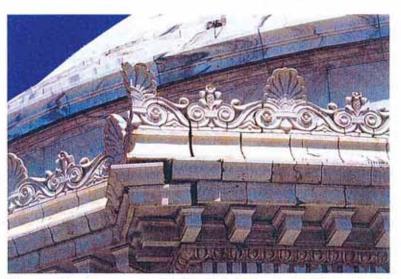
The poor condition of the terra-cotta cornice is evident in this view. The separation of the terra-cotta units is due to not only the failure of the anchoring system, but also the expansion of the corroded material.
