**CINTEC**

**TERRA COTTA SOLUTIONS**

***Cintec, working with North American Architects, Engineers, Preservation Consultants and Contractors to provide specialized fixings for Terra Cotta repairs and re-attachment.***

## **A SELECTION OF TYPICAL ANCHORING DETAILS FOR TERRA-COTTA**

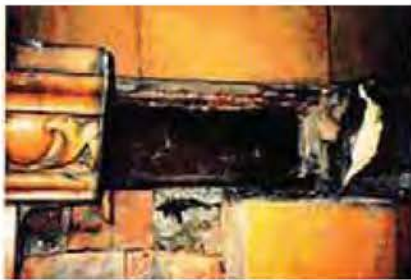
Example of steel beam corrosion causing failure of the decorative terra cotta facade.

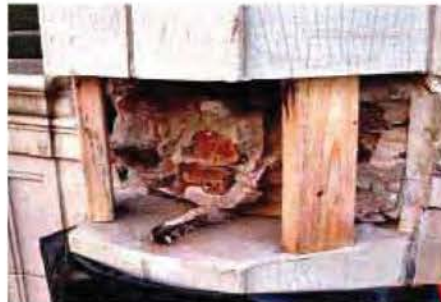
Corroded restraint fixing.

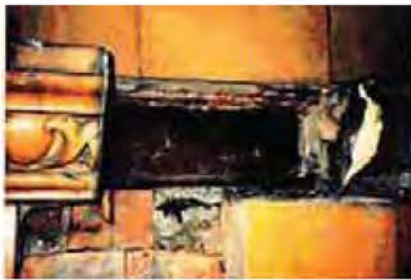
Example of steel beam corrosion causing failure of the decorative terra cotta facade.

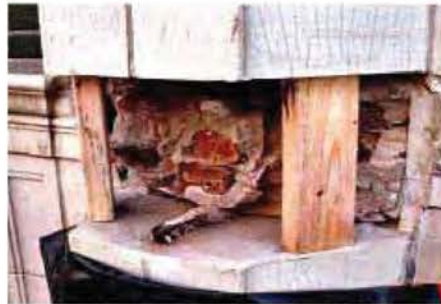
Corroded restraint fixing.

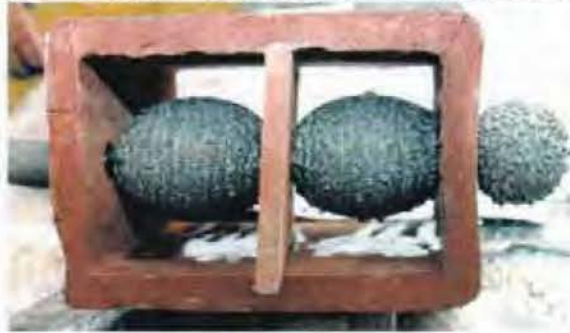
The Cintec anchor is inserted into a predrilled hole.

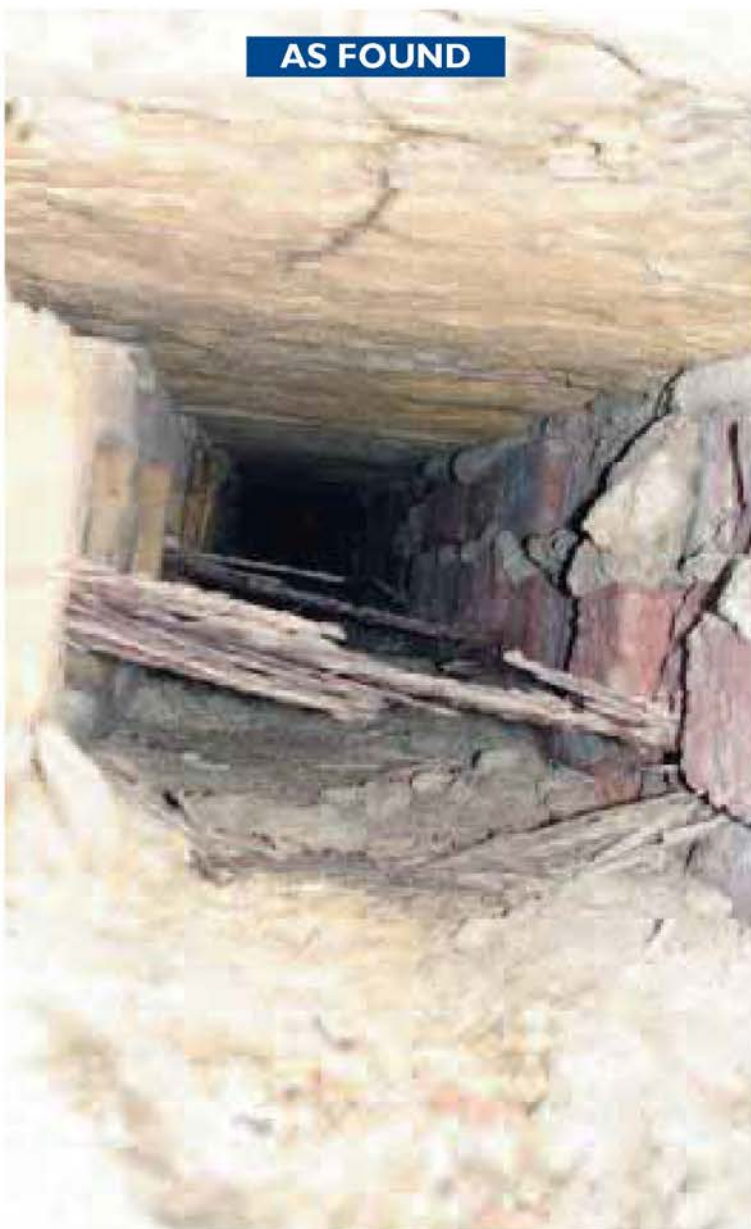
**AS FOUND**

Over time the steel hangers that hold back the terra cotta corrode. When this happens you have the potential for sections, or pieces, of the terra cotta to fall off the structure. The challenge is how to secure the new pieces to the existing facade, or how to stabilize the existing. Cintec has designed a stainless steel anchoring system that is compatible with the terra cotta and the substrate. The system has a 2 hour plus fire rating and can be installed to be invisible. There is no other anchor system, in the world, that offers this level of design flexibility.

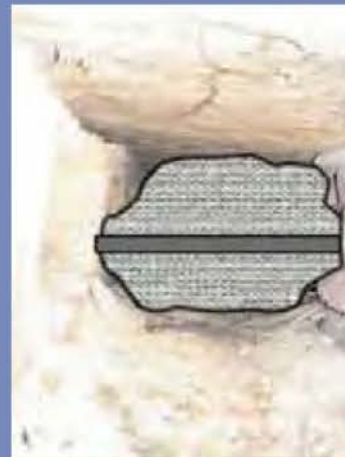
**PROPOSAL FOR STABILIZATION**

*Proposed terra cotta design retrofit of the Union Station Power House in Kansas City, Missouri.*

*Typical anchor detail Cintec M16 5/8th" Dia body 3" Dia sock set into 1 1/2" Dia hole subject to field conditions and requirements.*

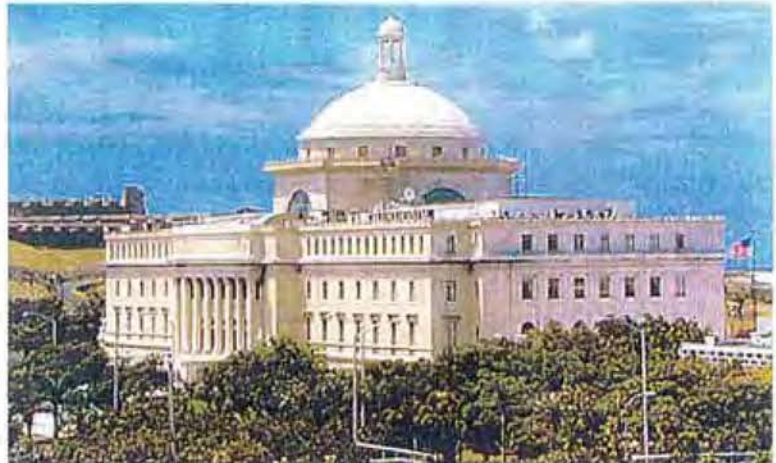
Puerto Rico's Capitol Building, or "El Capitolio," in San Juan, was completed and inaugurated in 1929. A major port city, San Juan faces the Atlantic Ocean to the north. This marine environment was a major factor in the dangerous corrosion of the anchoring system of the building's terra-cotta cornice.

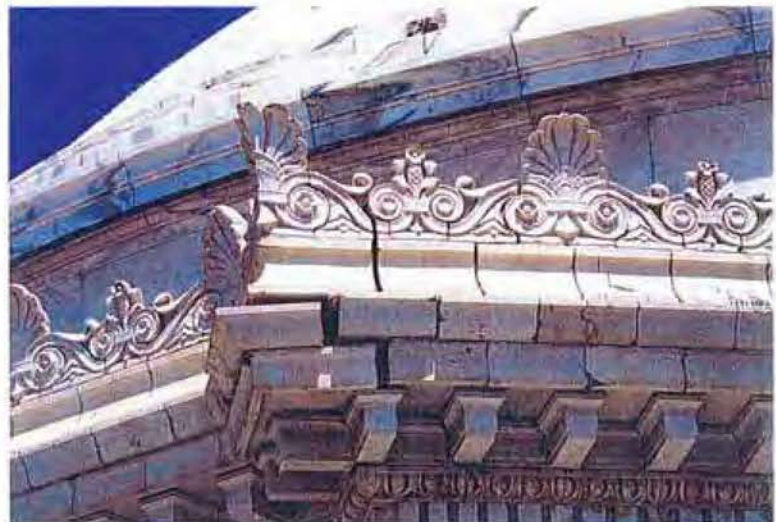
The poor condition of the terra-cotta cornice is evident in this view. The separation of the terra-cotta units is due to not only the failure of the anchoring system, but also the expansion of the corroded material.

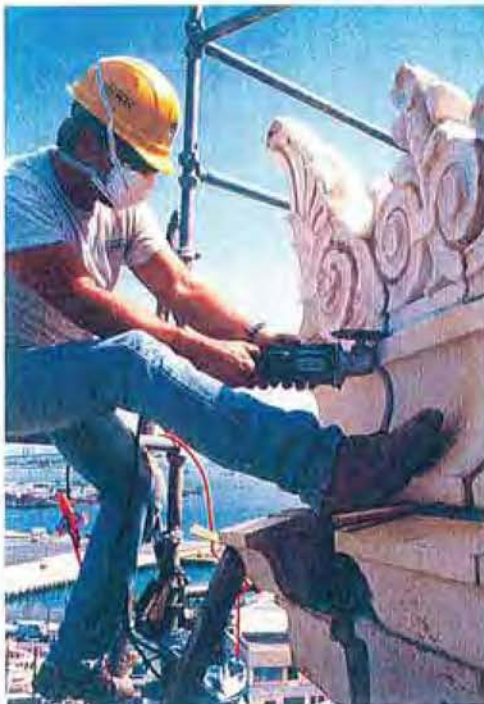
A worker is seen here cutting the mortar joints between the terra-cotta blocks in preparation for the disassembly of the cornice.

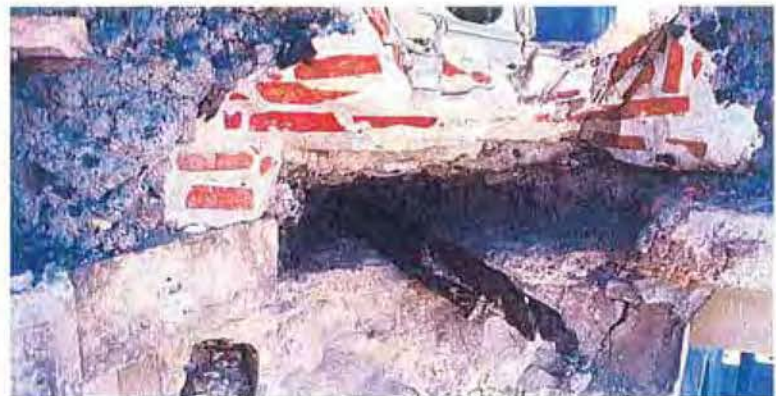
Once the cornice had been partially disassembled, the materials and techniques used in its construction could be easily identified. Note the clinker concrete, or "cindercrete," between the terra-cotta blocks and the brick backup material, and the severe deterioration of the steel supports. CSI recommended that all new steelwork be AISI Type 316 stainless steel, a non-corroding type, which is essential in this chloride-rich maritime environment.

As the careful cutting away commenced at the cornice's upper level, we found that the cornice was backed-up by a mass of "clinker concrete" or "cindercrete." This material is based on an aggregate of furnace ash and large fragments of clinker. Its use has been suspended for many years because the large quantities of sulfur compounds present in the ash and clinker have been found to cause severe corrosion of adjacent steel in the presence of moisture.

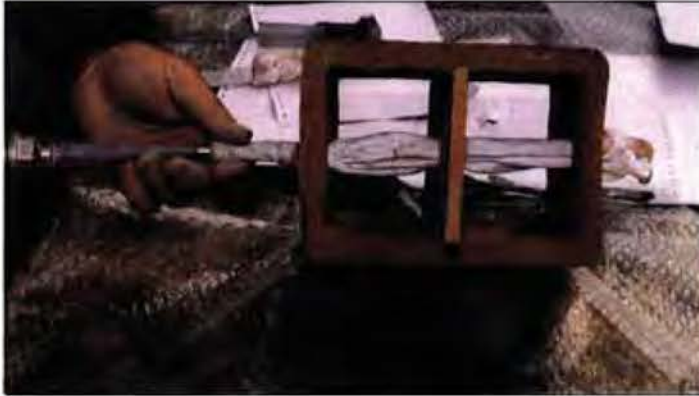
THE CINTEC ANCHOR IS INSERTED INTO A PREDRILLED HOLE.

L'ANCRE CINTEC EST INSÉRÉE DANS UN TROU PRÉ-PERFORÉ.

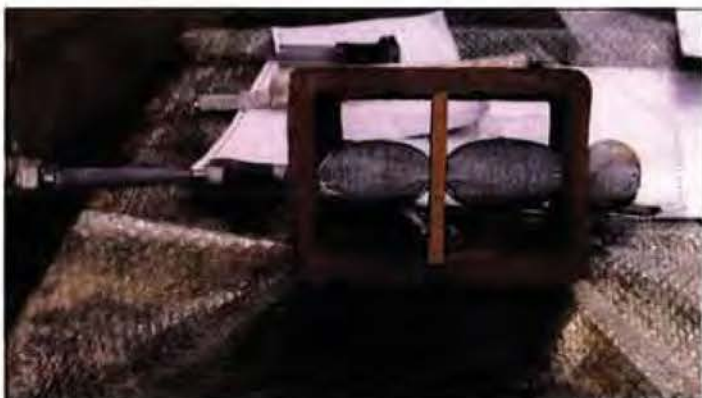
EL EQUIPO DE INYECCIÓN ES FIJADO AL ANCLA Y COMIENZA A INFLARSE A UNA PRESIÓN DE 42 P.S.I.

GROUT IS PUMPED INTO THE HOLLOW STEEL SECTION WHICH FLOWS INTO THE SOCKED AREA VIA A NUMBER OF FLOODED HOLES.

LE MORTIER EST POMPÉ DANS LE TUBE D'ACIER ET S'INFILTRE DANS LA GAINÉ PAR DE NONBREUSES OUVERTURES D'ÉCOULEMENT.

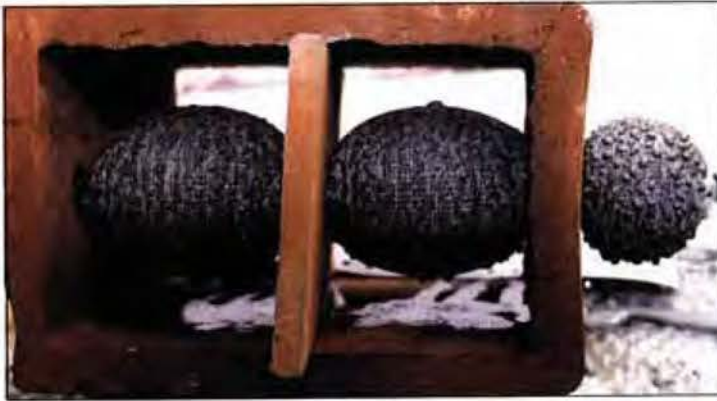
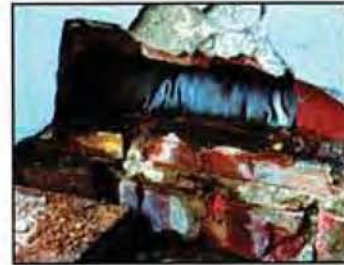
EN REMPLISSANT L'ANCRE, LA LAITANCE DU MORTIER PÉNÈTRE LA GAINE ET FORME UNE LIAISON CHIMIQUE ENTRE L'ANCRE ET LE MATÉRIAU SUPPORT.

AFTER APPROXIMATELY 15 SECONDS THE ANCHOR IS TOTALLY INFLATED WITH A MICRO FINE CONCRETE GROUT GIVING A MECHANICAL FIXING. IN ADDITION, THE GROUT MILK HAS PASSED THROUGH THE SOCK FORMING A CHEMICAL BOND TO THE SUBSTRATE.

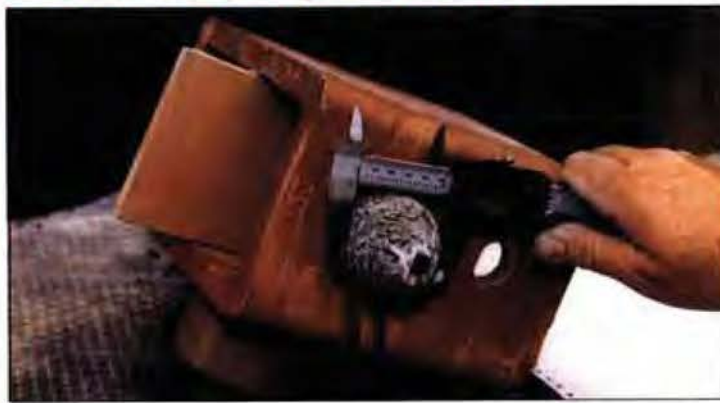
**DOUBLE FIXING CAPACITY.  
LA CAPACITÉ D'ANCRAGE EST DOUBLÉE.  
DOBLE CAPACIDAD DE FIJACION!!!**

IN TESTS CARRIED OUT BY AN INDEPENDENT LABORATORY ON A BUILDING OF SIMILAR MATERIAL, AXIAL PULL RESULTS IN EXCESS OF 3000 LBS. WERE ACHIEVED.

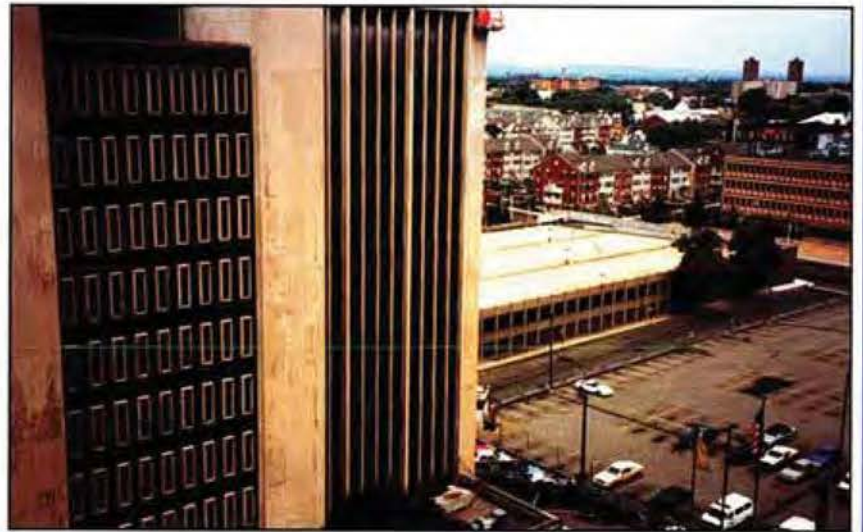
THIS DESIGNED ANCHOR SYSTEM WAS USED IN THE ESSEX COUNTY NEW COURT HOUSE & JAIL NEWARK, NEW JERSEY, USA. FOR FURTHER INFORMATION CONTACT OUR TECHNICAL DEPARTMENT.
