CINTEC

strengthening, repair and stabilization of high-rise buildings

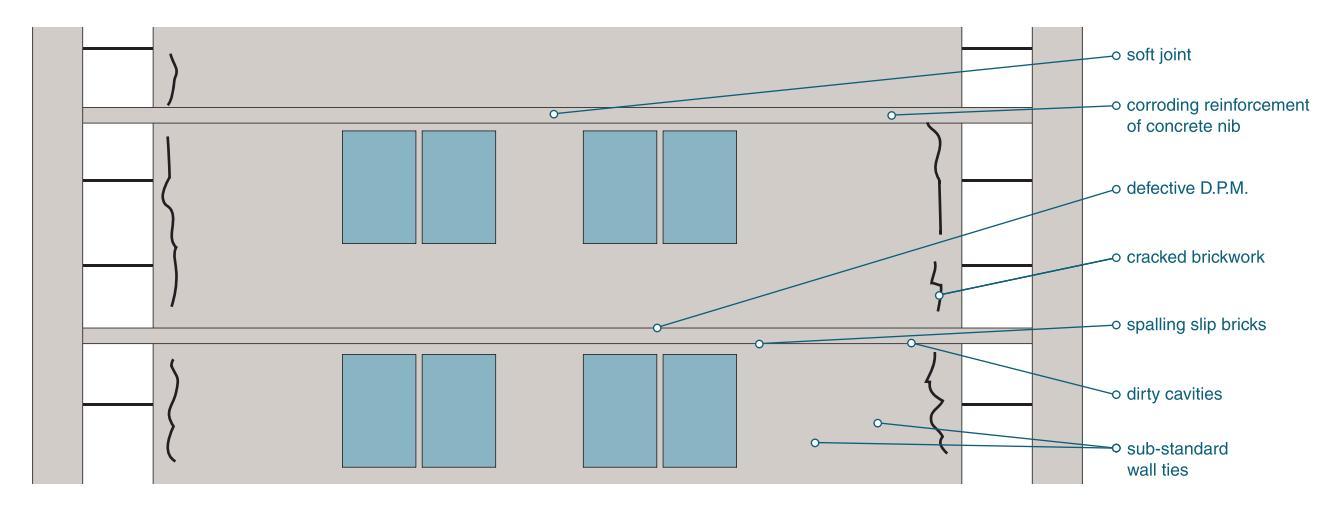
Observed defects on gable panel

Every block revealed a variety of problems. The number of wall ties required by the original drawings were not always present, particularly to the side of the windows. The galvanised steel ties were nearing the end of their useful life. Overall, wall ties were found to be skewed, deformed, off level, rusting, mismatched between dovetail and slot or inadequately anchored. Many of the panels were consequently deemed to be sub-standard and ineffective, even to the earlier lower requirements and standards for both quality and quantity.

Problems with gables were numerous: the dovetailed bronze ties were present in irregular quantities, but the tail was sometimes deformed or the tie mismatched with the slot. "L-shaped" galvanised mild steel ties from previous repairs were found to be sub-standard.

Brickwork was showing evidence of stress: corners developed vertical cracks, gable brickwork seating was inadequate, slip bricks were debonded from nib bricks spalled above and below nib levels, damp-proof course had squeezed out, pointing had eroded, cavities were dirty. External concrete elements, incuding floor slab nibs and balconies were problematic: reinforcement was very close to the surface and local rusting, there was minor stress cracking, the face of nibs were palling from the gables at corners, balustrade posts were corroding where inserted into the balcony; and patches on balcony soffit were loose or missing. Chloride ion levels were found to be low and carbonation depths were very variable.

Frame shortening had transferred undue loads to the brickwork which were now showing signs of distress. The projecting 'nib' at the edge of each floor slab, supported a storey-height panel of outer leaf brickwork. At certain locations, the continuing structural support from this nib to the panel of brick above was in doubt.

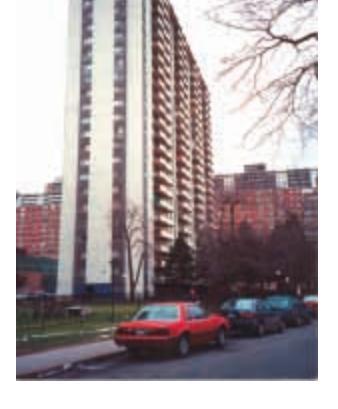
> > > 5/16" dia (8mm) RAC stitching anchor to secure the cracked through brick tie

1 3/16" (30mm) corbel anchor to transfer the load of the external wall to the inner leaf

3 two stage RWT 5/8" dia (15mm) anchor secured into the floor slab under the inner leaf overhang

Deterioration was caused by a shortening of the structural frame. Lack of soft joints below the shelf angles to accommodate movement resulted in bowing of walls and crushing of over-stressed units, as well as rotation of shelf angles. Corrosion deterioration had also occurred in the shelf angles and connecting bolts.

Repair was accomplished with two strategies: Cintec Corbel Anchors were installed to transfer vertical loads from the exterior walls to the back-up walls, and Cintec stitching anchors were installed to restore broken header ties.

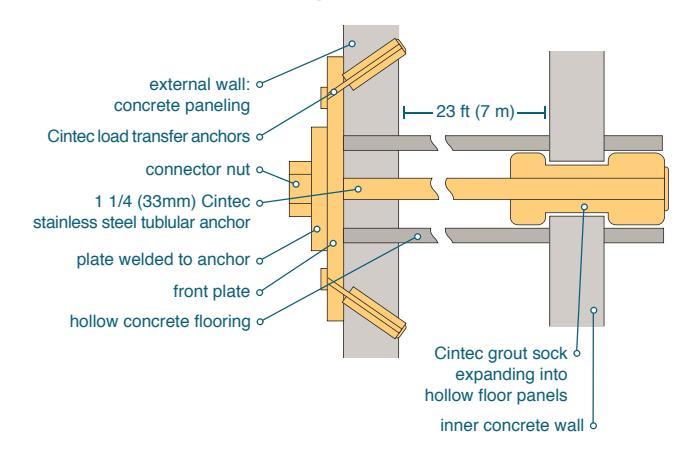
Cintec anchoring detail

Cintec Anchors provided a solution which fixed the external panels to one another and also to an inner wall via the insulation cavity of the hollow concrete flooring. The anchor ensemble was held together by a plate welded to the external end of the tubular anchor. The inner end of the anchor was locked to the internal wall, and provided the strong mechanical bond achieved in testing.

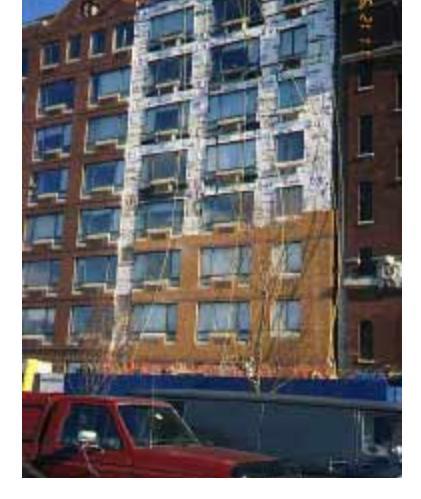
section at wall intersection

This luxury condominium had only recently been completed when it was discovered that a gradual separation was developing between the 8 inch (203mm) concrete plank flooring and the vertical walls upon which they rested. The threat of demolishment was very real. A solution, however, was found by the installation of 709 Cintec Anchors to maintain the building's structural integrity. Drilled into the concrete flooring, each anchor was fitted with a 16 x 3.3 inch (400 x 83mm) front plate attachment. This locked the flooring back against the supporting wall. Outer brick-work was then replaced to fully conceal the work.
