Introduction to the Cintec Anchoring & Reinforcement System Non Destructive Test Procedure. Client Reports from International Testing Establishments with relevent standards.

# TEST DATA FOR CINTEC ANCHORS

# CINTEC'S ANCHORING AND REINFORCEMENT SYSTEM

Moisture/Temperature cycling tests On the Cintec remedial wall tie

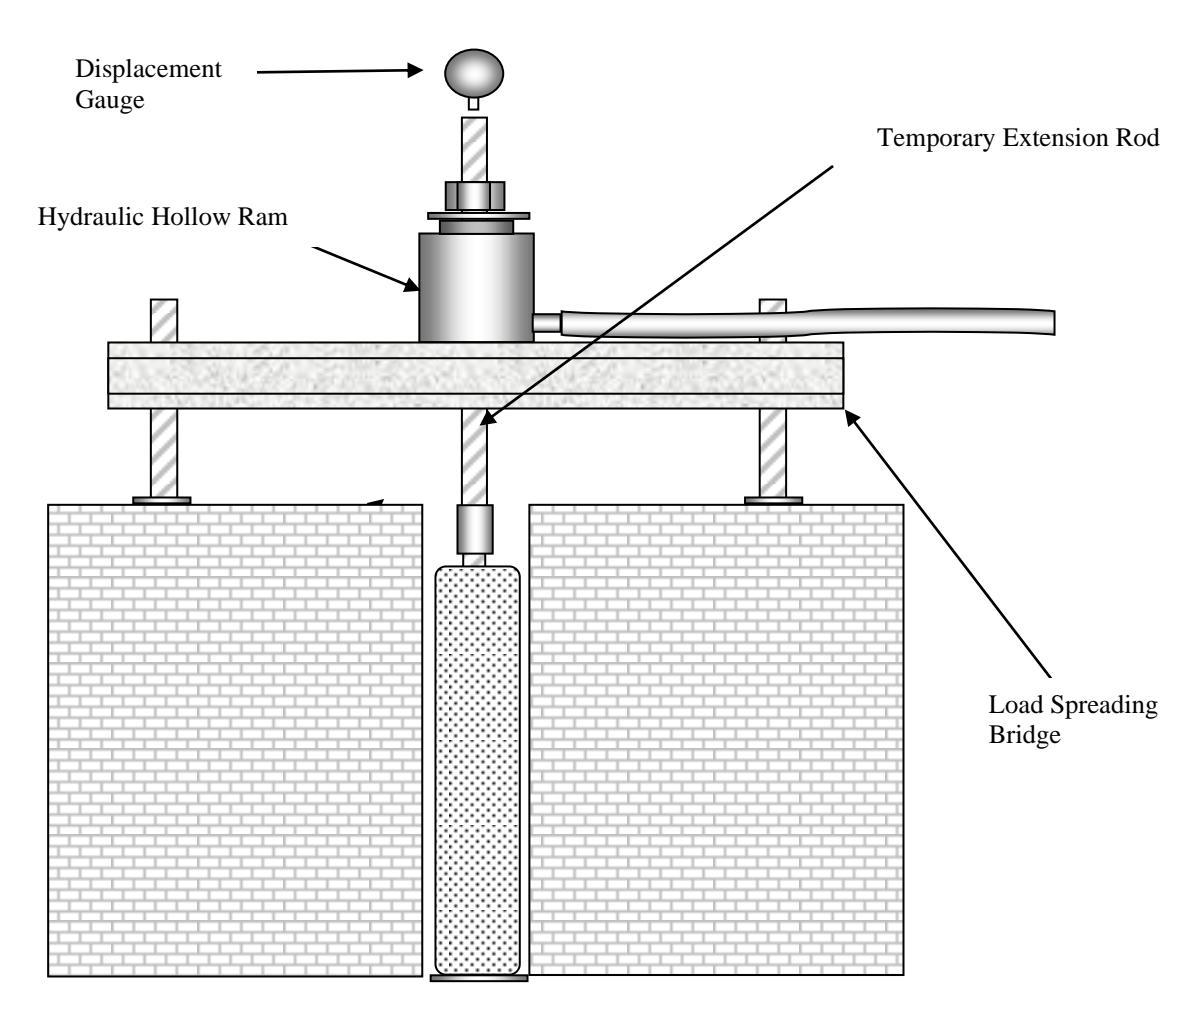
Install Cintec anchor and allow to cure for seven days, attach test rig as shown above and apply a 20kn load to settle the rig.

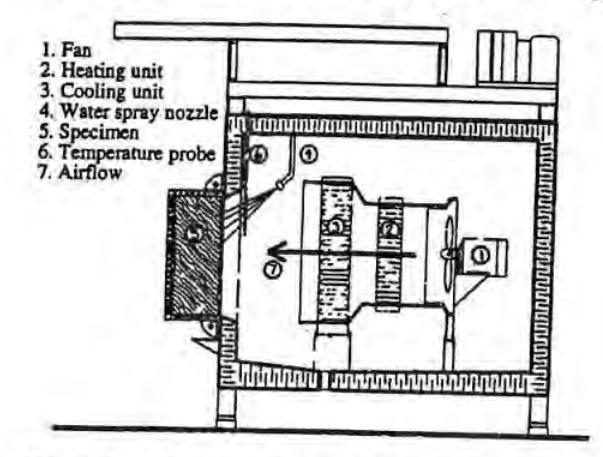
Figure 1 Schematic of Test Apparatus

The uni-directional freeze-thaw apparatus is capable of generating a cold stream of air within the chamber to lower the temperature of the face of the specimen to -15°C. This temperature is reached within one hour of the beginning of the test. The initial freeze cycle is six hours in duration to fully freeze the specimen. Thawing at the end of each cycle is achieved by blowing a stream of warm air against the face of the test panel for twenty minutes, followed by spraying a two minute flood-coat of 25°C water which re-saturates the face of the specimen and starts the next cycle. After the initial cycle each subsequent freeze period is 120 minutes in duration.

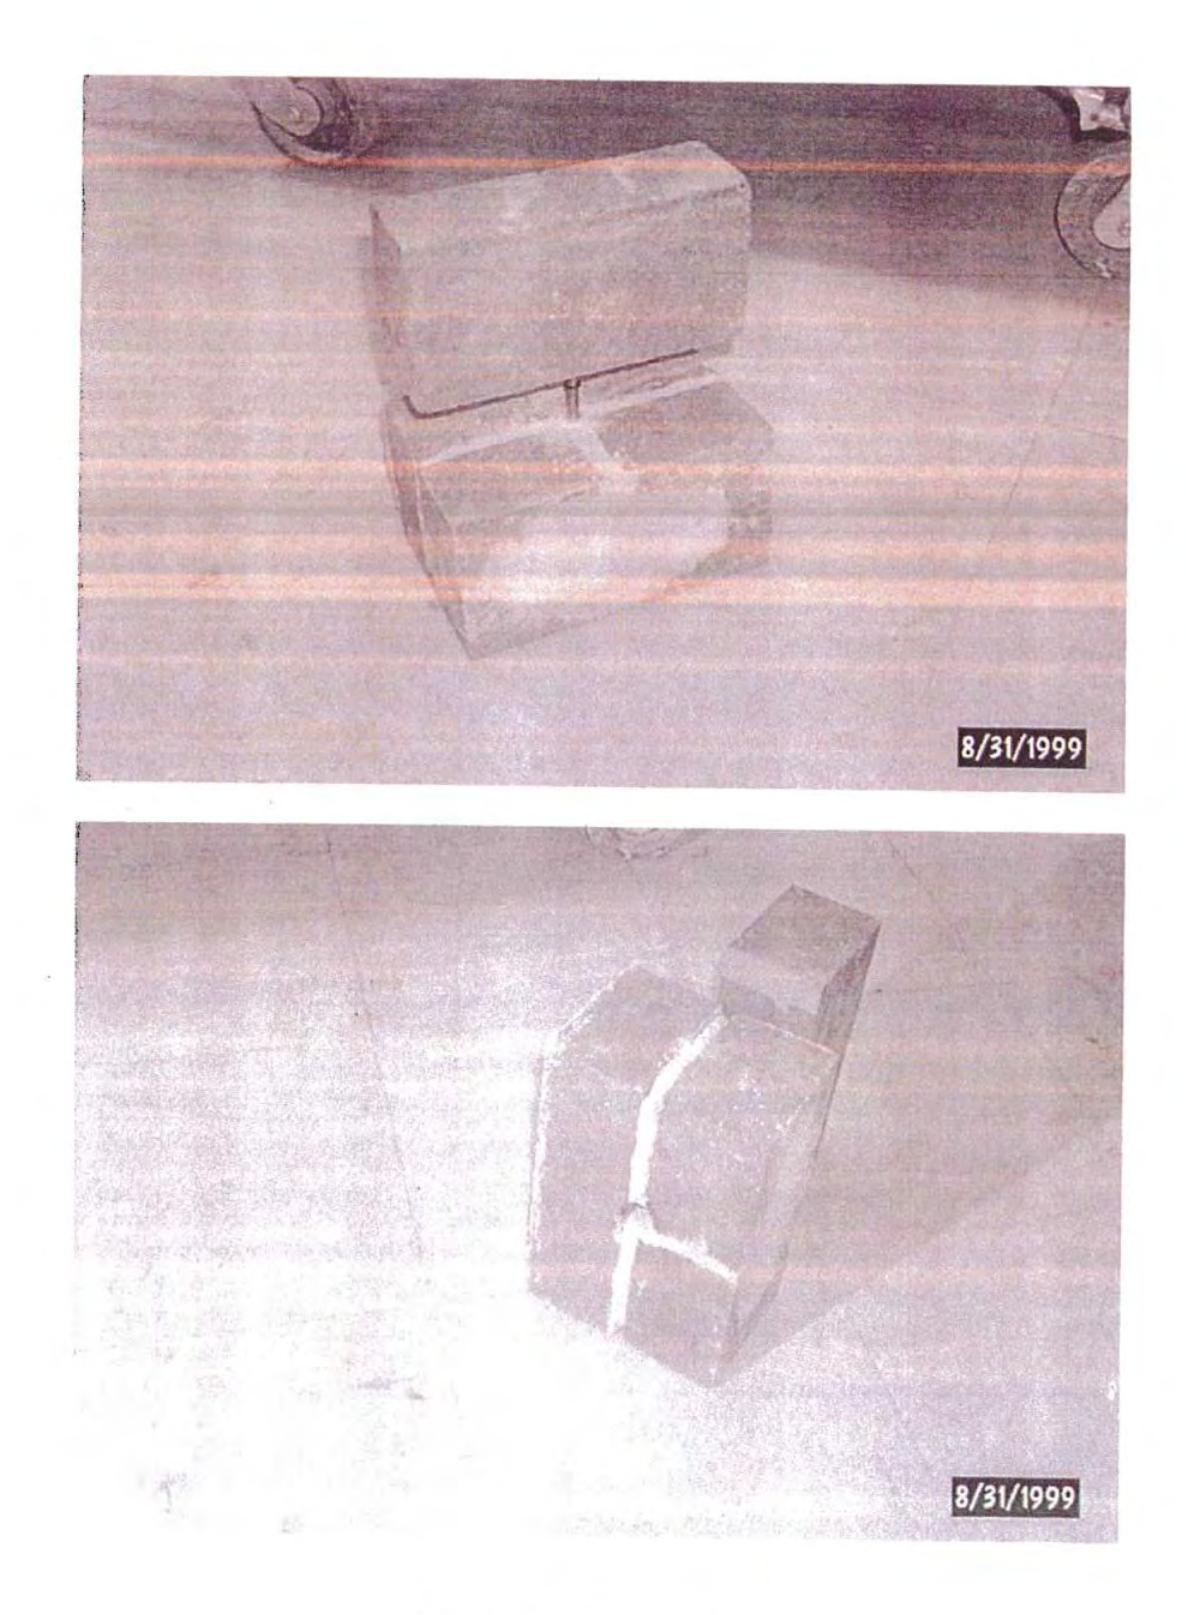
FIGURE 1. Test Specimen

Manufacturer:	CLS Cintec Australasia Pty Ltd
	P.O. Box 141
	Newcastle NSW 2300
Job Number:	A/156 - 1999
Description:	Type A cavity remedial wall ties, described by the manufacturer as a "Cintec Remedial Cavity Wall Ties". The wall ties are 215 mm long, 8 mm diameter and are made of stainless steel grade 3.16. The ties are installed by drilling through the joint of the brick couplet (full brick plus two half bricks) and inserted into the full brick (in joint - brick connection) with a cavity of 50 mm, as shown in Figure 1. The drill hole size was 18 mm.
Test Description:	The wall ties were evaluated using the performance requirements of Draft Australian / New Zealand Standard DR 97300-97302 (revision of AS 2699-1984) - Appendix A: Method for determination of characteristic strength and characteristic stiffness of type A ties and the Amendment No. 1 to AS3700 - 1998.
Test Date:	September, 1999.
Classification:	The ties are classified as type A, Heavy Duty cavity ties for a cavity width of 50 mm and in joint - brick connection.

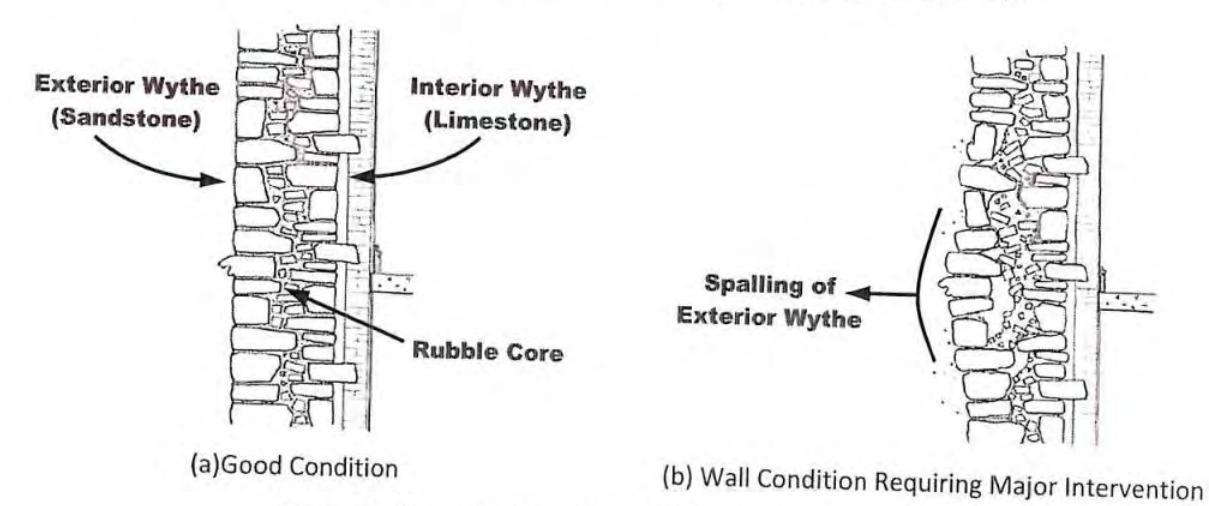
Figure 2 – West Block Structure Wall Details and Conditions

of the building to harsh Canadian weather has caused the outer wythe to separate from the rubble core at several locations on the structure. The separation is shown in Figure 2(b) and the severity of this deterioration was further evaluated by PWGSC with an additional survey in 2005. A summary of the results from this survey are shown in Figure 3.

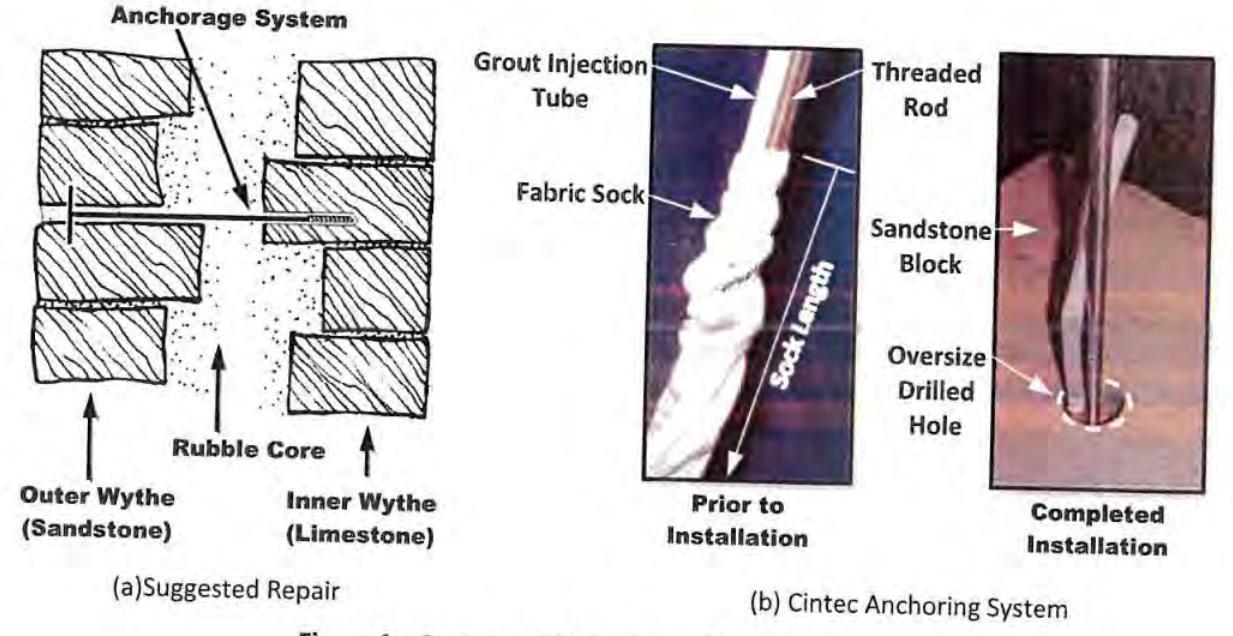
Figure 4 – Outer Wythe Reparation Scheme and Details

As shown in Figure 4(a), the separation of the wall segments can be repaired or prevented by anchoring the outer wythe (sandstone) to the inner wythe (limestone). This strengthening technique requires the insertion of anchors, and therefore foreign materials, within the stonework. These materials should be chosen with care to prevent any detrimental impact on the stonework. Many researchers (Benedetti and Castoldi 1982, Benedetti and Pezzoli 1996, Tomazevic et al. 1993, Tomazevic et al. 1996) have conducted experimental investigations on the use of steel ties to strengthen heritage stone masonry structures. Although steel ties are susceptible to corrosion, most rehabilitation techniques are designed to limit moisture uptake and protect the anchorage system from detrimental weathering conditions. Research from Binda et al. (1997) and Tomazevic (1999) has also suggested that the use of grout to secure the ties in anchorage systems improves

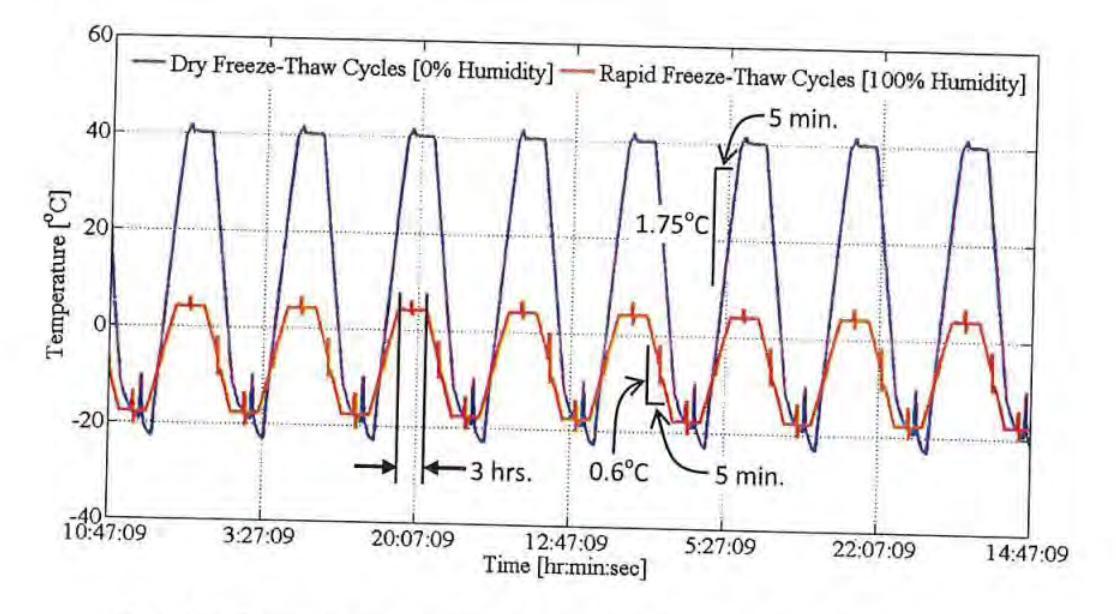
Figure 5 – Temperature Fluctuation during Conditioning: Chamber Records

during conditioning. The extremes of temperature were maintained for 3 hours with a ramping of 1.75°C every 5 minutes. The temperature variation for these dry freeze-thaw cycles is illustrated in Figure 5 over the course of approximately 4 days.

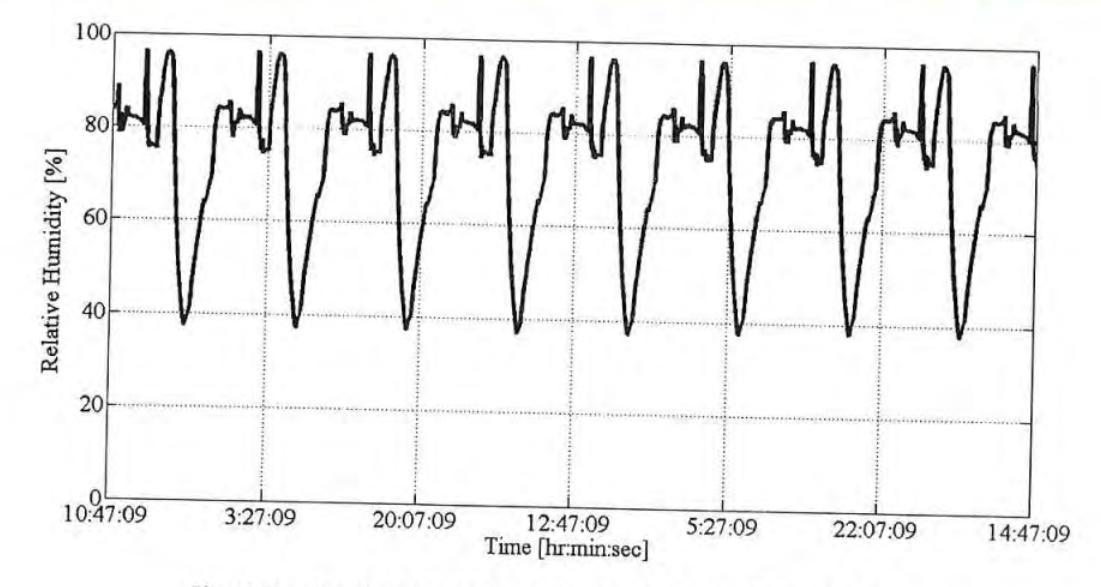
Figure 6 – Relative Humidity during Rapid Freeze-Thaw Cycles

The second conditioning scheme consisted of subjecting five of the samples for each of the 75mm, 150mm and 200mm sock lengths considered to a total of 150 thermal cycles ranging from -18°C to 4°C. The conditioning was performed in accordance with ASTM C666/C666M (2003), which required a relative humidity of 100% to be maintained during each cycle. As indicated in Figure 5, the extremes of temperature were also maintained during 3 hours with a ramping of 0.6°C every 5 minutes. The relative humidity for this conditioning scheme is shown in Figure 6 and indicates that it is difficult to maintain a level of 100% during each cycle. This slight discrepancy arises from the fact that temperature is generated by convection using large fans that circulate air from the back of the chamber. This flow of air creates a temporary state of drying during the ramping stages of the cycles when the temperature increases from -18°C to 4°C. There are also some fluctuations at -18°C that arise from the chamber defrosting stages. Nevertheless, the chamber was able to maintain an average relative humidity of 80% during most of the cycle durations.

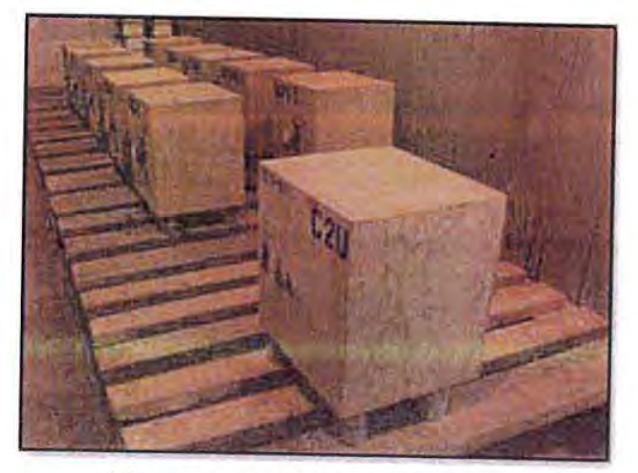
(a) Dry Freeze-Thaw Cycle Chamber

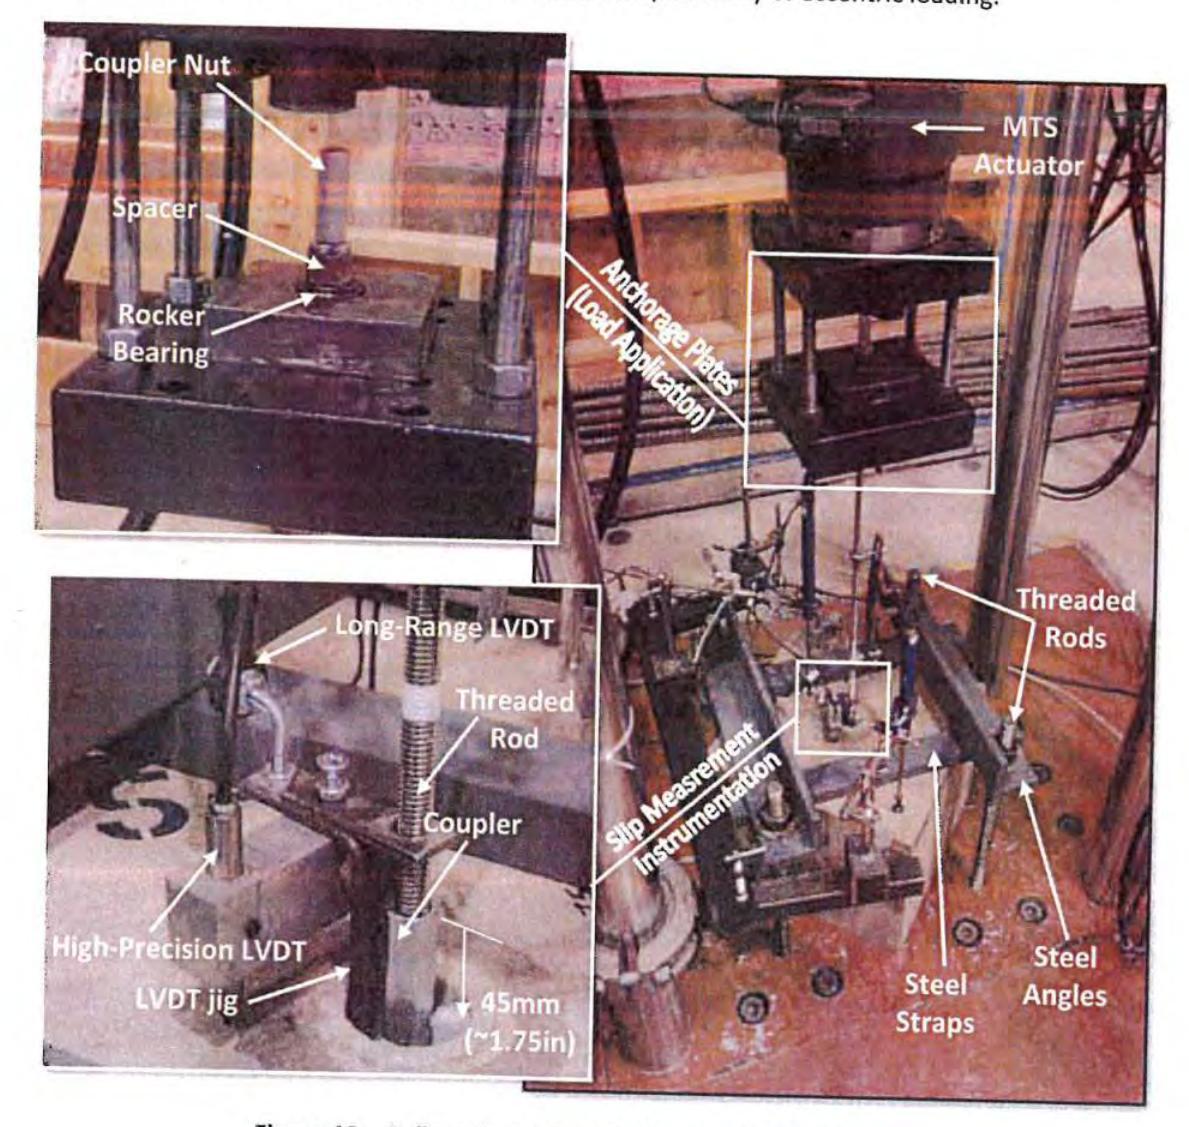
Figure 10 - Pullout Test Setup: 1000kN MTS Machine

firmly attached to the strong floor with four threaded bars, two steel angles as well as two steel straps. A picture outlining the details of the test setup can be found in Figure 10. The figure also shows that a 45mm (~1.75in) long coupler was used to extend the threaded rod stub extruding from the stonework to the anchorage plates for loading. The stub was extended using the same portion of the threaded rod that was removed during sectioning. The figure also shows that the jig supporting the LVDT sensors was secured below the coupler to minimize external sources of displacement. Finally, a rocker bearing was inserted for load application in order to accommodate the possibility of eccentric loading.

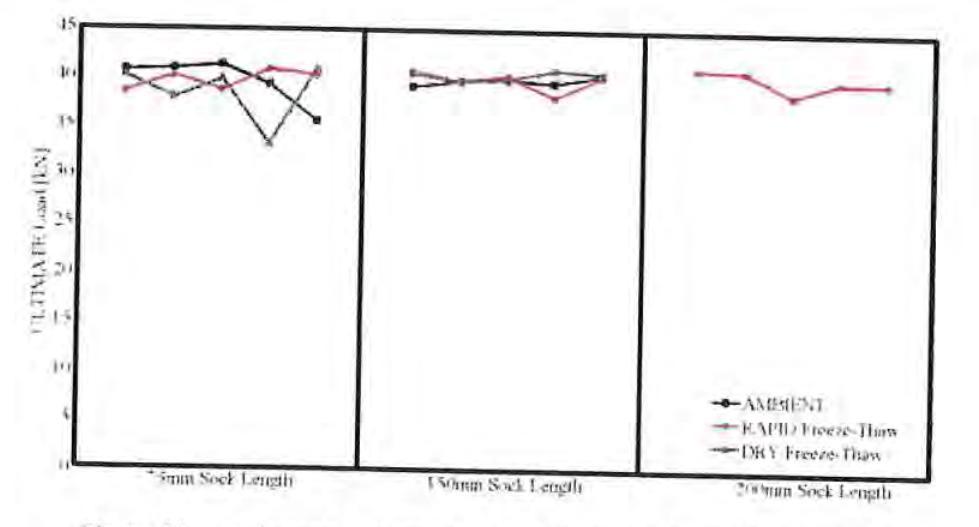
Figure 11 – Anchorage System Capacity in Ohio Sandstone (All Samples)

Results in this figure do not show sufficient evidence to conclude that rapid freeze-thaw or dry freezethaw conditions have any influence on the capacity of Cintec anchors embedded in Ohio sandstone masonry blocks using either 75mm or 150mm sock lengths. Figure 11 also shows that providing a r

Results from all tests performed in this project are shown in Table 3 in terms of the ultimate load and type of failure. The failure loads are consistent among all specimens and weathering conditions considered. The table also shows that two main failure types were observed. These include steel failure in the threaded rod within the grouted portion of the anchor followed by slippage but also failure of the steel in the rod between the stonework and the anchorage plates. The ultimate loads recorded during the tests are shown in Figure 11 with respect to sock length as well as in terms of weathering conditions.

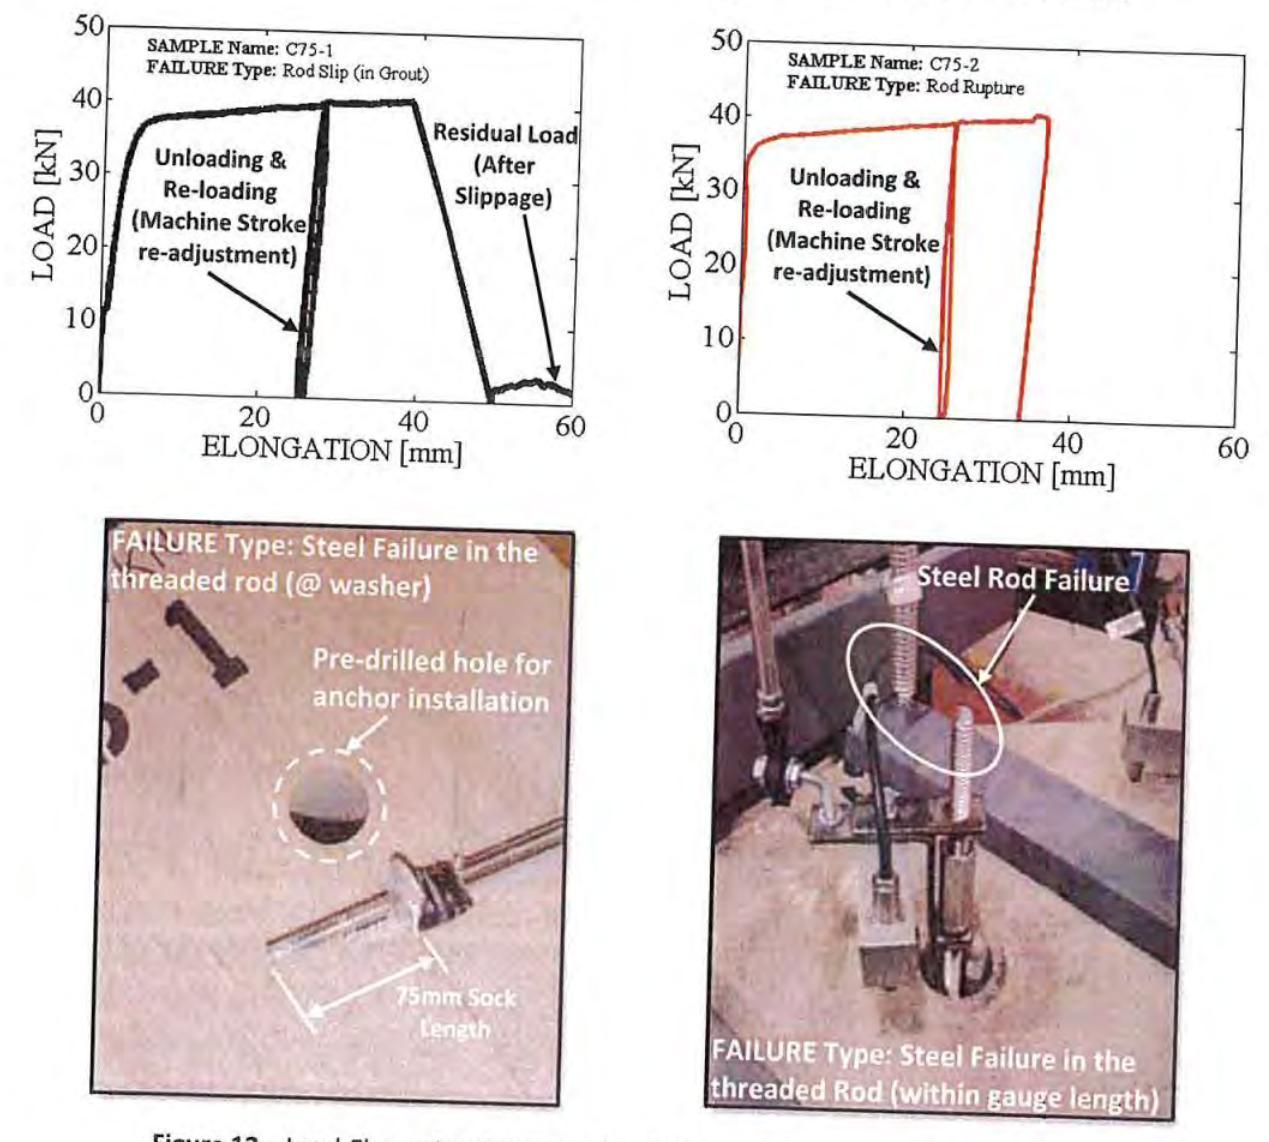
Figure 12 – Load-Elongation Behaviour (Control Samples – 75mm Sock Length)

attributed to yielding of the threaded rod prior to failure. The extent of elongation is illustrated more clearly in Figure 12 and appears to be sustained under loads gradually increasing towards failure.

This ductile behaviour provided by the Cintec repair technique is strongly advantageous because it provides ample warning of impending failure while sustaining a surcharge comparable to the capacity of the anchor. Figure 12 also shows that there is a slight recovery of load once the threaded rod has initiated slip within the grouted portion of the anchor. This residual load gradually reduces until the rod is completely removed from the assembly. Finally, the figure displays an unloading/re-loading stage that was required in most of the tests to re-adjust the stroke of the machine once the limit was reached. The load-elongation behaviour for all samples tested in this study can be found in Appendix A of this report.

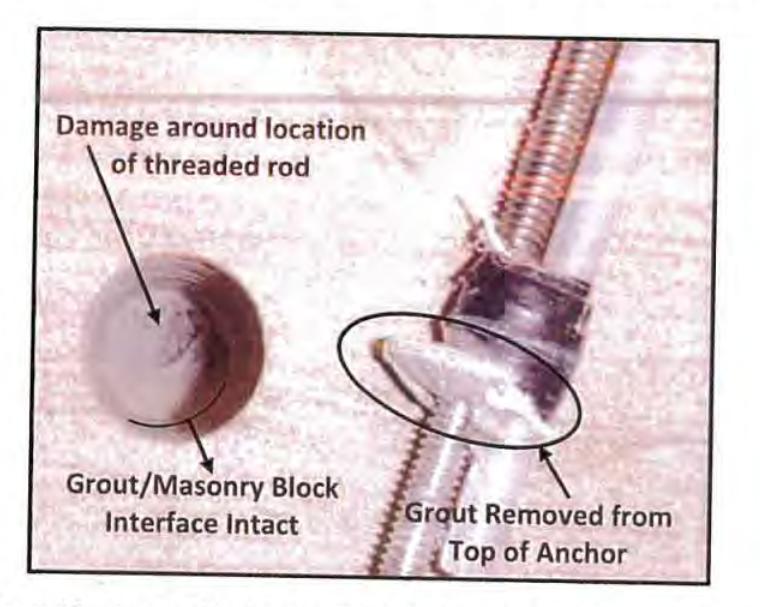
Figure 13 – Grouted Hole after Threaded Rod Pullout (Control Sample C75-1)

Another key observation made after testing relates to the quality of the grouted portion of the anchor, particularly at the interface with the stonework within the hole that was drilled for installation. Failure is initiated by yielding of the rod, after which considerable elongation causes damage to the grout surrounding the rod during testing. Figure 13 suggests that this damage is contained in the vicinity of the rod as well as at the top of the grouted hole. It does not extend towards the interface to affect the bond between the fabric sock and the stonework. The result underlines another advantage of the Cintec anchorage system for rehabilitating structures similar to the West Block building on Parliament Hill.

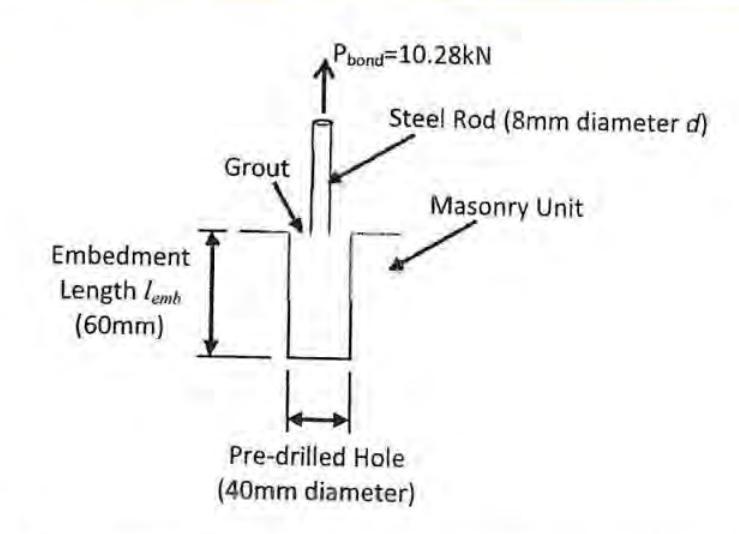
Figure 14 – Grouted Cintec Anchor Assembly (BRE Technical Consultancy Report, 1990)

As observed in Table 3 and mentioned in the previous section, there are two main failure modes observed for the Cintec anchors embedded in the Ohio Sandstone blocks provided by PWGSC. These include steel failure in the rod between the stonework and the machine fixtures. In order to evaluate the first of these failure modes, we refer to test data provided in the BRE Technical Consultancy Report (November 1990) for Cintec anchors. The data was obtained from tests conducted on masonry samples that were instrumented with 8mm diameter steel rods grouted in 40mm diameter holes that were 60mm in length. The sample geometry is shown in Figure 14 and, using force equilibrium, can be used to derive an expression (EQ.1) for the average bond strength between the steel rod and grout.

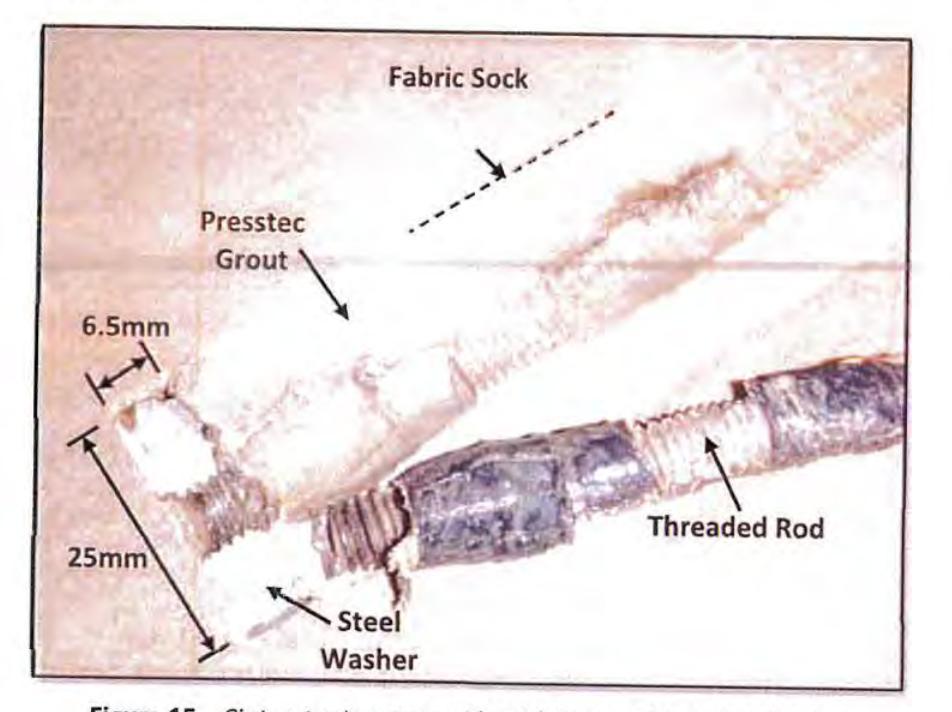
Figure 15 - Cintec Anchor Assembly with Bottom Threaded Washer

failure in the rod at the bottom of the grouted hole, immediately above the washer. This additional strength will increase the ultimate loads listed in Table 5 for bond failure to that which is equivalent to steel failure and thereby confirms the consistency obtained for pullout loads listed in Table 3 despite having used varying embedment (sock) lengths for the anchors.

A complete illustrative documentation of the failure planes similar to the one shown in Figure 15 after testing is provided in Appendix B of this report. The illustrations do not show evidence of damage in the grouted portion of the anchor for any of the failure modes, which indicates that the Cintec rehabilitation technique is resilient despite the consideration of thermal weathering. It should be noted that the failure planes in these illustrations were exposed by sectioning the samples down the center of the grouted hole. Sectioning was performed by DiTECH International Inc. and took place at the University of Manitoba. Several pictures of the sectioning procedure are shown in Figure 16.

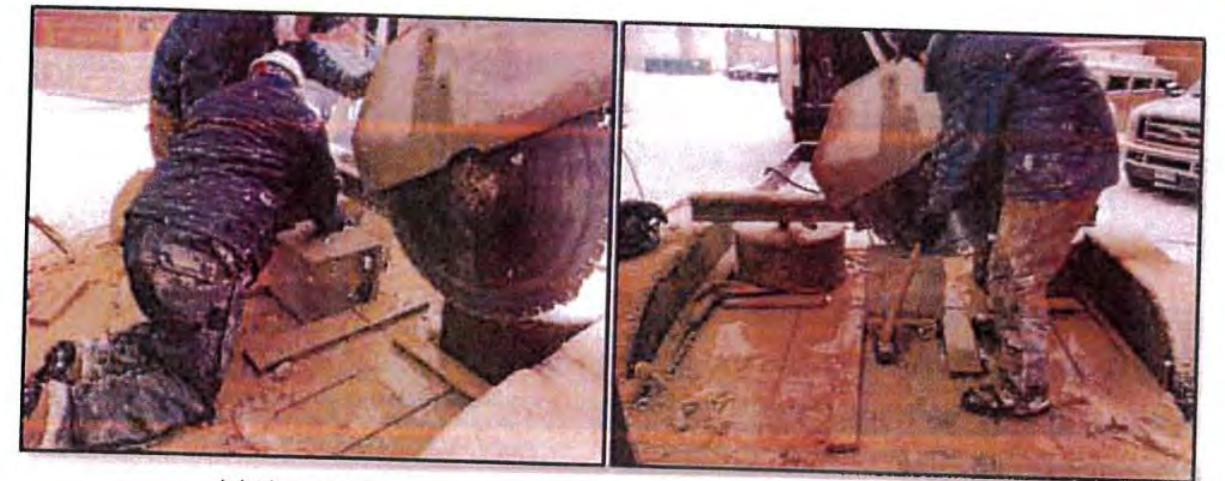
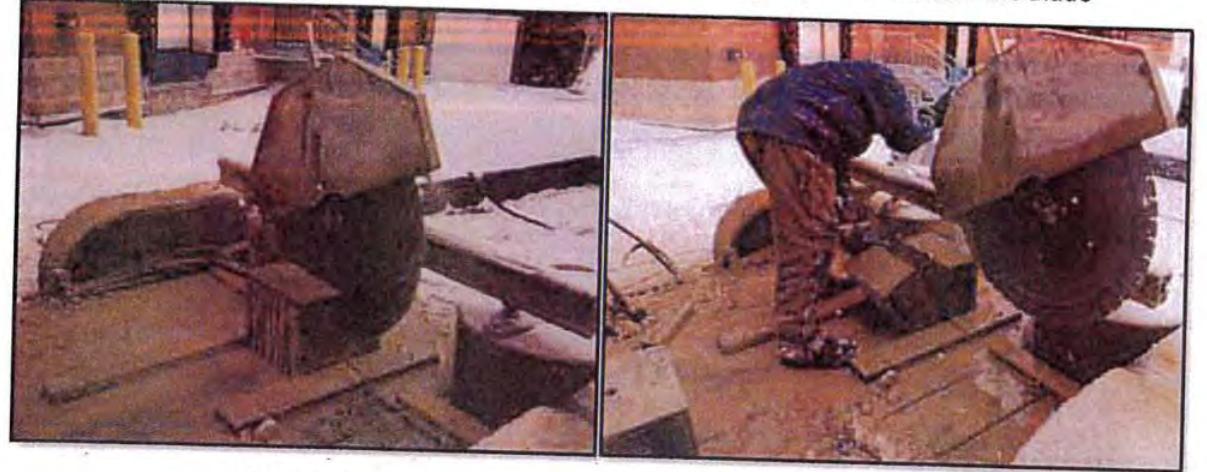
(a) Placement

(b) Adjustment under the Blade

(c) Cutting (d) Removal of Sectioned Pieces **Figure 16** – Sectioning Procedure (DiTECH International Inc.)

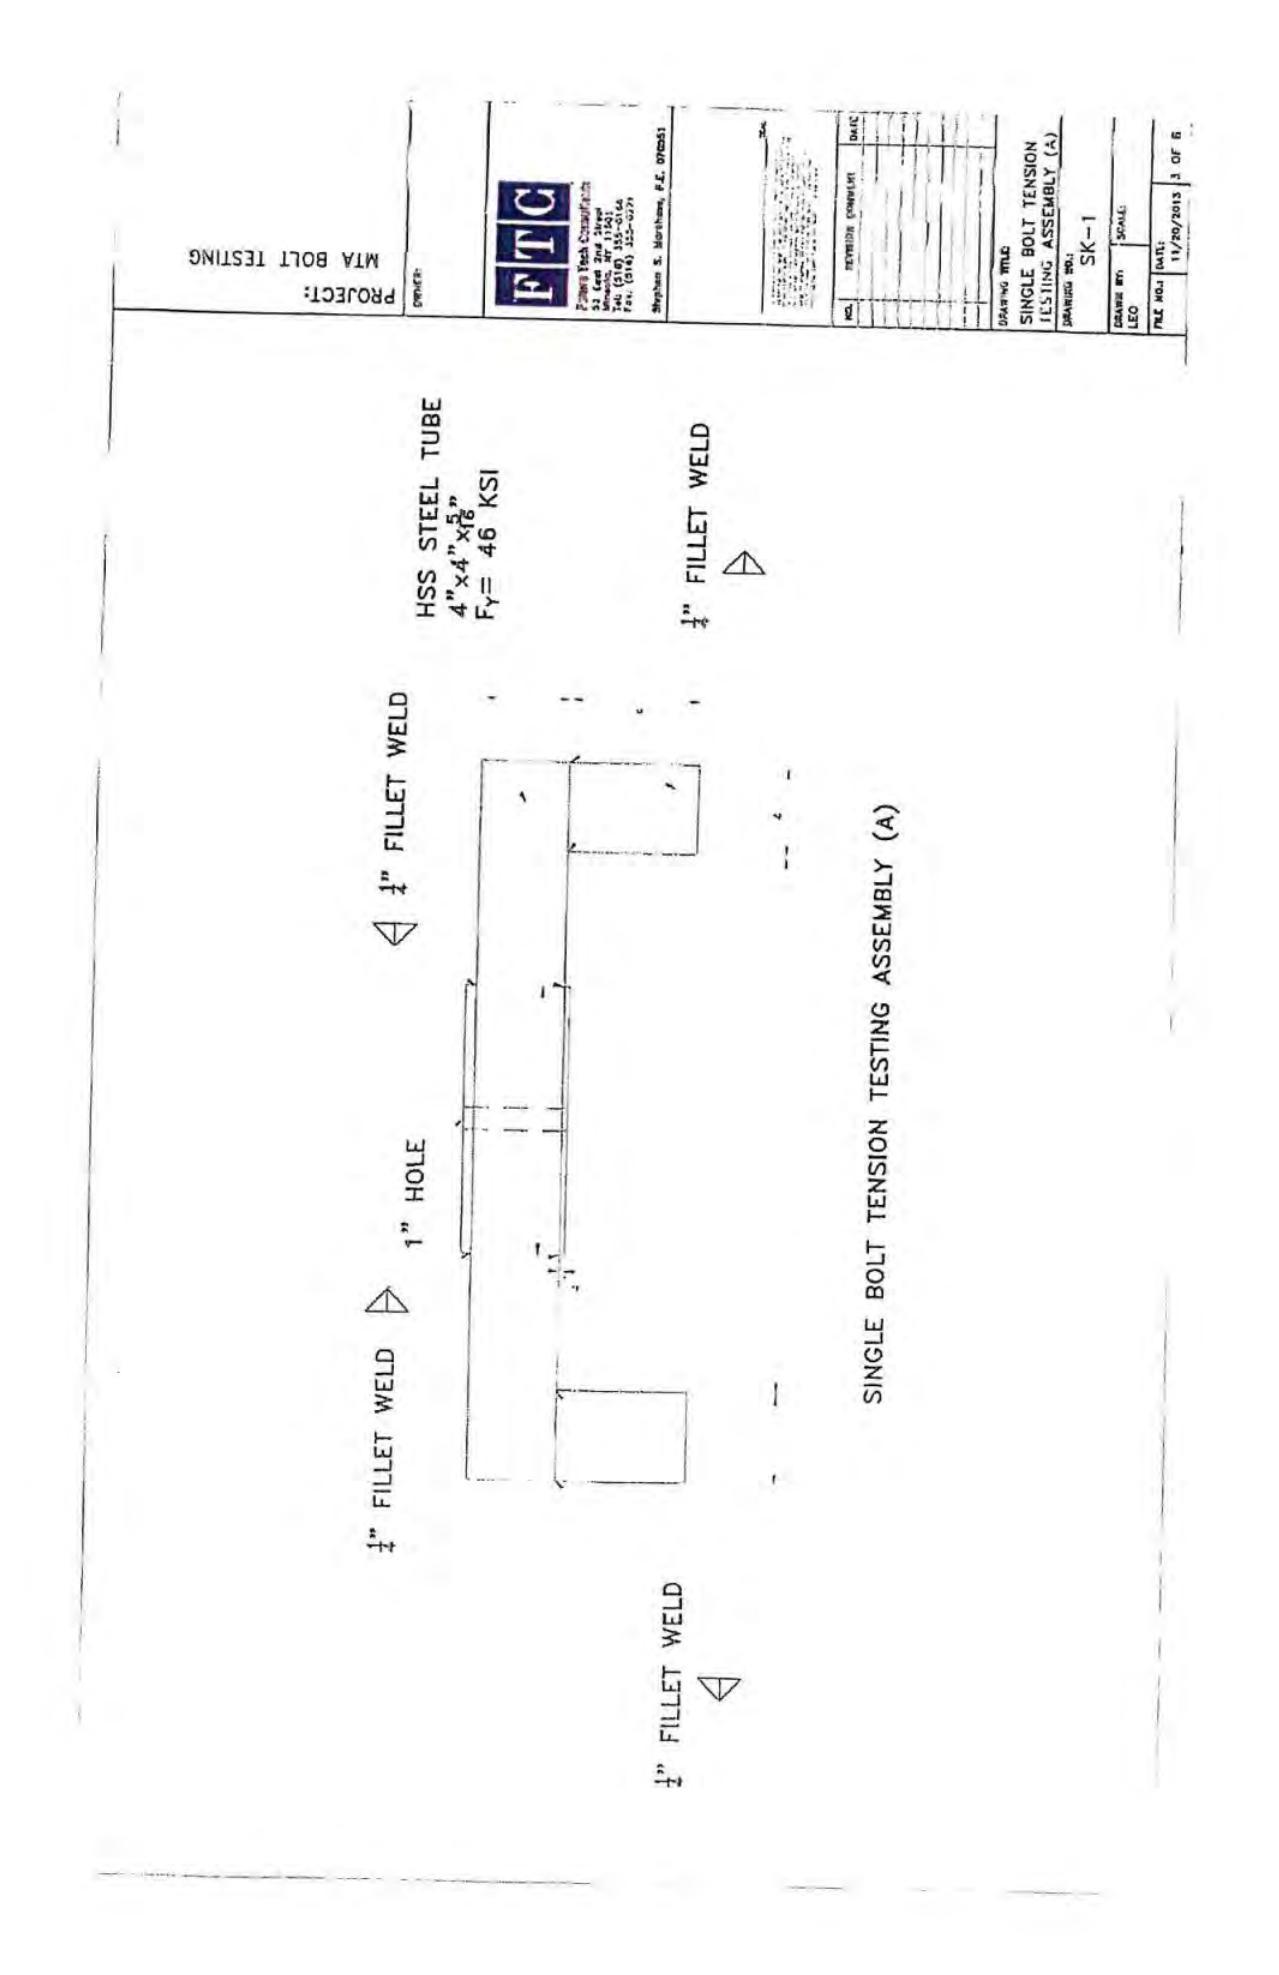
### TYPICAL TEST SET UP W 168<sup>TH</sup> ST. STATION # GROUP A

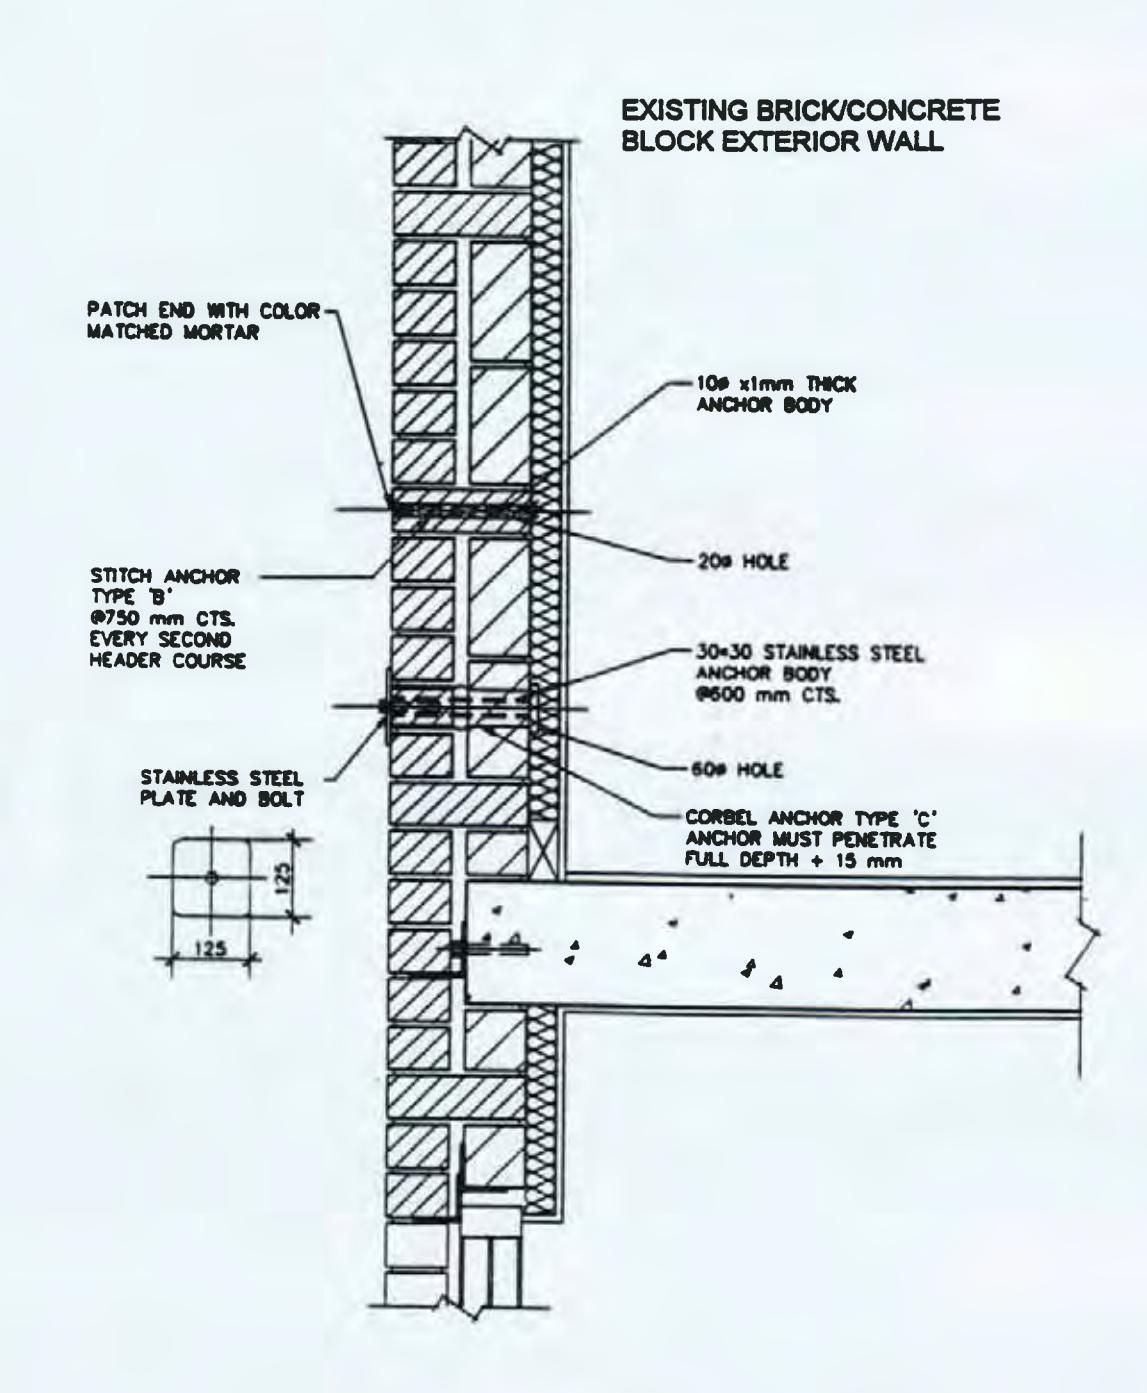
**PROPOSED ANCHOR APPLICATION**

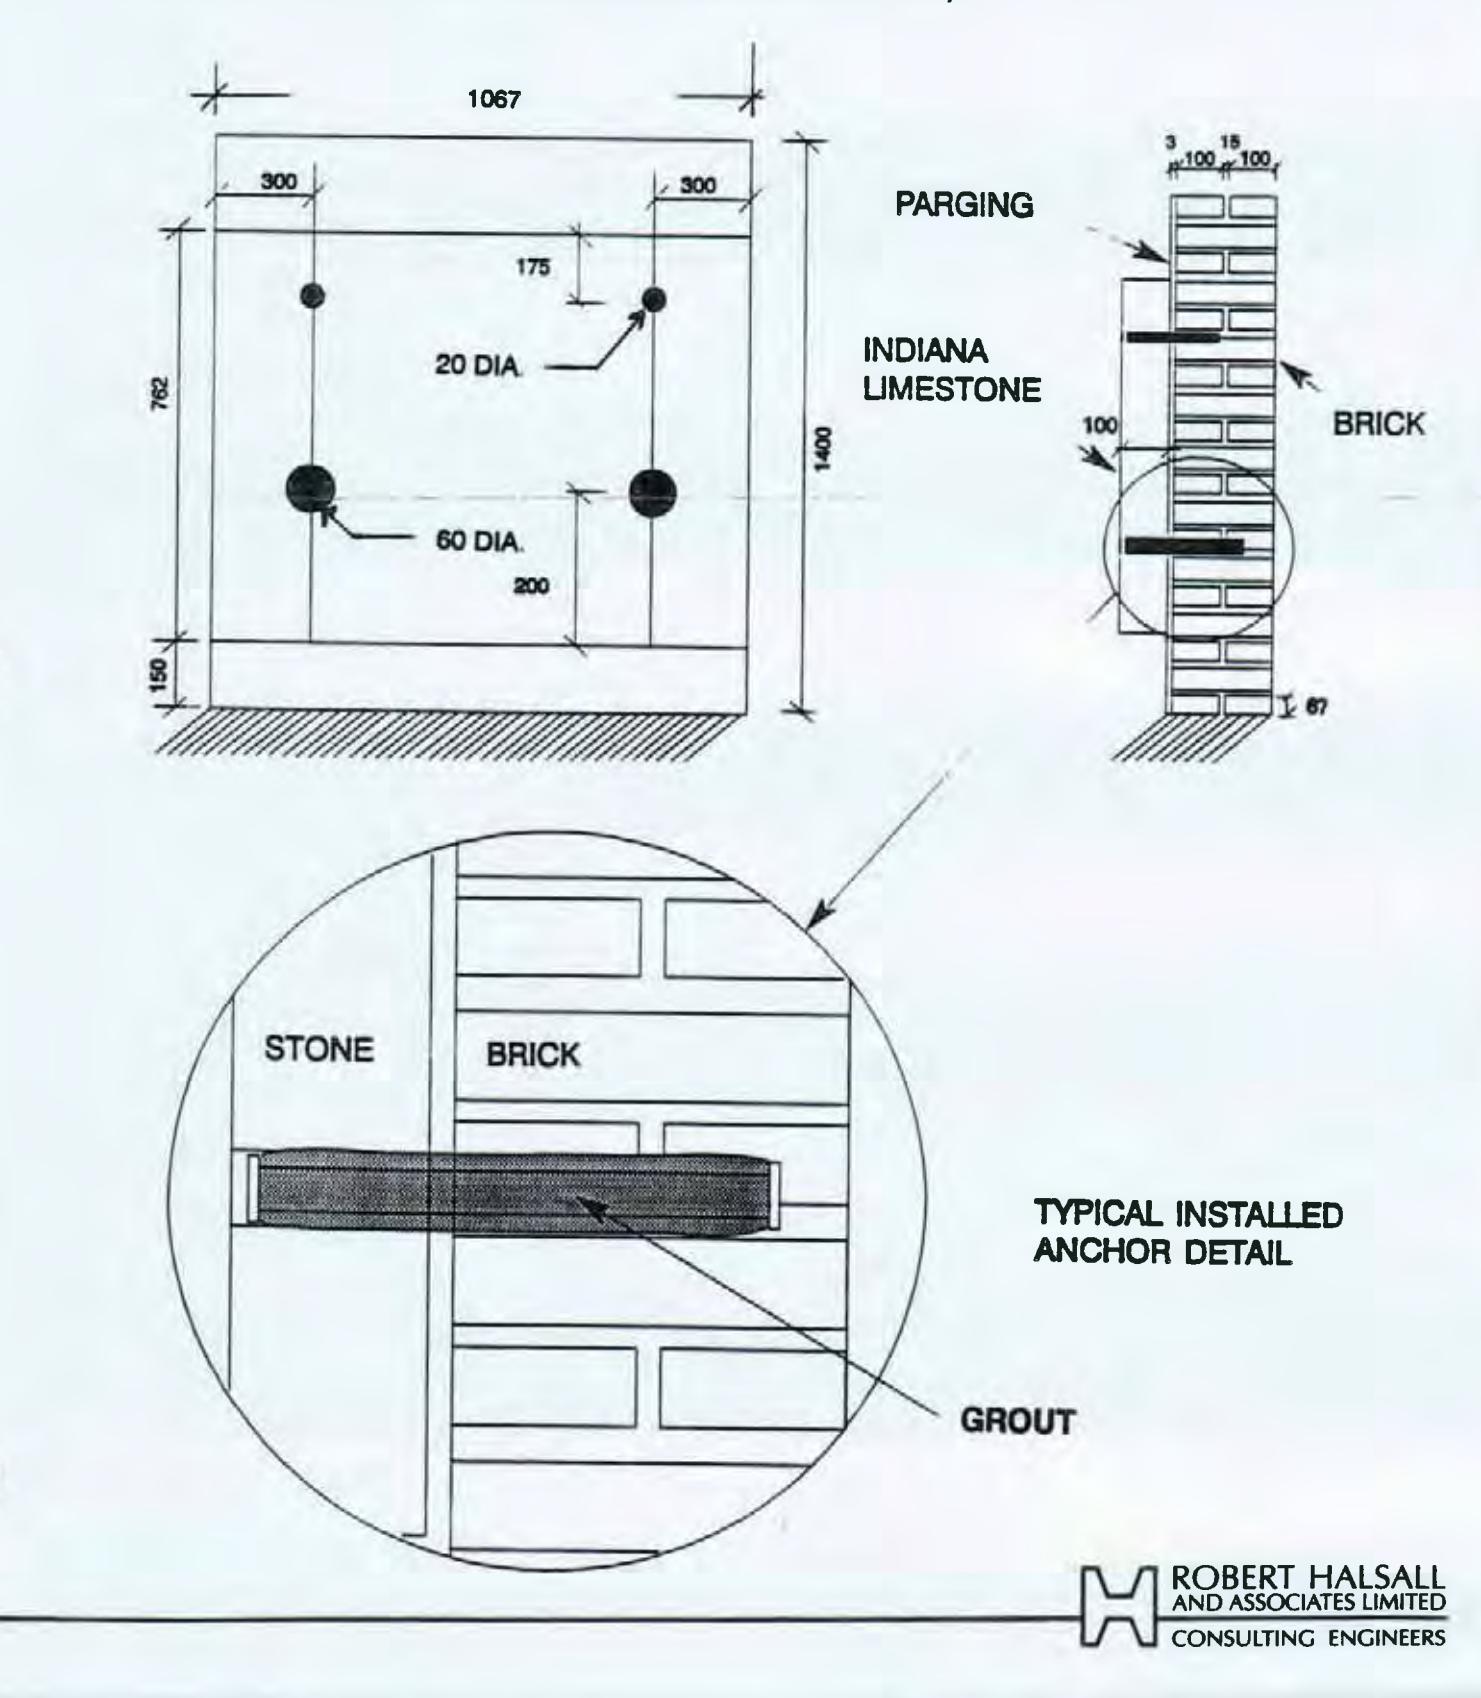
TEST ASSEMBLY DRAWINGS (all measurments in mm):

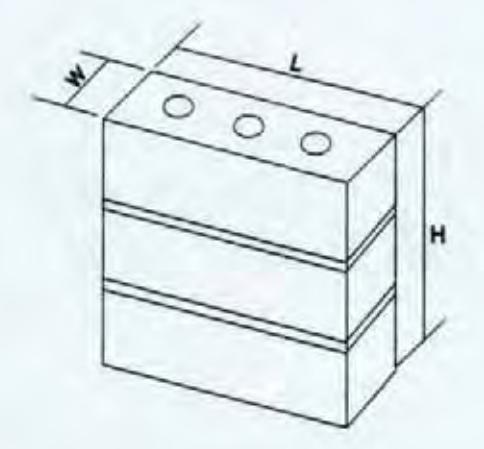
**TYPICAL PRISM**

- PRISMS WERE CUT FROM TEST WALL
- PRISM ENDS WERE CAPPED WITH HYDROSTONE CEMENT
