Introduction to the Cintec Anchoring & Reinforcement System Non Destructive Test Procedure. Client Reports from International Testing Establishments with relevent standards.

# TEST DATA FOR CINTEC ANCHORS

# CINTEC'S ANCHORING AND REINFORCEMENT SYSTEM

Moisture/Temperature cycling tests On the Cintec remedial wall tie

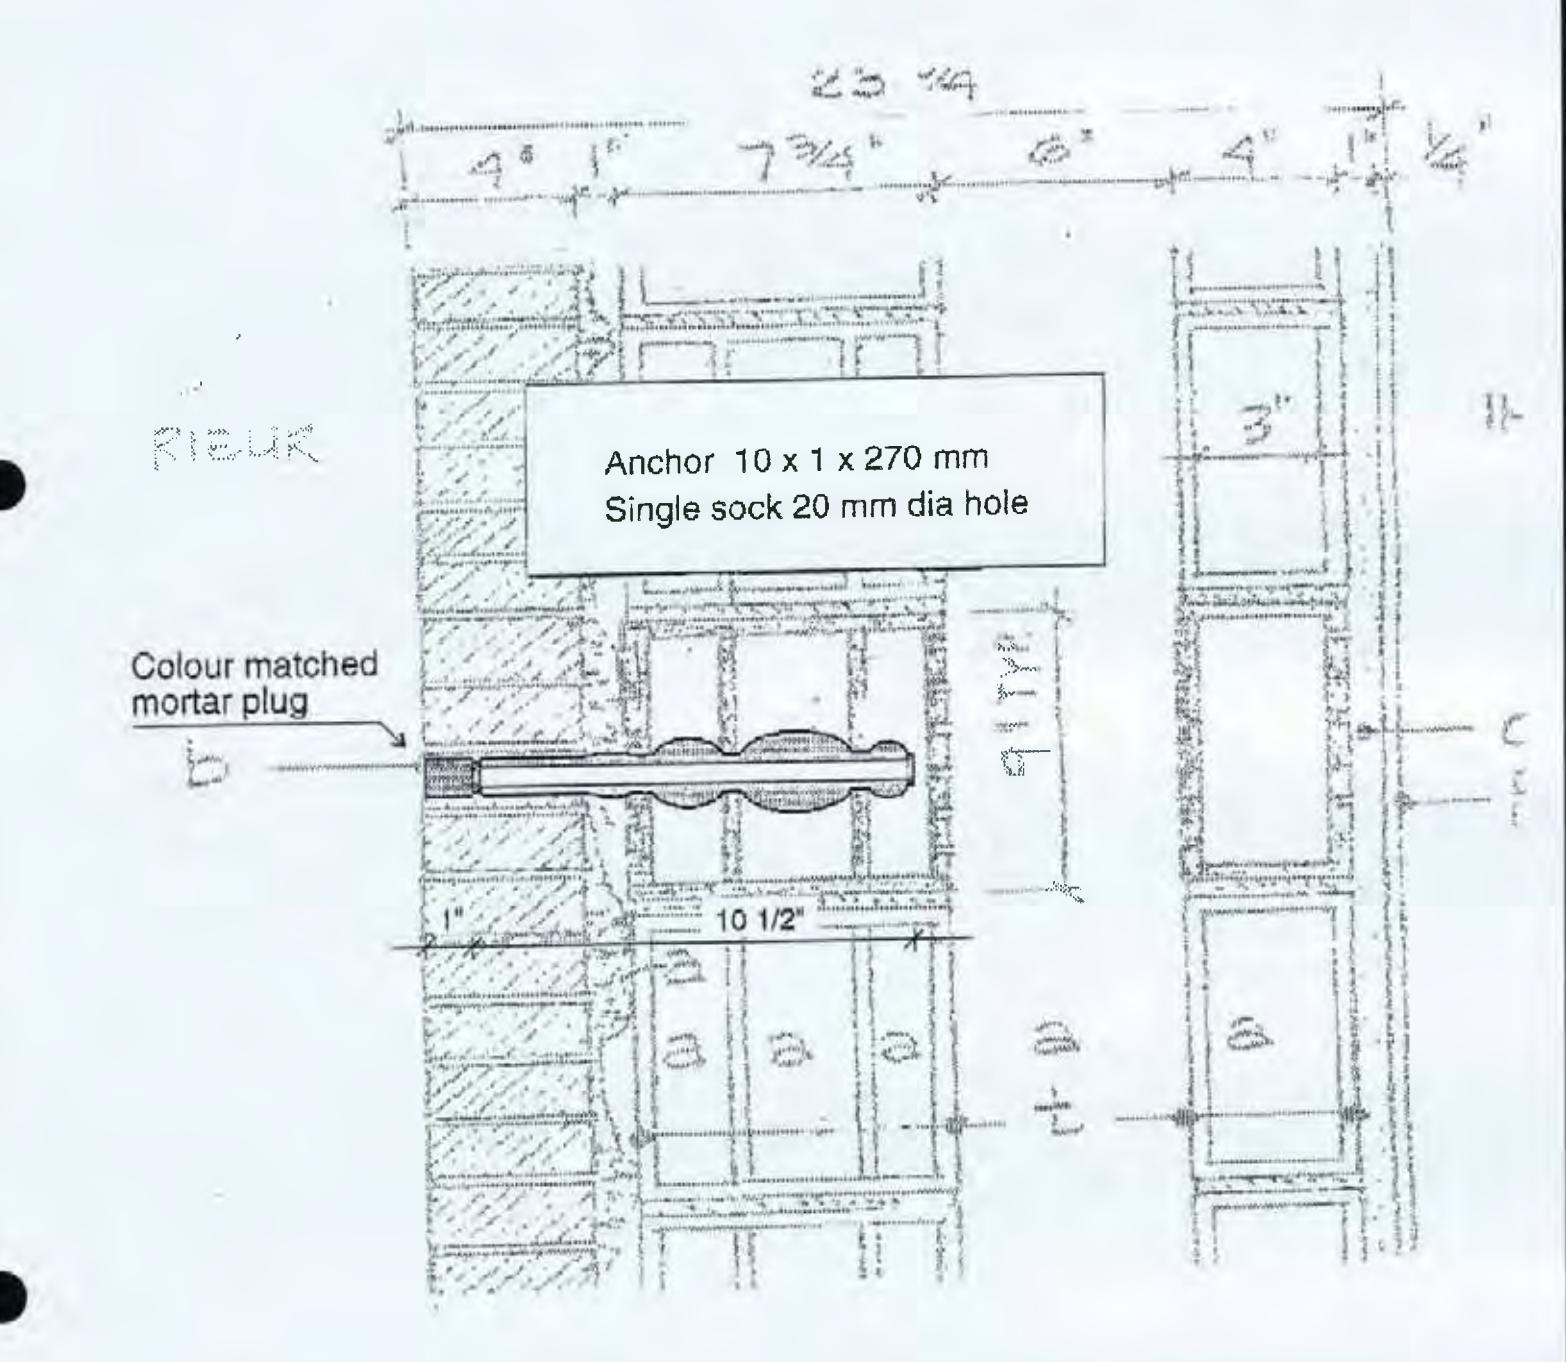
### **Anchor Layout**

18 x 36system

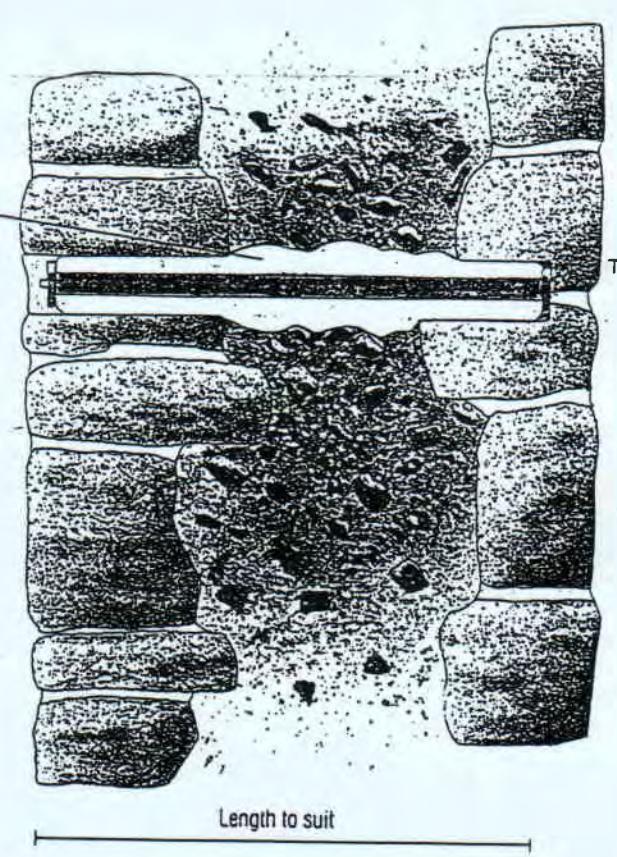
### STITCHING ANCHOR

Anchor body design dependent on load
