NOVEMBER • 2011

# Civil Engineering

### *Air Bags and Stainless Steel Anchors and Mesh Help Preserve Egyptian Pyramid*

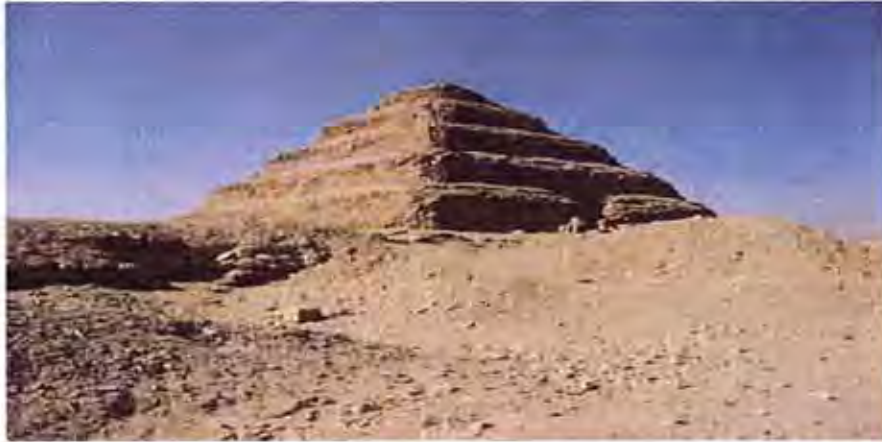
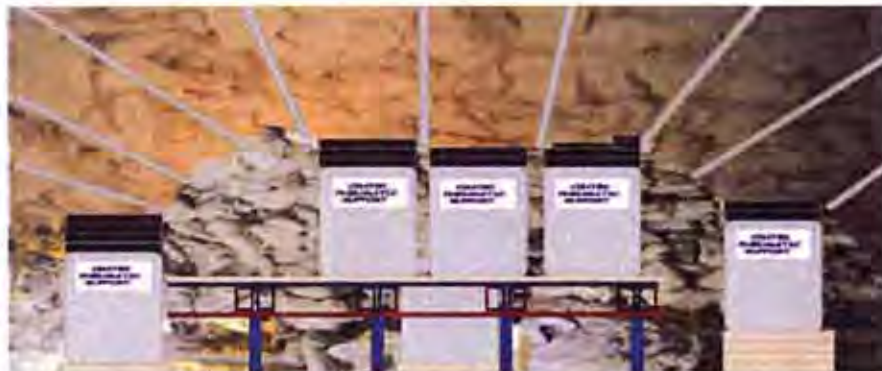
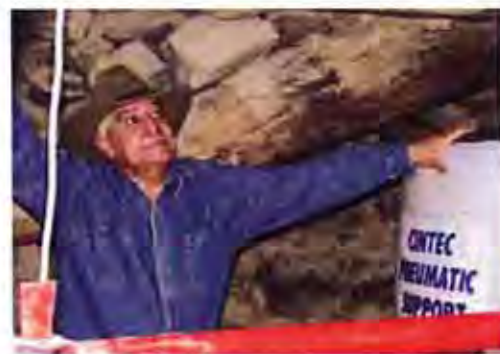
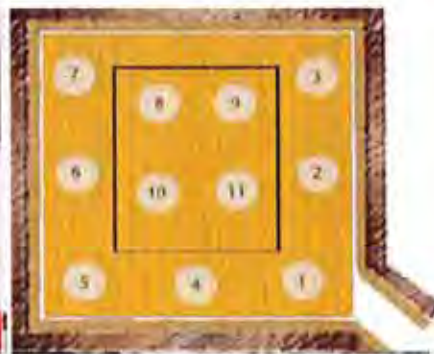
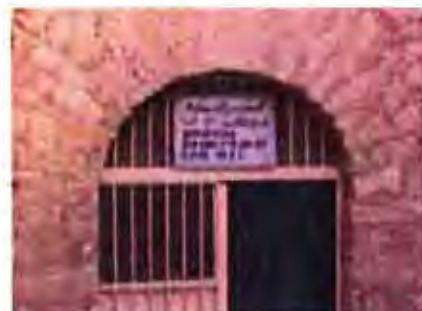
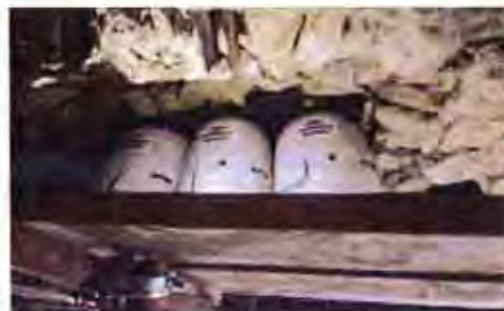
**A**N EFFORT TO PRESERVE and protect the oldest pyramid in Egypt involves the use of air bags and stainless steel anchors and mesh to secure the ancient structure's burial chamber and prevent any additional seismically induced collapse. Located in the Saqqara (Sakkara) burial complex – the necropolis of the ancient city of Memphis – roughly 30 km south of Cairo, the 4,700-year-old Step Pyramid of Djoser is considered by Egypt's Supreme Council of Antiquities to be the earliest example of large-scale stone construction in that country. Its name derives from its terrace profile, and it has been damaged by earthquakes throughout its history, most recently in 1992.

To perform the work on the chamber roof, Acrow Misr, a Cairo-based metallic scaffolding and framework designer and manufacturer, erected a steel scaffolding system that spans the space containing the sarcophagus. The scaffolding was erected in such a way that no loads were imposed on the sarcophagus or the tunnels beneath it. Next, a work platform was raised to the underside of the chamber roof, and Cintec constructed a second level for this scaffolding. This smaller "mezzanine" section, in the center of the main scaffolding and the mezzanine section provided the bases from which Cintec's engineers installed a series of 11 custom-designed air bags, each roughly 1.5 m long and 1 m diameter. Adapted from a Cintec product known as the Waterwall – a structure made of a tough synthetic fabric that can be filled with water to provide protection against explosive blasts – the systems used in the Step Pyramid featured thin layers of poly-vinyl chloride and were filled with air rather than water. The thinner polyvinyl chloride fabric was easier to control during the inflation process and thus could

Connected to a common manifold and pressurized either individually or in groups, as the site circumstances dictated, the bags were gently inflated, initially at a low pressure of 1 psi, to form the shape overall dimensions required, James says. The pressure in each bag was then gently increased to a maximum of 8 psi, at which point each bag could support 3 metric tons of stone. The tops of the bags were adjusted to provide the optimal support to the roof's jagged profile. Timber shims were used to support the undersides of the air bags, and thin blocks of high-density, semi-rigid foam were carefully cut and shaped to fit around the hanging stones. These foam blocks were used atop the bags to ensure "a gentle kiss with no compression" between the bags and the surfaces of the stones, James notes. "We just want to hold the stones where they are," he says.

Once all of the bags are in place, Cintec engineers will spend about a month or so using a lime grout to fill in gaps around the stones. Then, using a diamond drill, they will carefully create a series of 52 mm diameter holes at roughly 2 to 4 m intervals along the perimeter of the roof and at varying angles in the stones. The drilling will be conducted under dry conditions, and a dust extraction system will be used throughout the process, James adds.

Stainless steel anchors generally 2 to 4 m in length will then be installed in the drilled holes and secured with additional grout by means of a proprietary Cintec process featuring a vacuum tube that applies the grout under low pressures. This process is also designed to prevent any negative buildup of pressure that might prevent the anchor from being properly installed. The anchors will create what is essentially a three-dimensional archlike support at the roof to stabilize the

A second series of holes that will have diameters of 32 mm will be drilled and filled with 750 mm long anchors. These smaller anchors will secure a stainless steel mesh tightly against the ceiling to prevent smaller stones from falling. The mesh will also be attached to the ends of the main anchors.

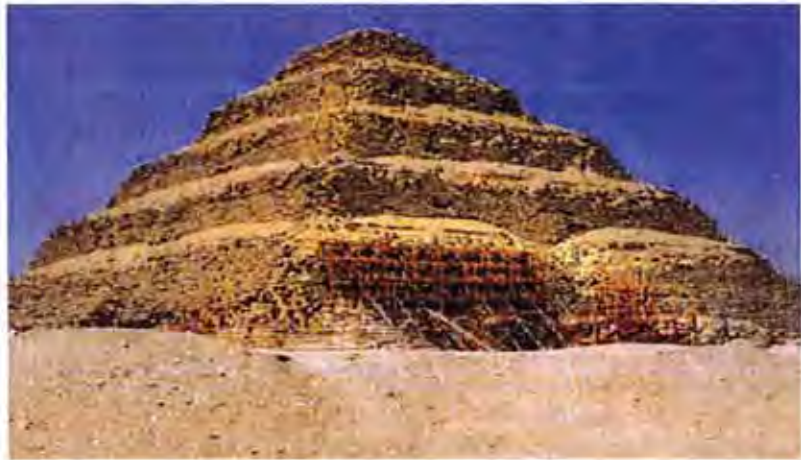
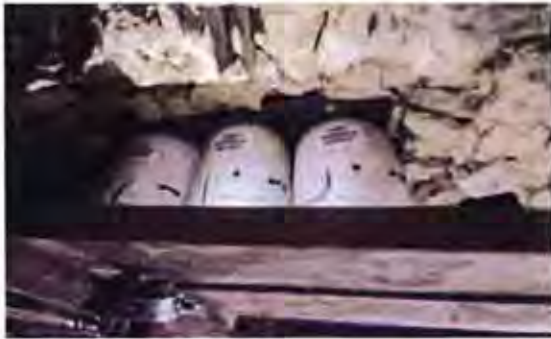
The 4,700-year-old Step Pyramid of Djoser – so named because of its terraced profile – was damaged over the centuries by repeated earthquakes, most recently in 1992. Located in the Saqqara (Sakkara) burial complex roughly 30 km south of Cairo, the structure is considered the oldest pyramid in Egypt. At a maximum of 8 psi, each air bag, left, can support 3 metric tons of **stone**. Thin blocks of high density, semi-rigid foam carefully cut and shaped to fit around the hanging stones were used atop the air bags. Over the centuries the burial chamber's flat timber roof deflected and collapsed. The chamber was closed to the public after an earthquake in 1992 caused as much as 200 metric tons of loose stone and rubble, as well as the supporting timber props, to fall from the roof onto the sarcophagus.

When the current repair project began, Egyptian engineers inspected and strengthened the supports for the sarcophagus itself as well as for the tunnels beneath the tomb, installing stainless steel pins to anchor the stonework where necessary. Work crews removed the debris from atop the sarcophagus, carrying the material out in small loads through the narrow, lower tunnels. Archaeologists from the Supreme Council of Antiquities carefully monitored this work, inspecting each rock as it was removed to determine its possible historical significance, the council also monitored all subsequent efforts by Cintec, James notes.
