Goodrington Sea Wall, Devon, U.K.

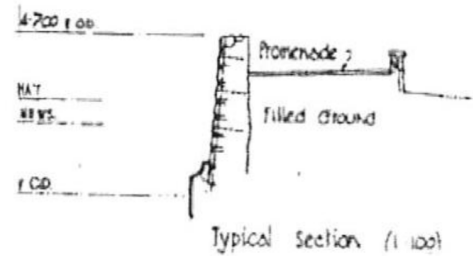
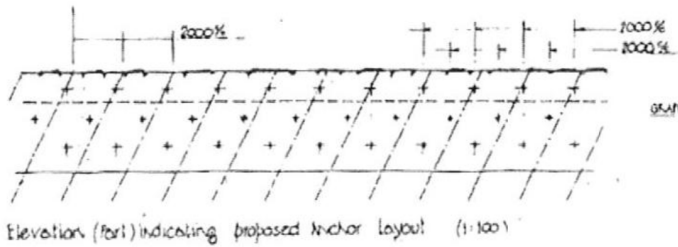
The Sea wall at Goodrington Beach, in Devon, UK, was constructed of local stone and founded upon a concrete footing. The whole wall was gradually moving towards the sea by sliding off the concrete foundation

To overcome the problem, Torbay Borough Council proposed a design using Cintec anchors to pin the wall to the foundation. The anchors were inserted at an angle to mobilize the full length of the wall.
